Modified to Fit Waterford Unit #3

Concrete Phase I Construction

POP-N-713
USE OF DISCREPANCY REPORTS

WATERFORD III SES
ANALYSIS OF CRACKS AND WATER SEEPAGE
IN FOUNDATION MAT
LOUISIANA POWER & LIGHT COMPANY
REPORT NO. 8304-1
SEPTEMBER 19, 1983

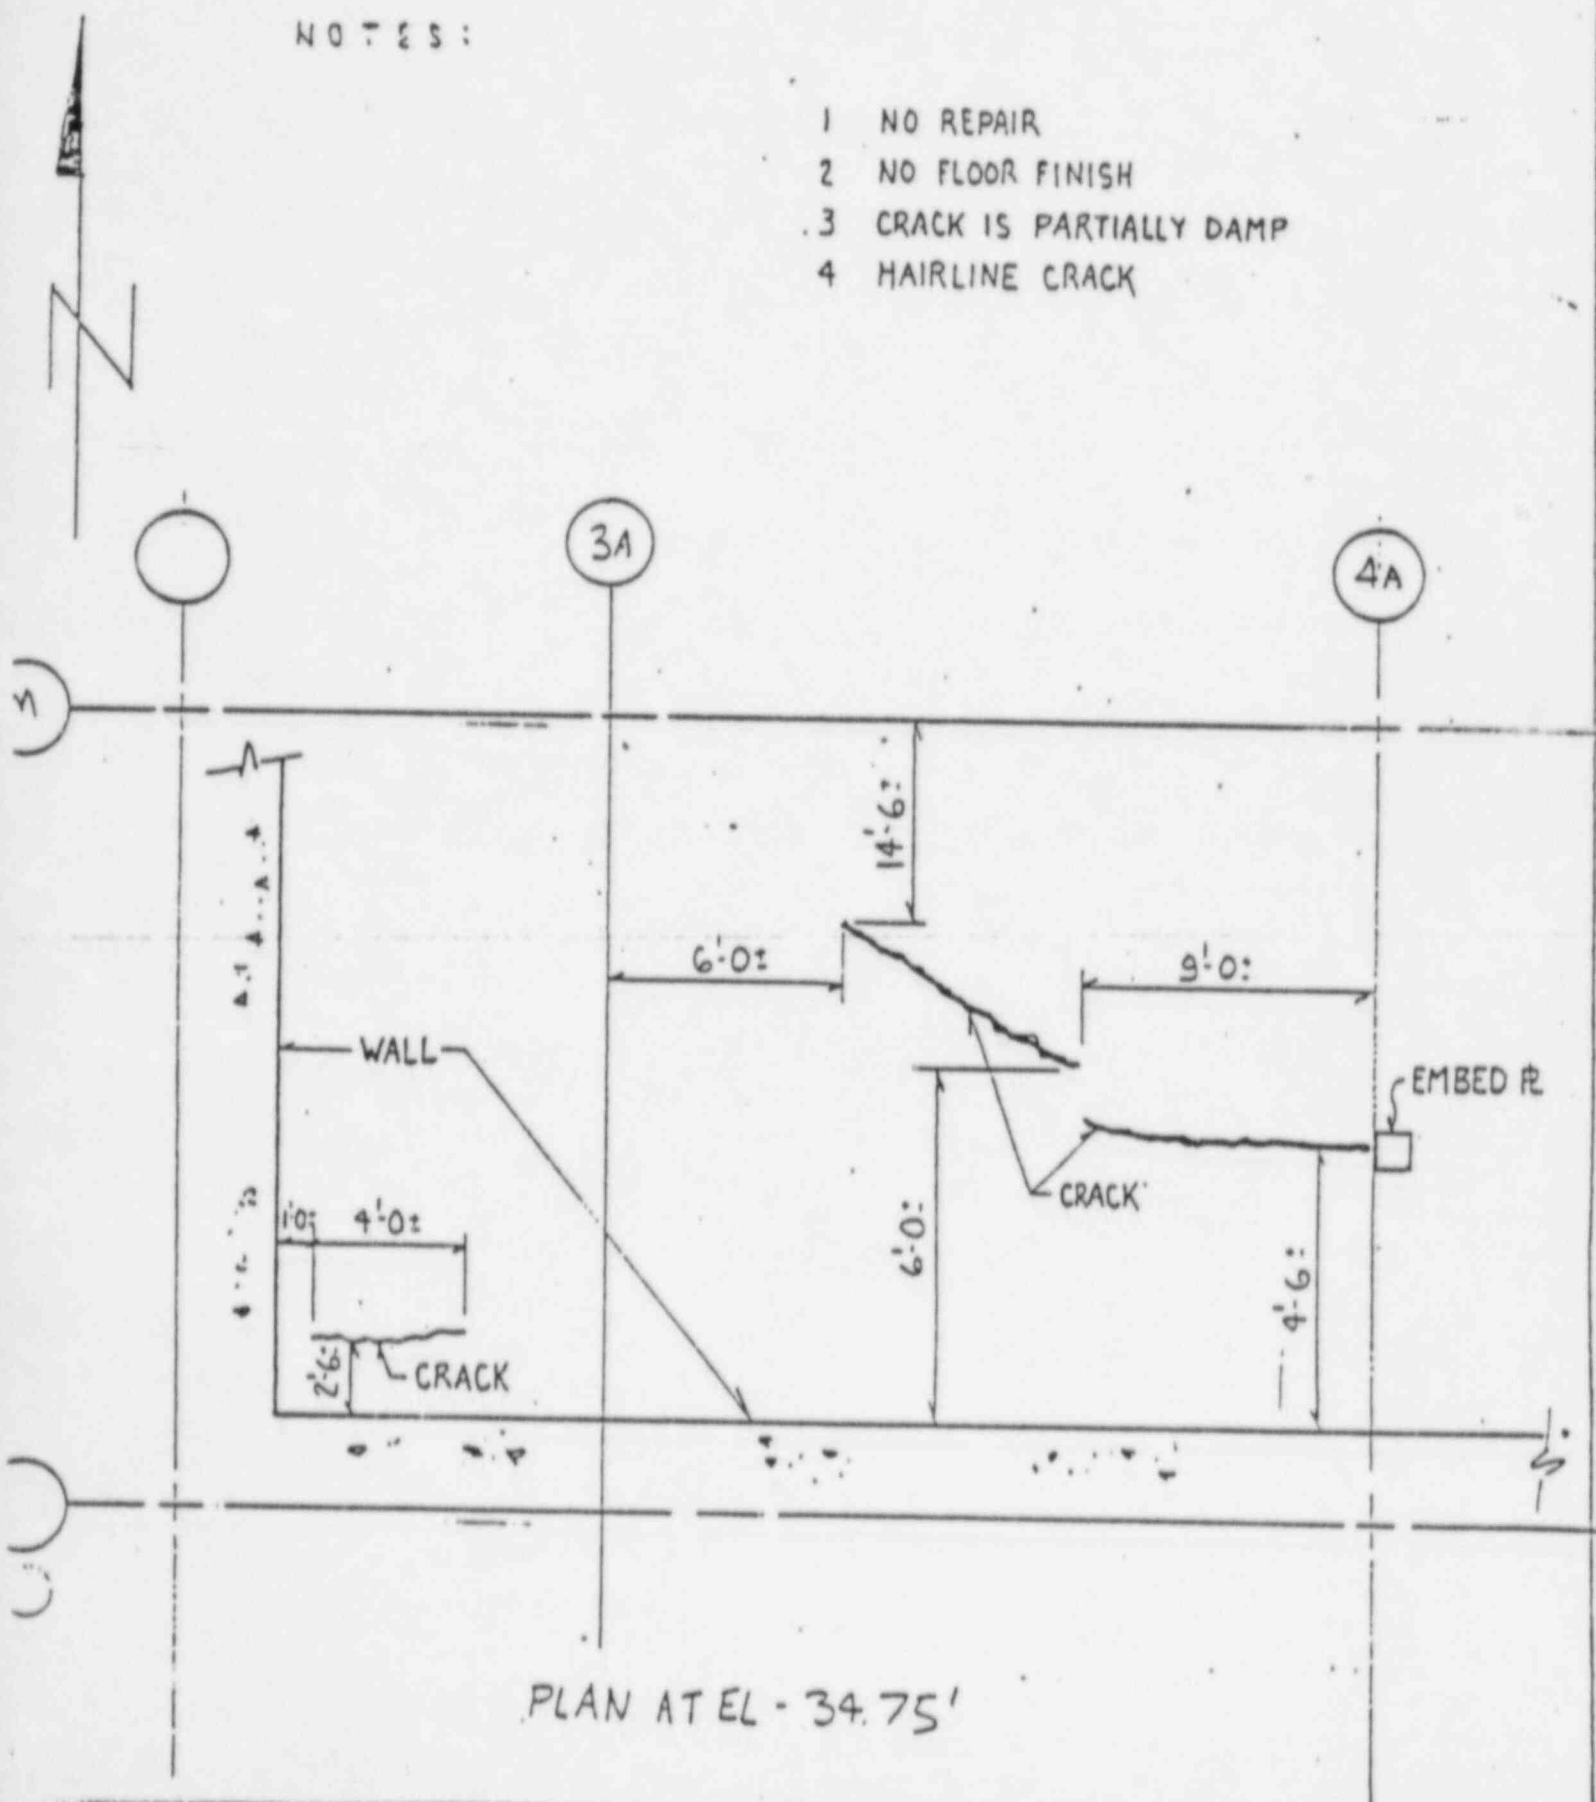
- 1 NO REPAIR
- 2 NO FLOOR FINISH
- 3 CRACK IS PARTIALLY DAMP
- 4 HAIRLINE CRACK

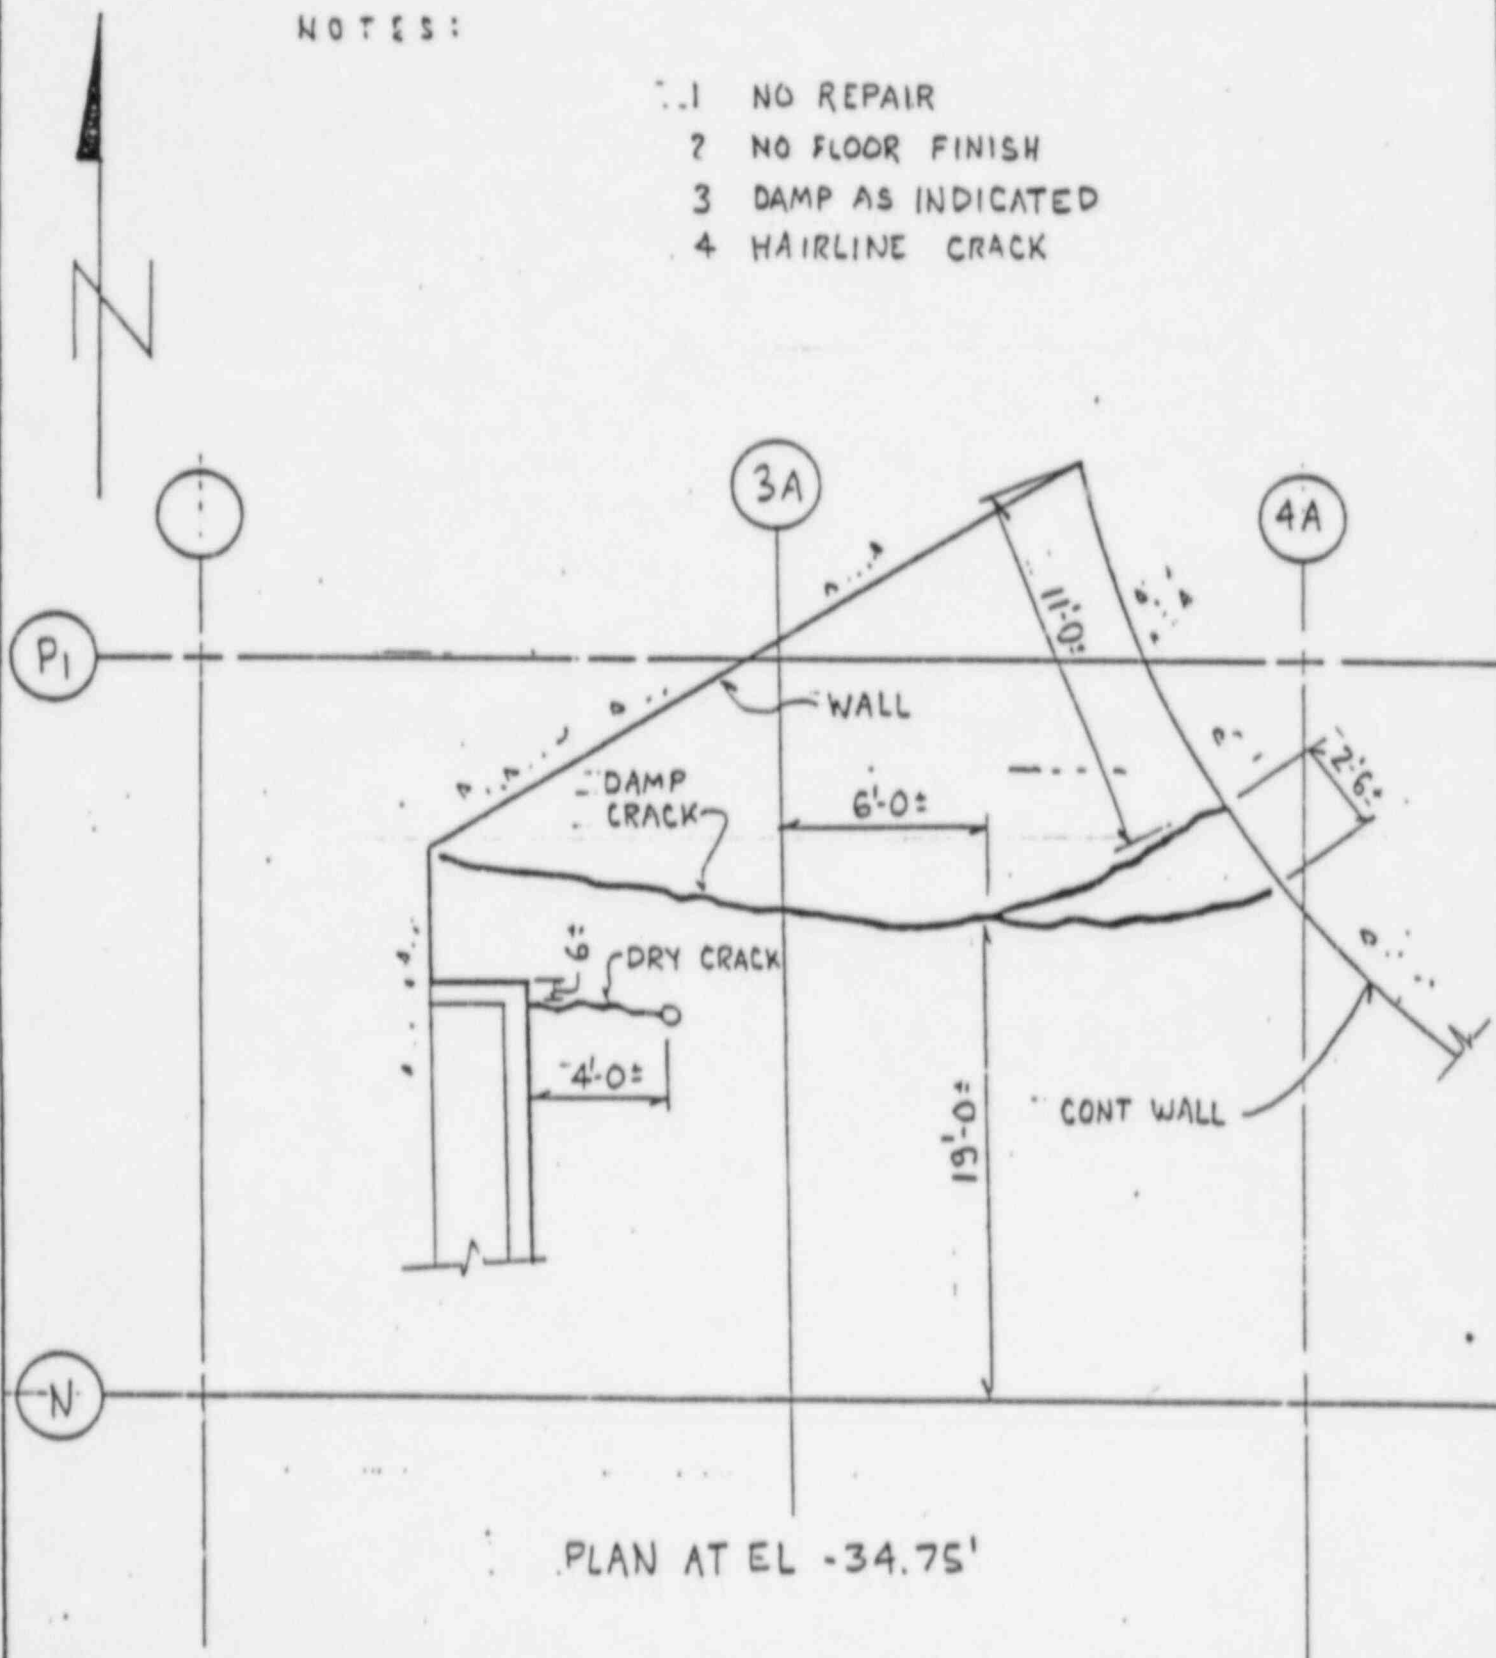
PLAN AT EL -34.75'

- 1 NO REPAIR
- 2 NO FLOOR FINISH
- 3 DAMP AS INDICATED
- 4 HAIRLINE CRACK

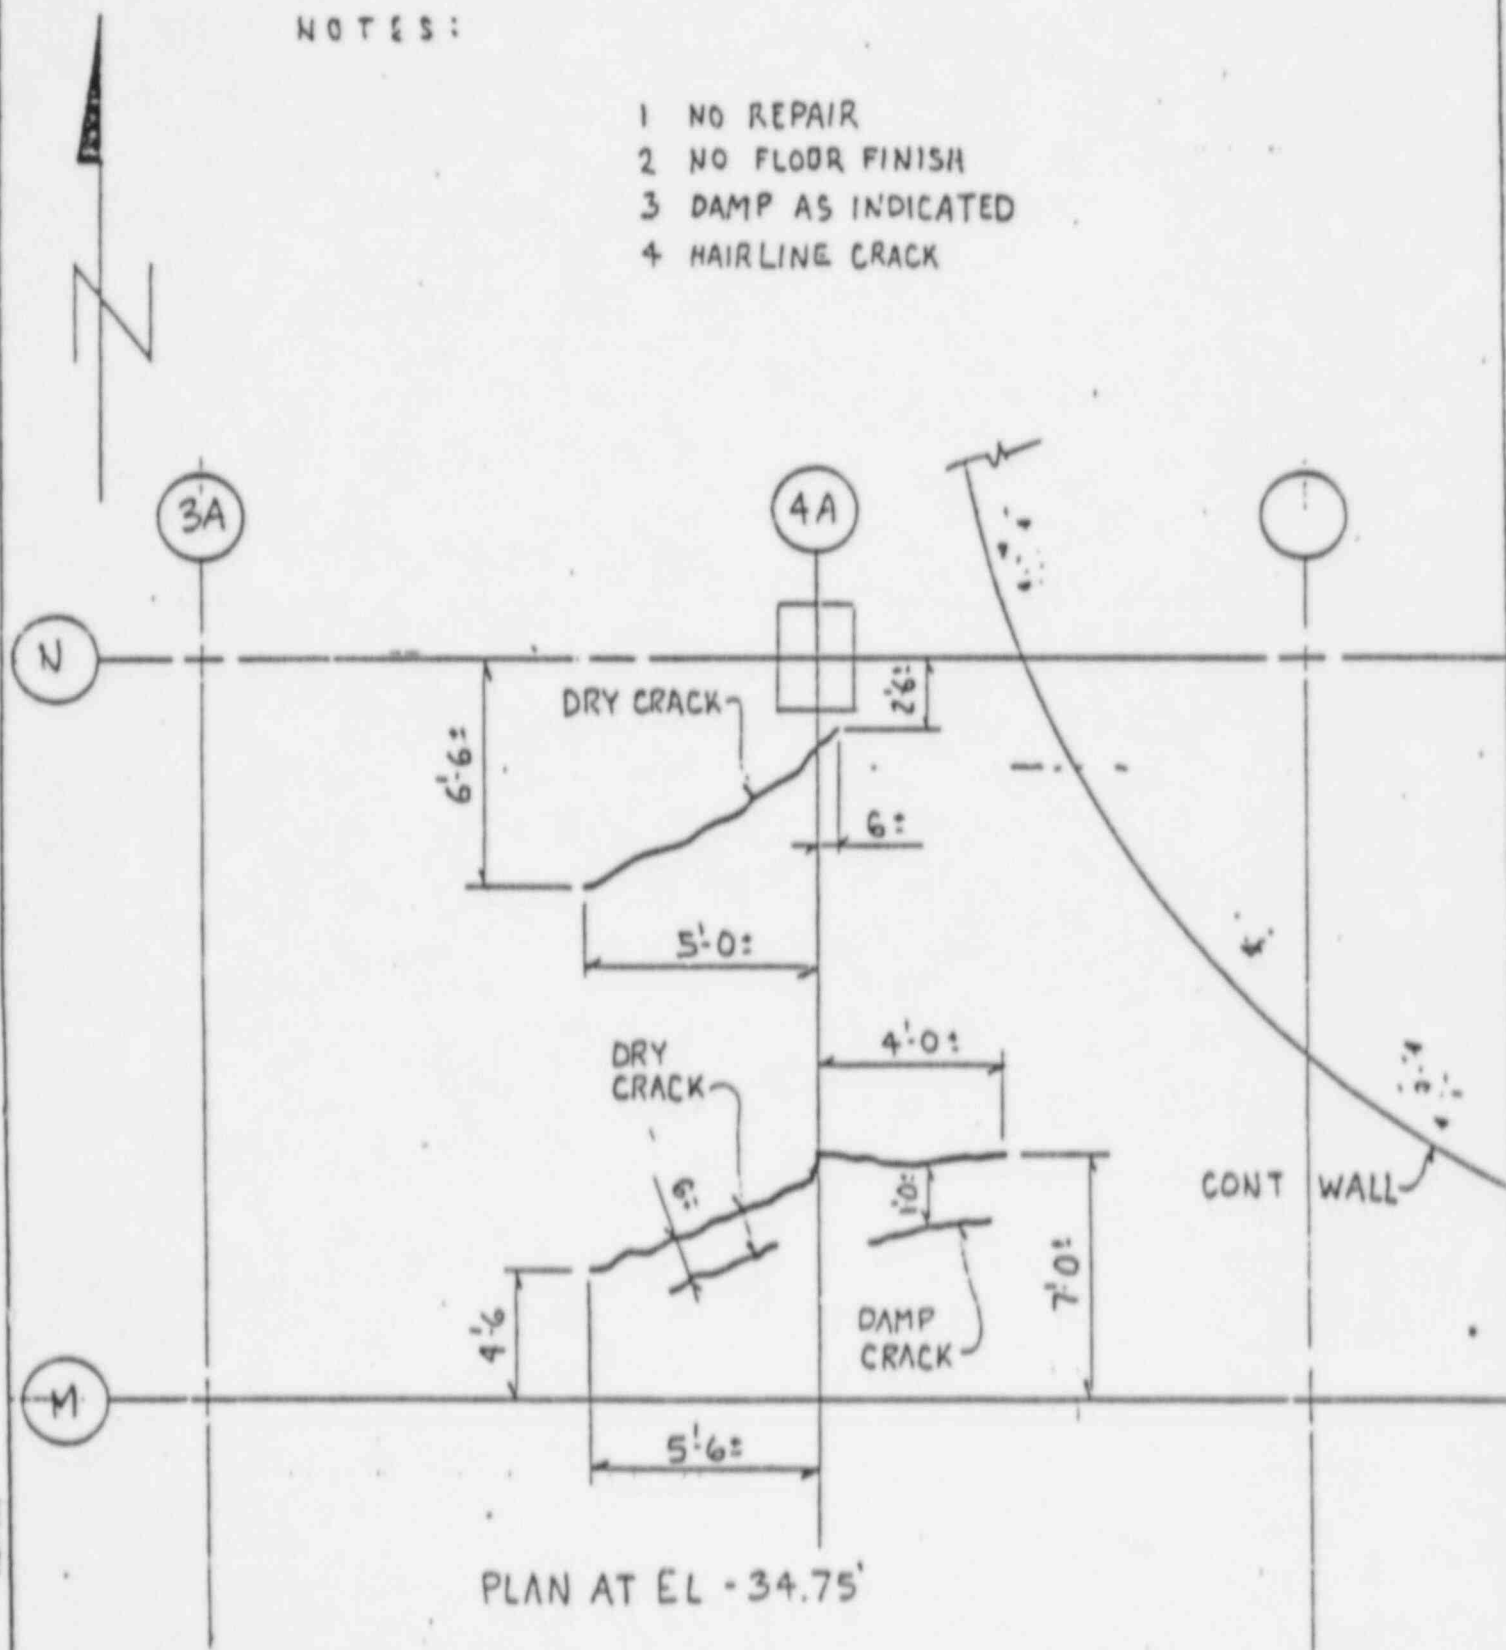
PLAN AT EL - 34.75'

- 1 NO REPAIR
- 2 NO FLOOR FINISH
- 3 DAMP AS INDICATED
- 4 HAIRLINE CRACK
