UNITED STATES  
NUCLEAR REGULATORY COMMISSION  
REGION I  
631 PARK AVENUE  
KING OF PRUSSIA, PENNSYLVANIA 19406

SUBJECT: POTENTIAL BOARD NOTIFICATION - TDI DIESEL AIR START CHECK  
VALVE CRACK AT SHOREHAM

PRELIMINARY NOTIFICATION OF EVENT OR UNUSUAL OCCURRENCE--PNO-I-85-22

Subject: TDI DIESEL AIR START CHECK VALVE CRACK

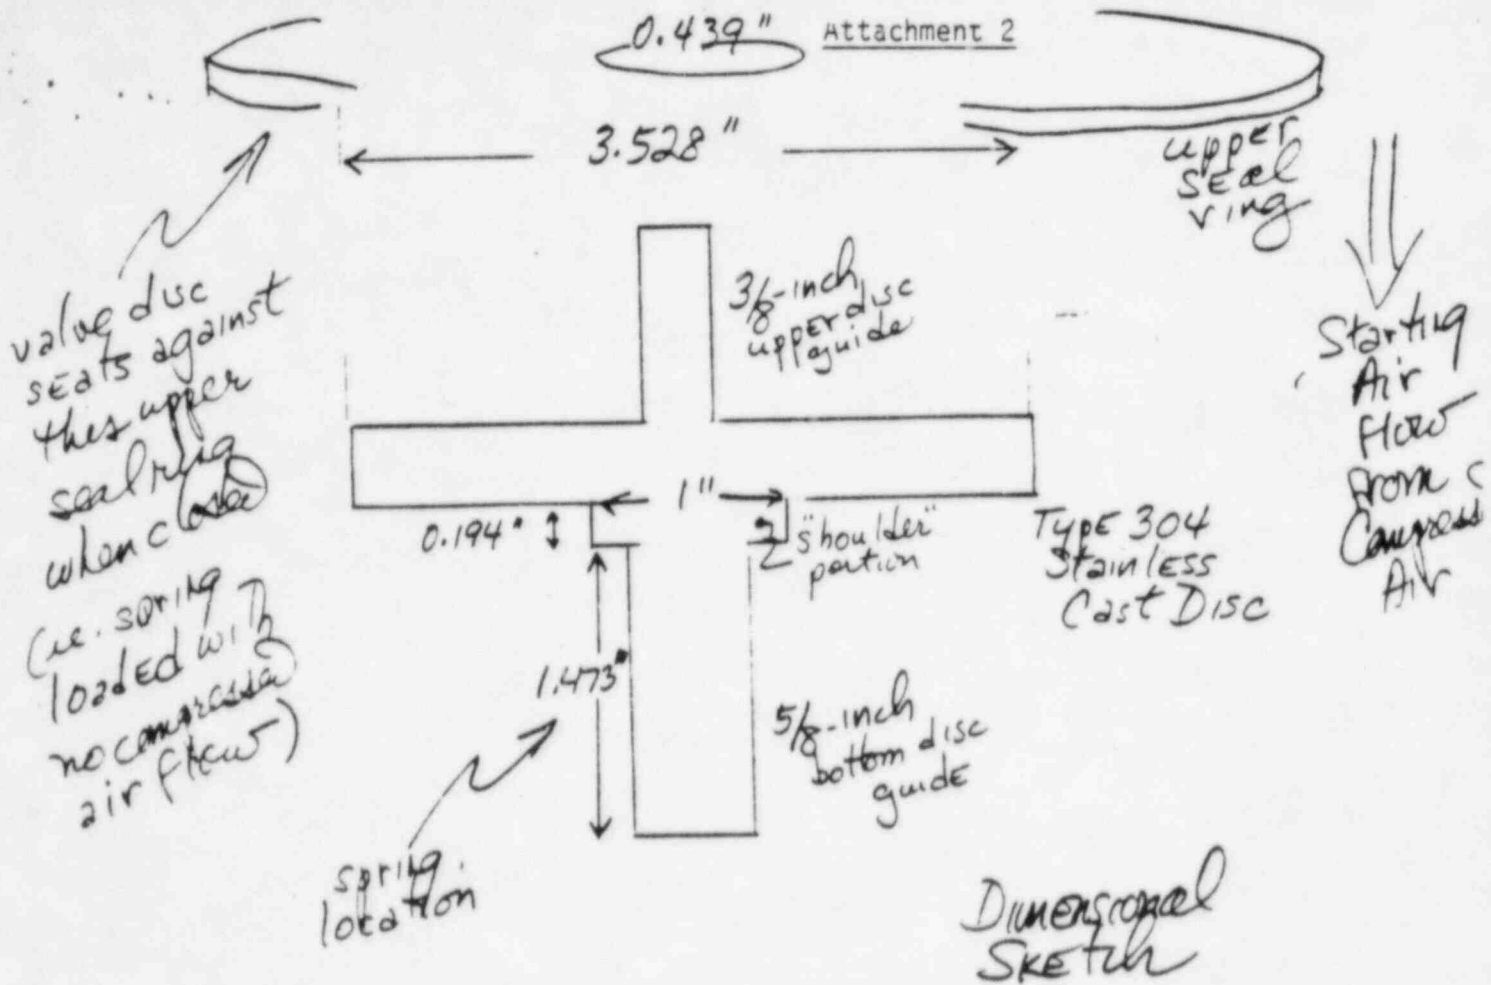
LP testing in the center web support area of the six valves, from engine numbers 101, 102, and 103, has been completed. Only one valve, originally installed on EDG-101, has been found to have cracking in this area. The cracking was apparently caused in service by improper internal dimensional tolerances which caused the "shoulder" portion of the lower disc guide (which protects the valve's spring) to hammer against the center web support stop, which eventually cracked. A dimensional as-built sketch of this cracked valve (Tag No. R43\*03V-213A, Serial No. 43378) is attached. The depth of the shoulder (0.194 inches) exceeded the center web piece depth (0.171 inches) into which it was suppose to fit.
