## LICENSEE EVENT REPORT (LER)

FACILITY NAME (1) Millstone Nuclear Power Station Unit 3 DOCKET NUMBER (2) 0 5 0 0 0 4 2 3 PAGE (3) 1 OF 0 4

TITLE (4) Incomplete Construction of Fire Boundary Wall

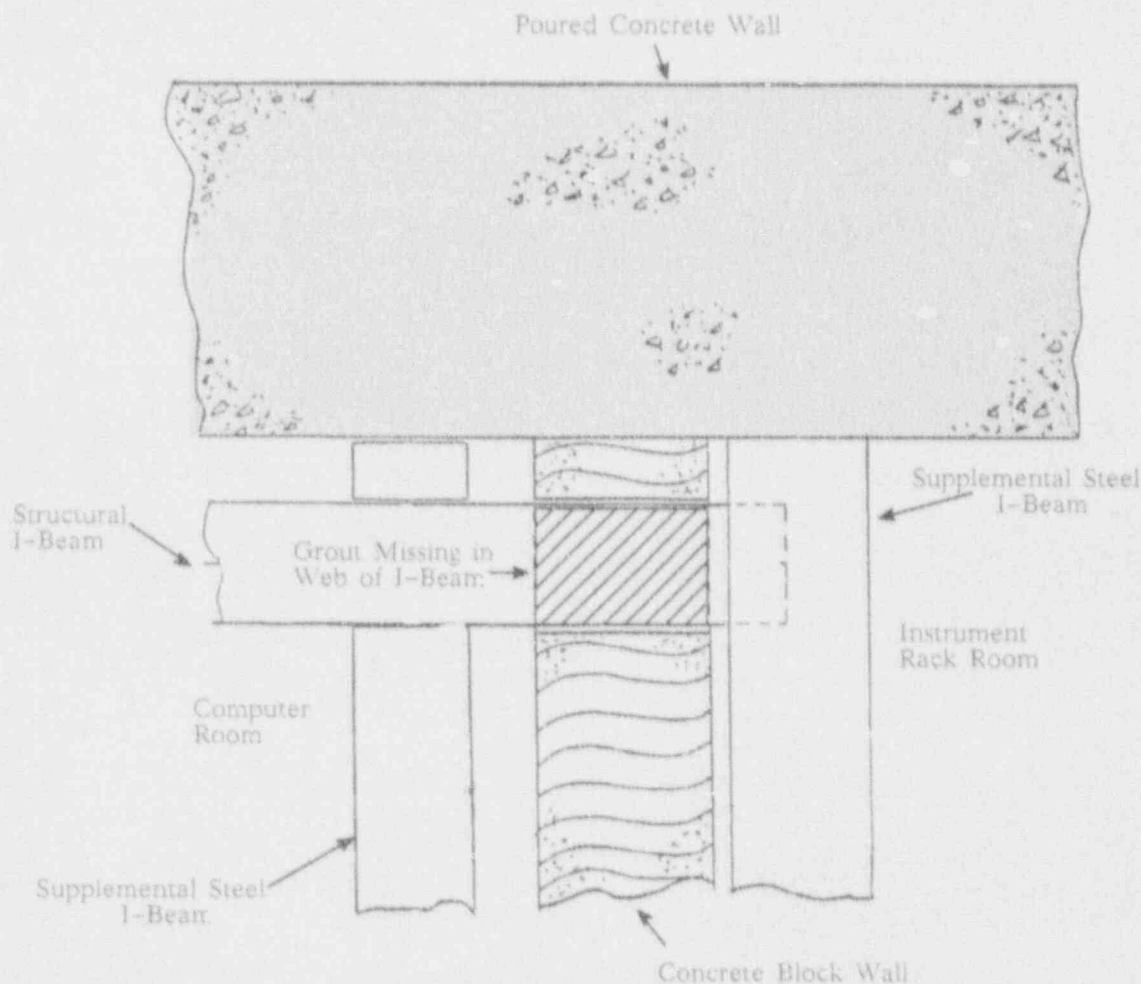
Plane View of Deficiency

On December 31, 1992, at approximately 2200 with the plant in Mode 1 at 100% power (575 degrees Fahrenheit and 2250 psia), a PEO (non-licensed operator) discovered a Technical Specification fire boundary wall which was missing fire grouting in the web of a structural I-beam. The deficiency was difficult to see because it was approximately 17 feet above the floor and hidden by supplemental steel. The deficiency was discovered during the surveillance of Fire Rated Assemblies. The fire boundary is located between the process computer room and the instrument rack room. Both areas are within the Control Room envelope.

The subject fire boundary wall had not been completed properly because installation detail was not provided on construction drawings for this beam configuration. Specific installation details were provided for other beam configurations.

Both wall deficiencies were approximately 50 square inches. All openings were blocked by supplemental steel on either side of the wall. While a communicable fire path did exist, the tortuous path would have prevented flame impingement on plant equipment within the instrument rack room. Therefore, the ability of required equipment to perform its design function was not significantly affected by this event.

As long term corrective action, the deficiencies in the wall were repaired in accordance with design requirements. In addition, the Fire Protection System Engineer will continue to work with the operations Department to clarify and strengthen the surveillance process.
