LICENSEE: Northeast Nuclear Energy Company
FACILITY: Millstone Nuclear Power Station, Unit No. 2
SUBJECT: SUMMARY OF MEETING WITH NORTHEAST NUCLEAR ENERGY COMPANY
CONCERNING EDDY CURRENT TEST (ECT) RESULTS ON MILLSTONE UNIT 2

MILLSTONE NUCLEAR POWER STATION, UNIT NO. 2

STEAM GENERATOR CHEMICAL CLEANING

STEAM GENERATOR TUBE INSPECTIONS

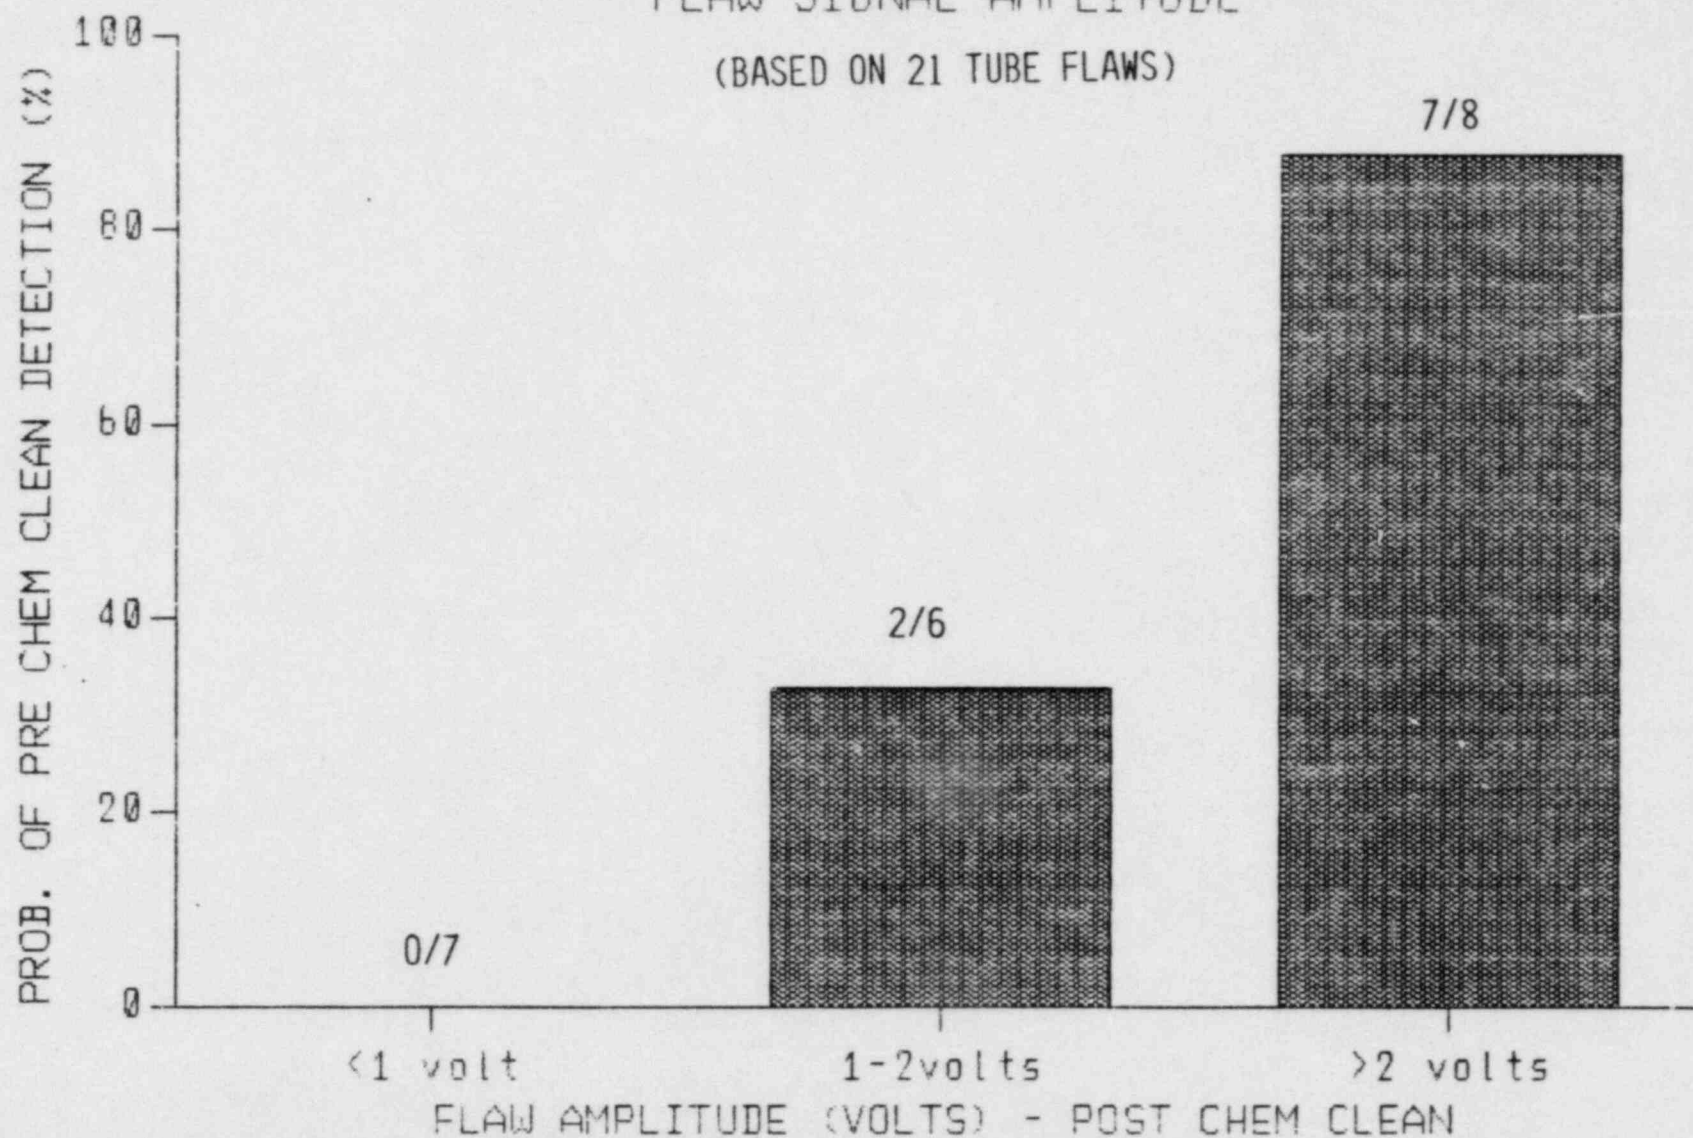
PROBABILITY OF PRE CHEMICAL CLEANING FLAW DETECTION
VS.
FLAW SIGNAL AMPLITUDE

(BASED ON 21 TUBE FLAWS)

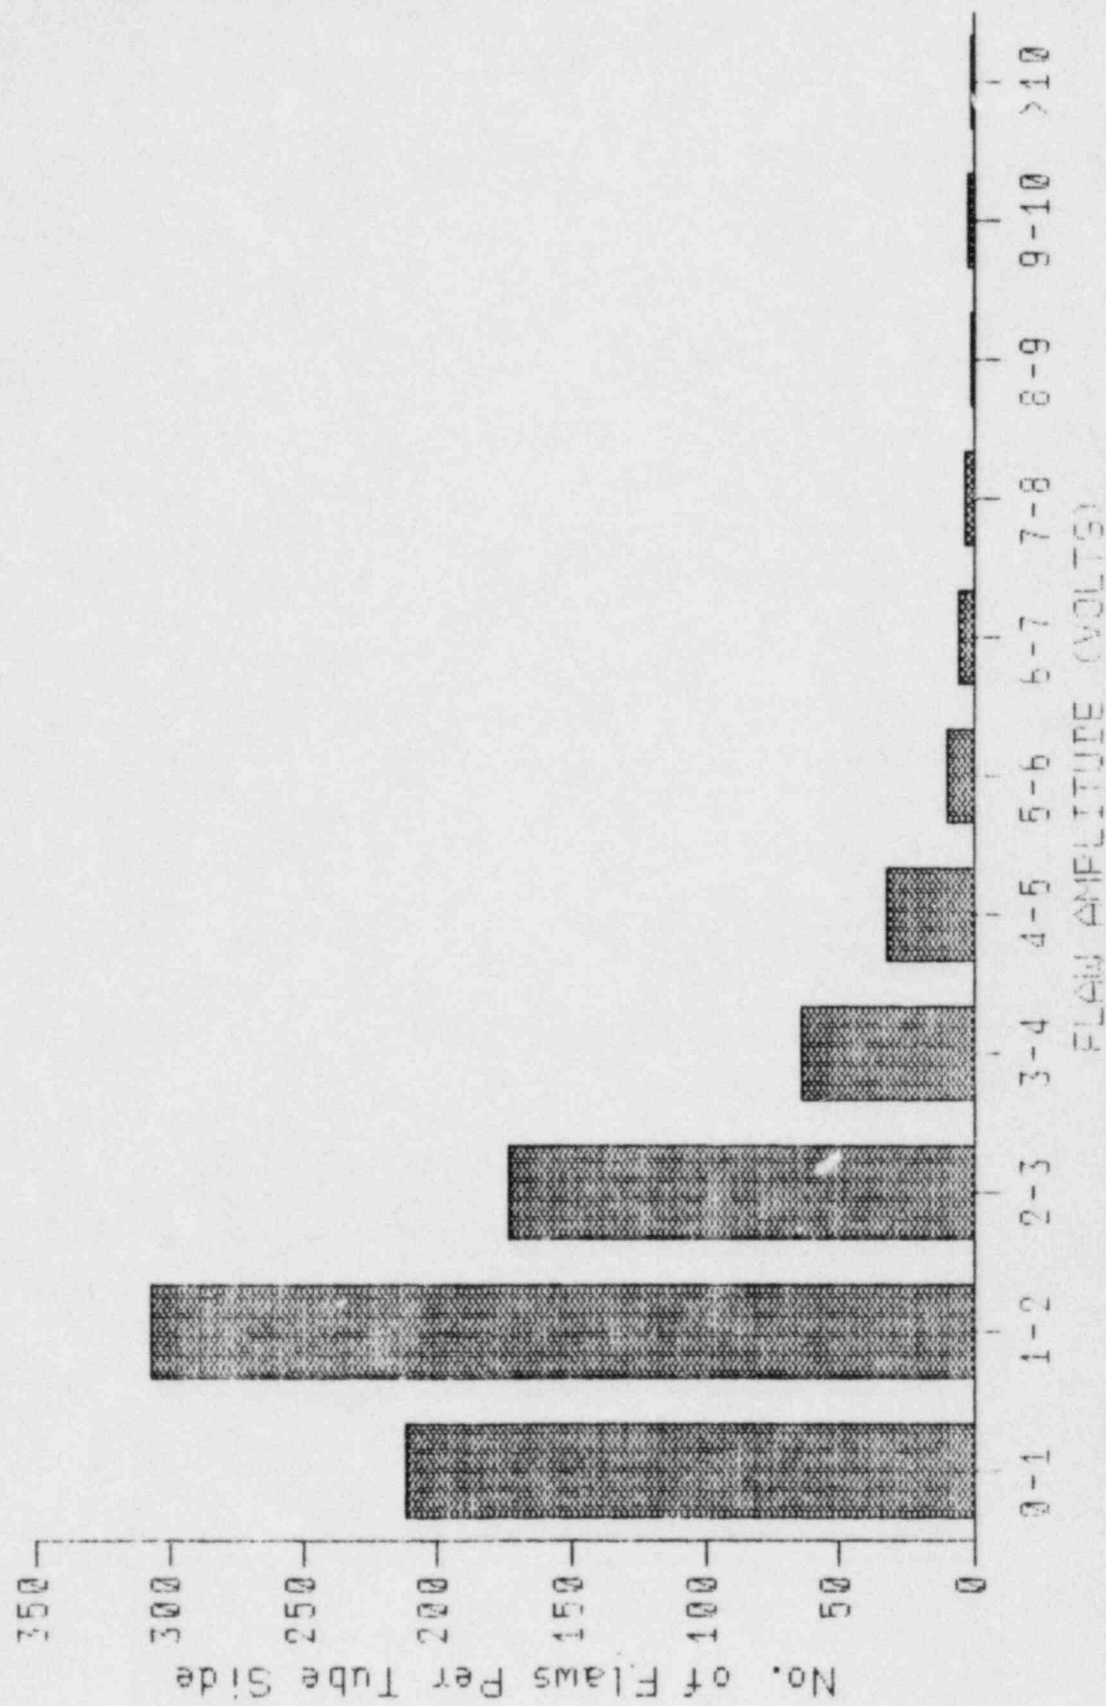
POST CHEMICAL CLEANING TUBE FLAW AMPLITUDES

FOR POST CHEM CLEAN FLAWS $\geq 40\%$

WHICH WERE NOT IDENTIFIED IN PRE CHEM CLEAN TESTING
