SECY-92-400

Subject: Supplement to NRC Bulletin 90-01, "LOSS OF FILL-OIL IN TRANSMITTERS MANUFACTURED BY ROSEMOUNT"

NRC BULLETIN NO. 90-01, SUPPLEMENT 1:      LOSS OF FILL-OIL IN TRANSMITTERS  
MANUFACTURED BY ROSEMOUNT

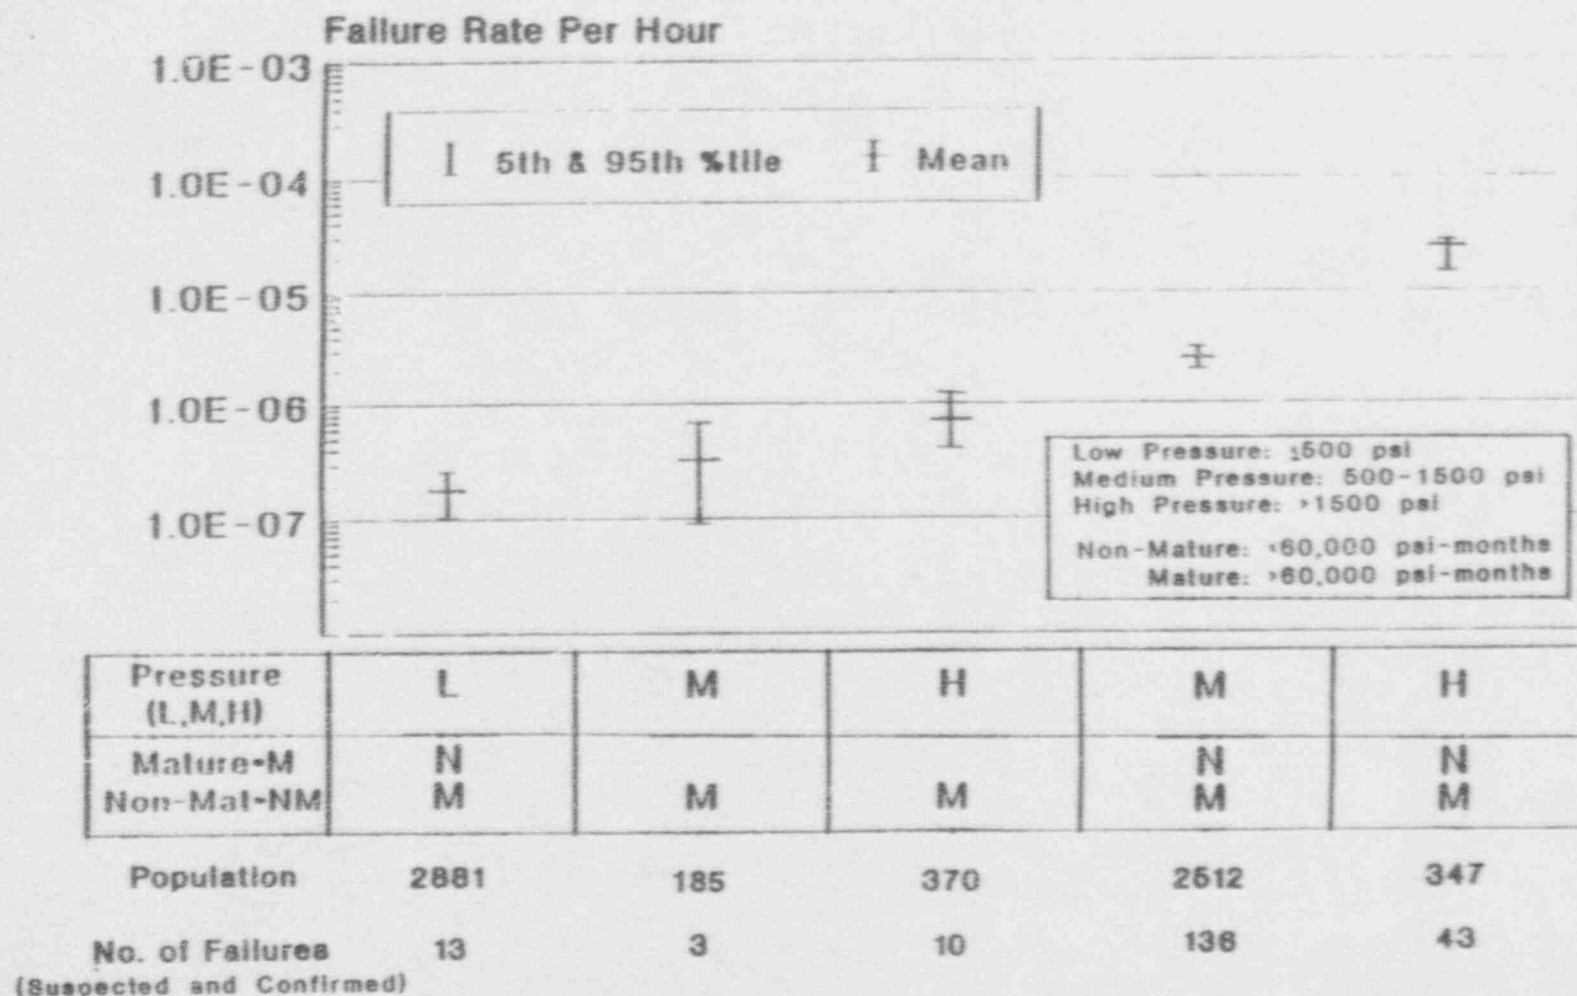
**Figure 1. Rosemount Transmitter Failure Rates**  
 (90% chi-squared confidence interval)

Second among these factors was time-in-service, with those transmitters having been in service for less than 60,000 psi-months exhibiting higher failure rates than transmitters that had been in service for more than 60,000 psi-months. Attachment 1 represents the staff estimates of Rosemount transmitter failure rates based on pressure application and the time in service derived from the NUMARC survey data.
