U. S. NUCLEAR REGULATORY COMMISSION
REGION I

Docket/Report No.: 50-443/92-25

Facility: Seabrook Station, Seabrook, New Hampshire

Dates: October 13 - November 16, 1992

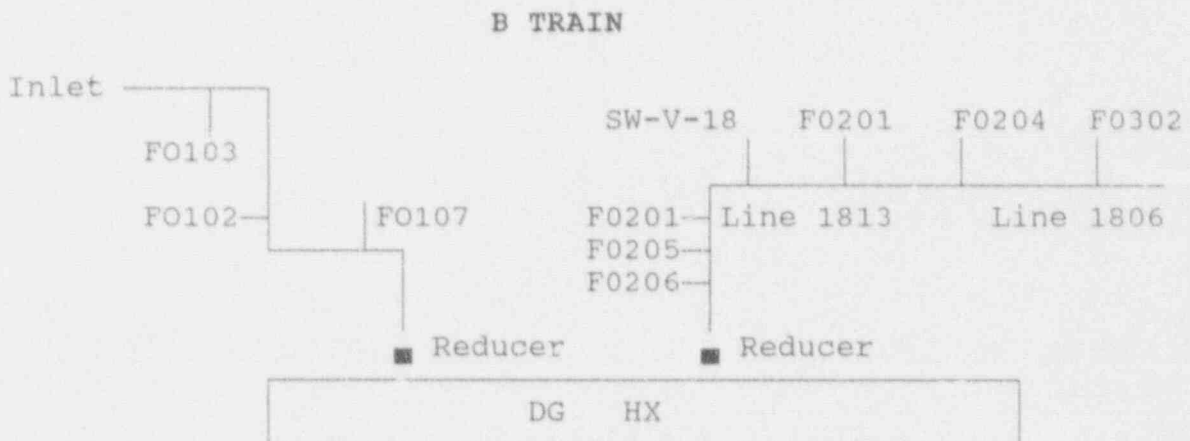
After removal of the reducer, the chemists determined that accelerated general corrosion caused the through wall crack in the carbon steel pipe. A one inch round crater in the cement lining allowed service water to reach and corrode the metal. Non-destructive examination (NDE) qualified inspectors performed ultrasonic tests (UT) on the welds in the service water inlet and outlet piping. The tested welds are shown below.

Preparation of the welds for ultrasonic testing identified a significant area of generalized corrosion in field weld 1806-F0102. Engineering developed and site utilities installed minor modification, MMOD-92-568, that attached a 4 inch weldolet with a blank flange to the pipe which completely enveloped the area of corrosion.

The ultrasonic tests identified areas of pipe wall thicknesses of 0.200 inches and 0.180 inches around field welds 1806-F0107 and 1813-F0205. The response to the request for engineering services, RES 92-480, determined that the wall thicknesses were acceptable for the next operating cycle based on a minimum code wall thickness of 0.120 inches. A detailed review of the acceptability of the pipe wall thinning is contained in NRC Inspection Report 50-443/92-20.

The inspector reviewed the UT results, MMOD-92-568, the associated 10 CFR 50.59 evaluation, and RES-92-480. The UT thickness grid for the other welds indicated wall thickness above the commercial minimum wall thickness of 0.295 inches with the exception of small areas on field welds 1813-F0206 and 1806-F0201 which were 0.280 inches and 0.270 inches thick respectively. The inspector used a Nortec, NDT 1240, ultrasonic test instrument to independently verify a sample of the wall thicknesses. The inspector determined that the pipe was above commercial minimum wall thickness except at the isolated locations identified by the licensee.

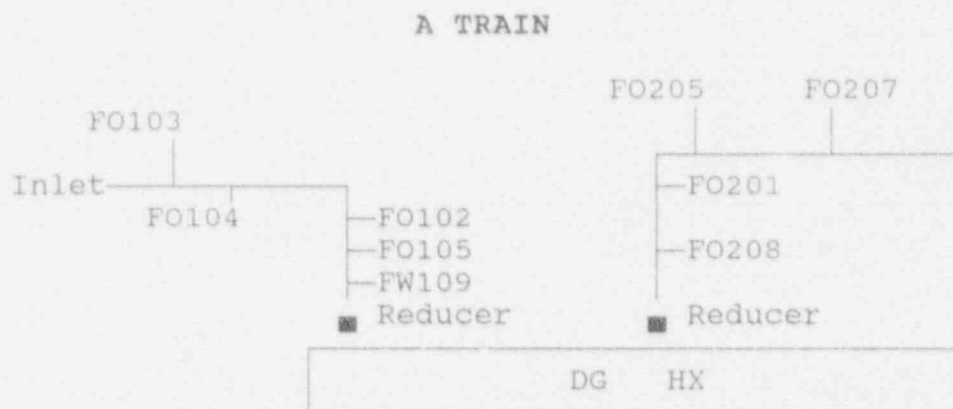
Subsequent North Atlantic NDE inspector UT examinations of the welds on the inlet and outlet service water piping to the 'A' train emergency diesel generator heat exchanger identified additional areas of pipe wall thinning. The welds examined are shown below.

Several corrosion related piping flaws, including a through-wall pinhole leak were identified. North Atlantic maintained the 'A' train service water system in operation to support the 'A' emergency diesel generator operability. The inspector reviewed the rationale utilized by North Atlantic in deciding to leave the service water system in service.

The inspector observed portions of the ultrasonic testing and independently verified the thickness of some areas on the piping which were below minimum code wall thickness. After reviewing the test data, engineering issued work request 92W4641 which provided instructions for conducting three weld repairs on the inlet piping and for replacing a portion of the outlet piping. The weld repairs were in the vicinity of field welds 1808-F0102, 1808-F0104 and 1808-F0105. The pipe replacement replaced field weld 1811-F0201, eliminated field weld 1811-F0208, and created a new field weld 1811-F0209 closer to the reducer. After operators removed service water train 'A' and emergency diesel generator 'A' from service, site utility workers performed the repairs.

The inspector reviewed the weld travelers, magnetic particle examination sheets, and the liquid penetrant examination sheets for the welds associated with the piping repairs. The inspector conducted an independent ultrasonic examination of the weld repairs and confirmed pipe wall thicknesses were above the commercial minimum wall thickness. No discrepancies were noted.
