RADIOLOGIC AND ENGINEERING ASSESSMENT

DOE ID NO.: GJ-10103-RS
ADDRESS: 133 GUNNISON AVENUE

JUNE 1985

BENDIX FIELD ENGINEERING CORPORATION
P.O. Box 1569
Grand Junction, Colorado 81502

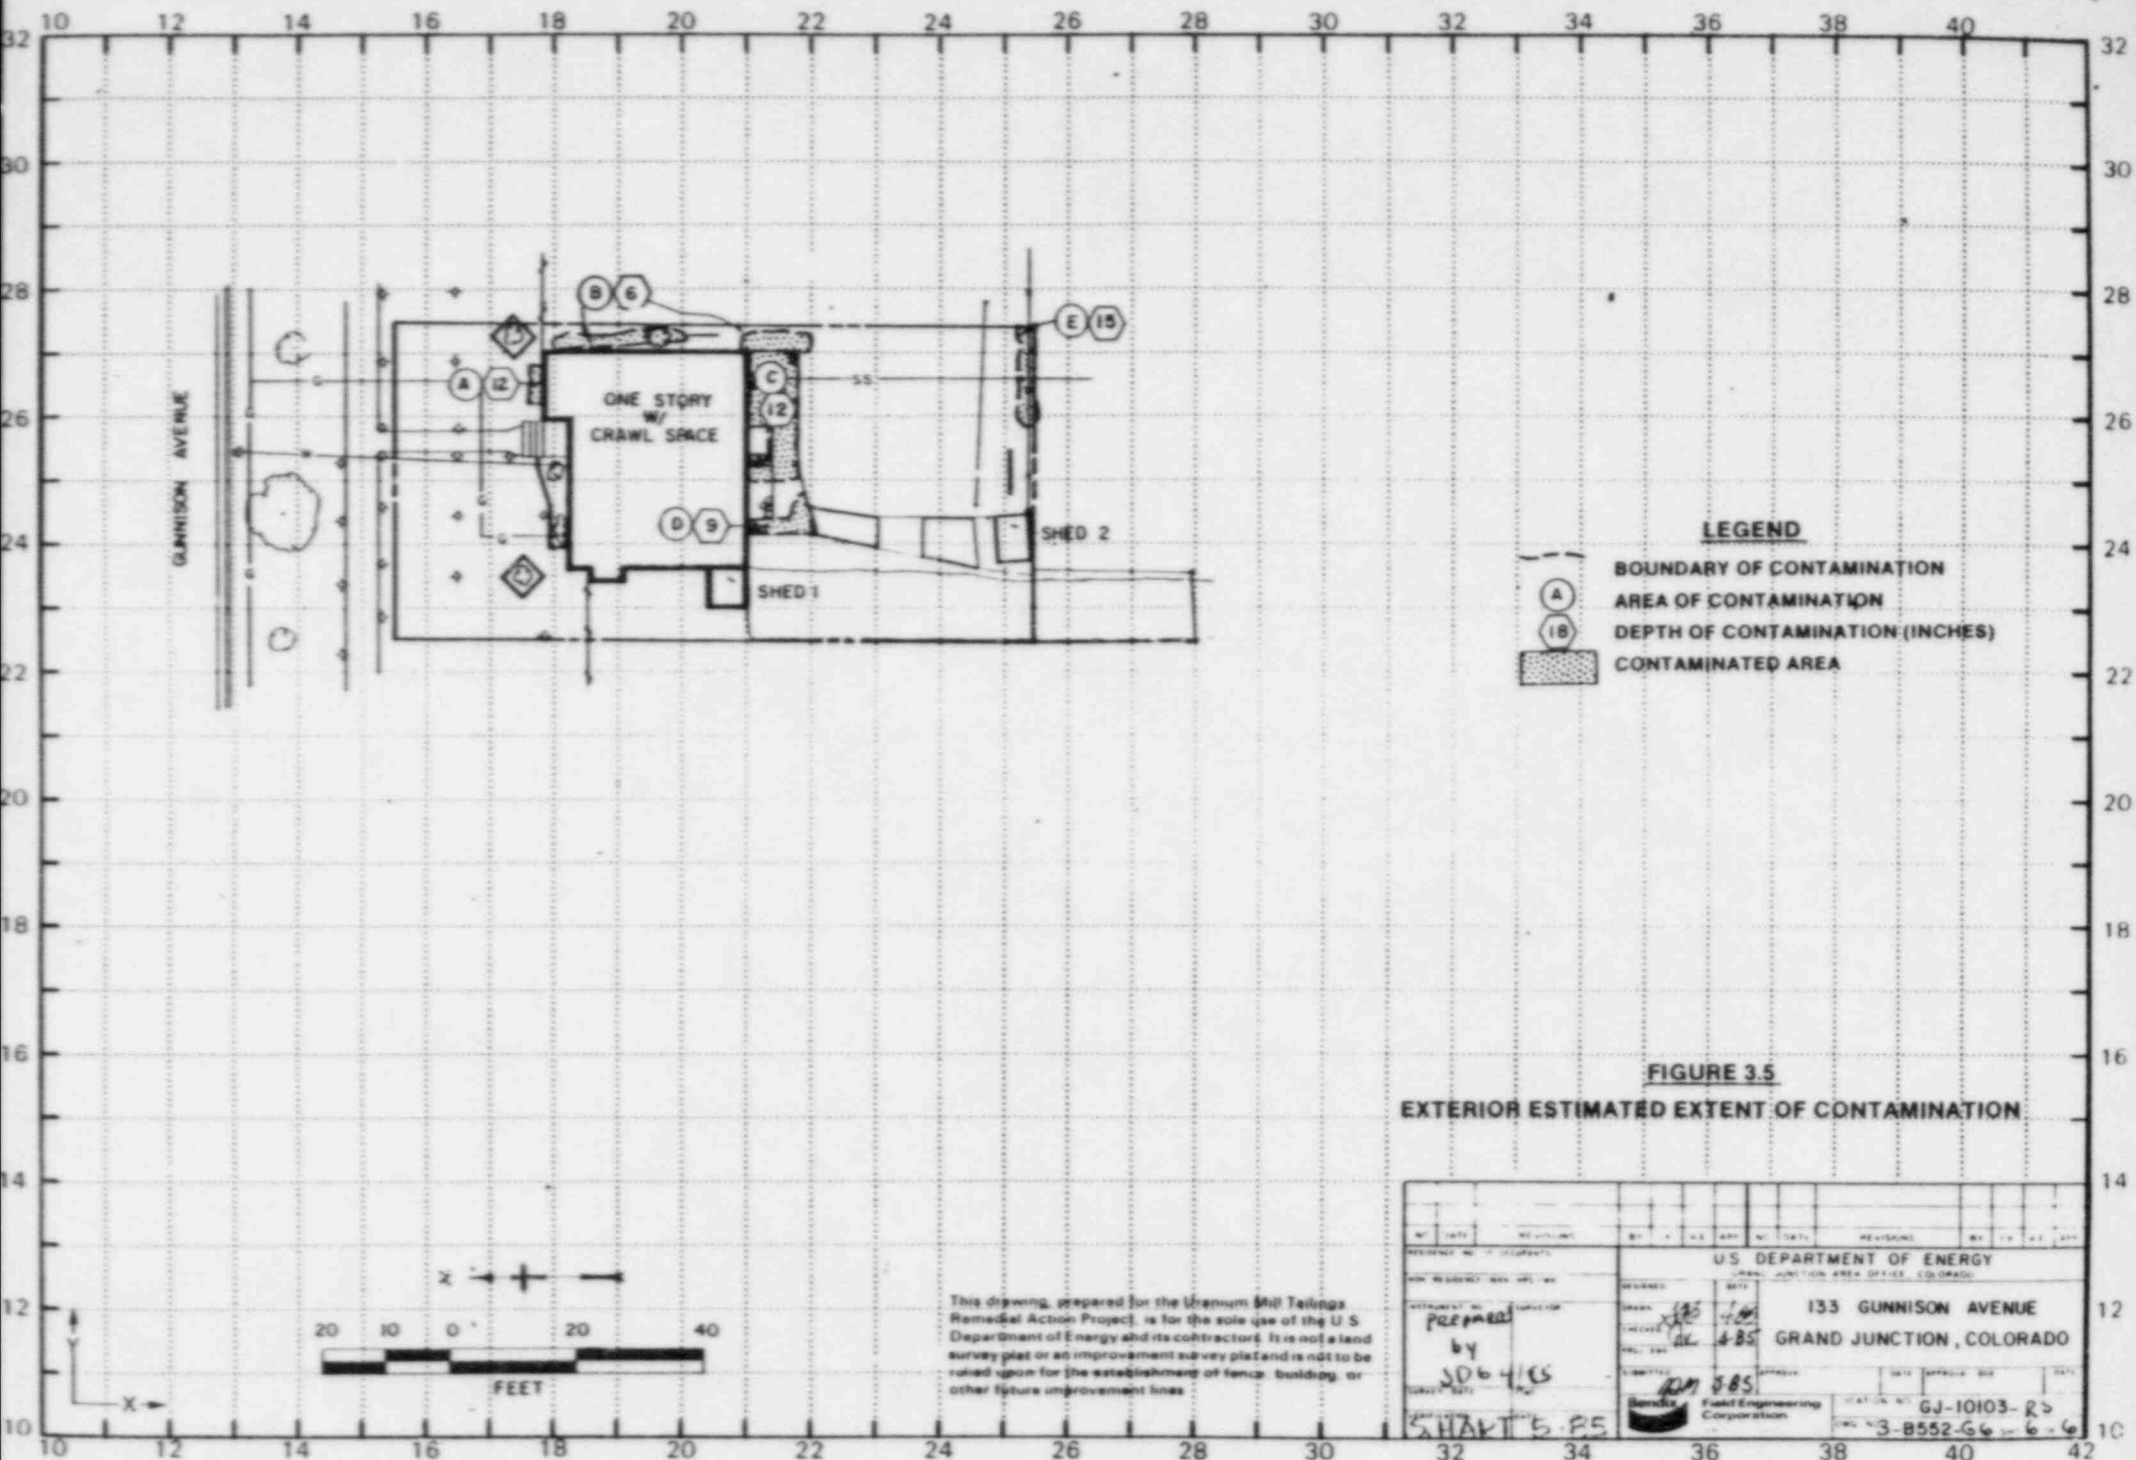
Appendix Figure 3.5 shows identified areas and estimated depths of contamination on this property, based on assessments of all measurements taken. As noted in this figure, areas recommended for remedial action that contain identified residual radioactive materials are:

- (AREA A) The soil in the planter north of the primary structure is contaminated to a depth of 12 inches (approximately 12 sf).
- (AREA B) In the lawn east of the primary structure, contamination extends to a depth of 6 inches (approximately 114 sf).
- (AREA C) South of the primary structure, the soil under a 2-inch-thick flagstone patio is contaminated to a total depth of 12 inches (approximately 160 sf).
- (AREA D) The soil beneath the west end of the flagstone patio is contaminated to a total depth of 9 inches (approximately 36 sf).
- (AREA E) The depth of contamination in the lawn, along the southern fence line, is 15 inches (approximately 45 sf).

Due to obstructions, a scan at the fence line west of Area E could not be done. When this area becomes accessible, monitoring should be done to assure that the contaminated deposit does not extend into this portion of the yard.

The recommended remedial action for this property, DOE ID No. GJ-10103-RS, includes removal of all areas identified as containing radioactive material (as discussed in Section 3.5 and shown in Appendix Figure 3.5) and transport of removed material to the disposal site.

After remedial action is completed, the areas involved will be restored to original condition in accordance with the Bendix drawings, Vicinity Properties General Construction Specification (Bendix Field Engineering Corporation, 1984), and Statement of Work for Construction Subcontractor.

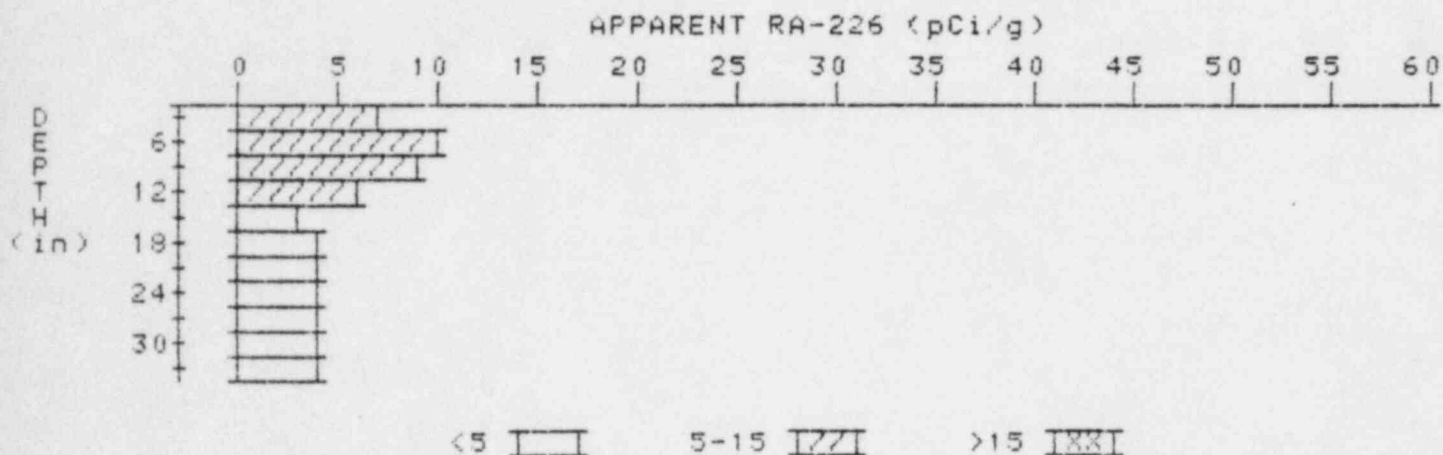
APPARENT RADIUM-226 CONCENTRATION 19 DECONVOLUTION GRAPH

Loc #	Grid Location	Depth (in.)	Meas. Type	In Situ Ra-226 (pCi/g)		Chem Ra-226 (pCi/g)	Comments
				Tot. Ct	Spectr.		
19	253262	09	TC	7.3		*	
		12	TC	6.1		*	
		15	TC	4.8		*	DC = 15 inches
		18	TC	4.5		*	
		21	TC	4.3		*	Based on the
		24	TC	4.2		*	deconvolution graph
		27	TC	4.2		*	
		30	TC	4.2		*	
		33	TC	4.3		*
