RADIOLOGIC AND ENGINEERING ASSESSMENT

DOE ID NO.: GJ-10653-RS
ADDRESS: 631 OURAY AVENUE

JUNE 1985

BENDIX FIELD ENGINEERING CORPORATION
P.O. Box 1569
Grand Junction, Colorado 81502

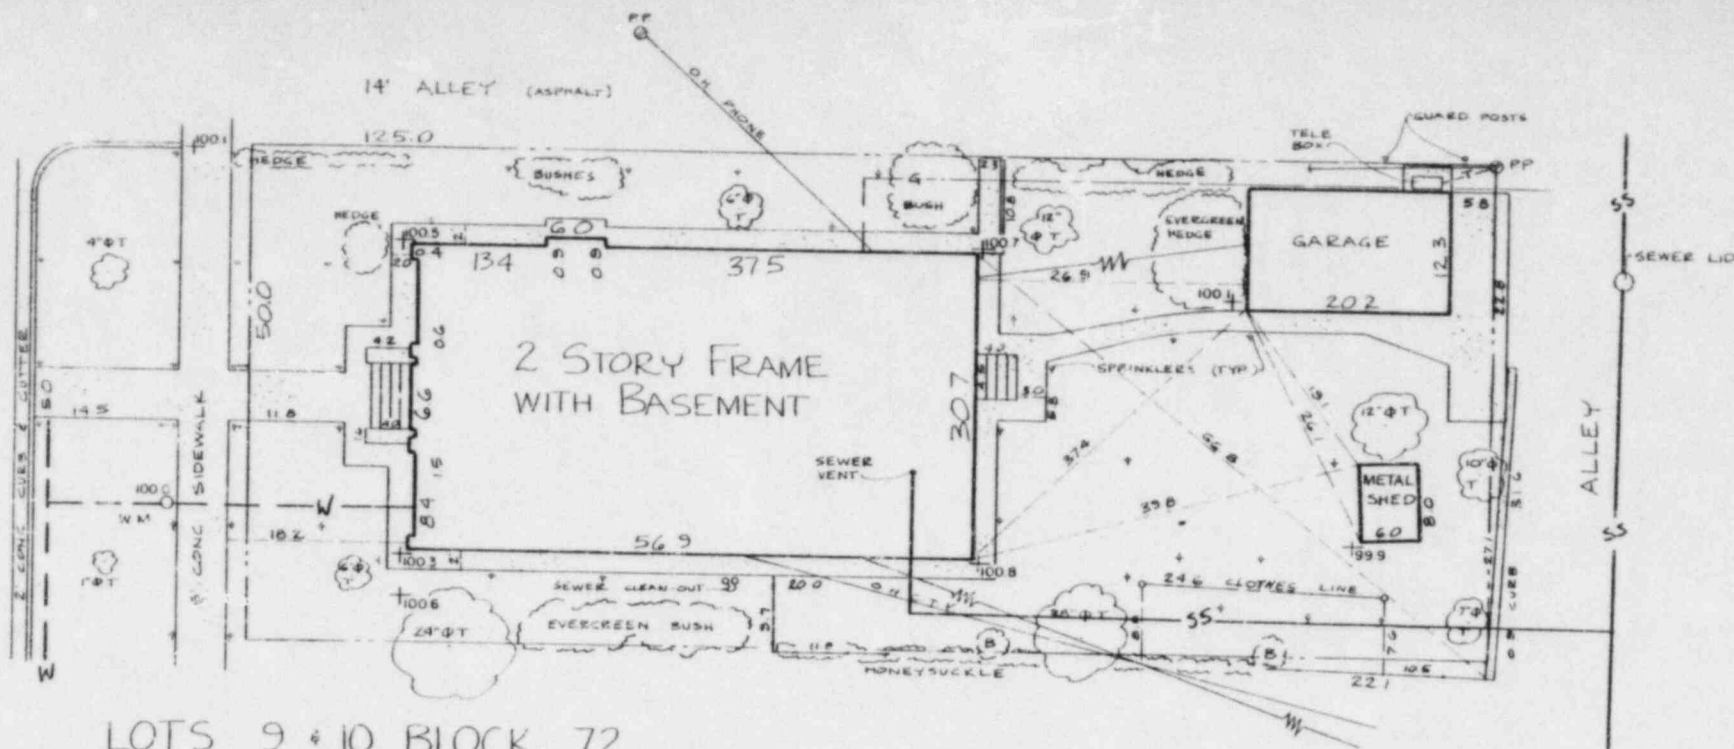
FIGURE 2.2 SITE PLAN

The front and backyard are well landscaped. Structures, utilities, landscaping, and other special features of this property are included in Appendix Figure 2.2.

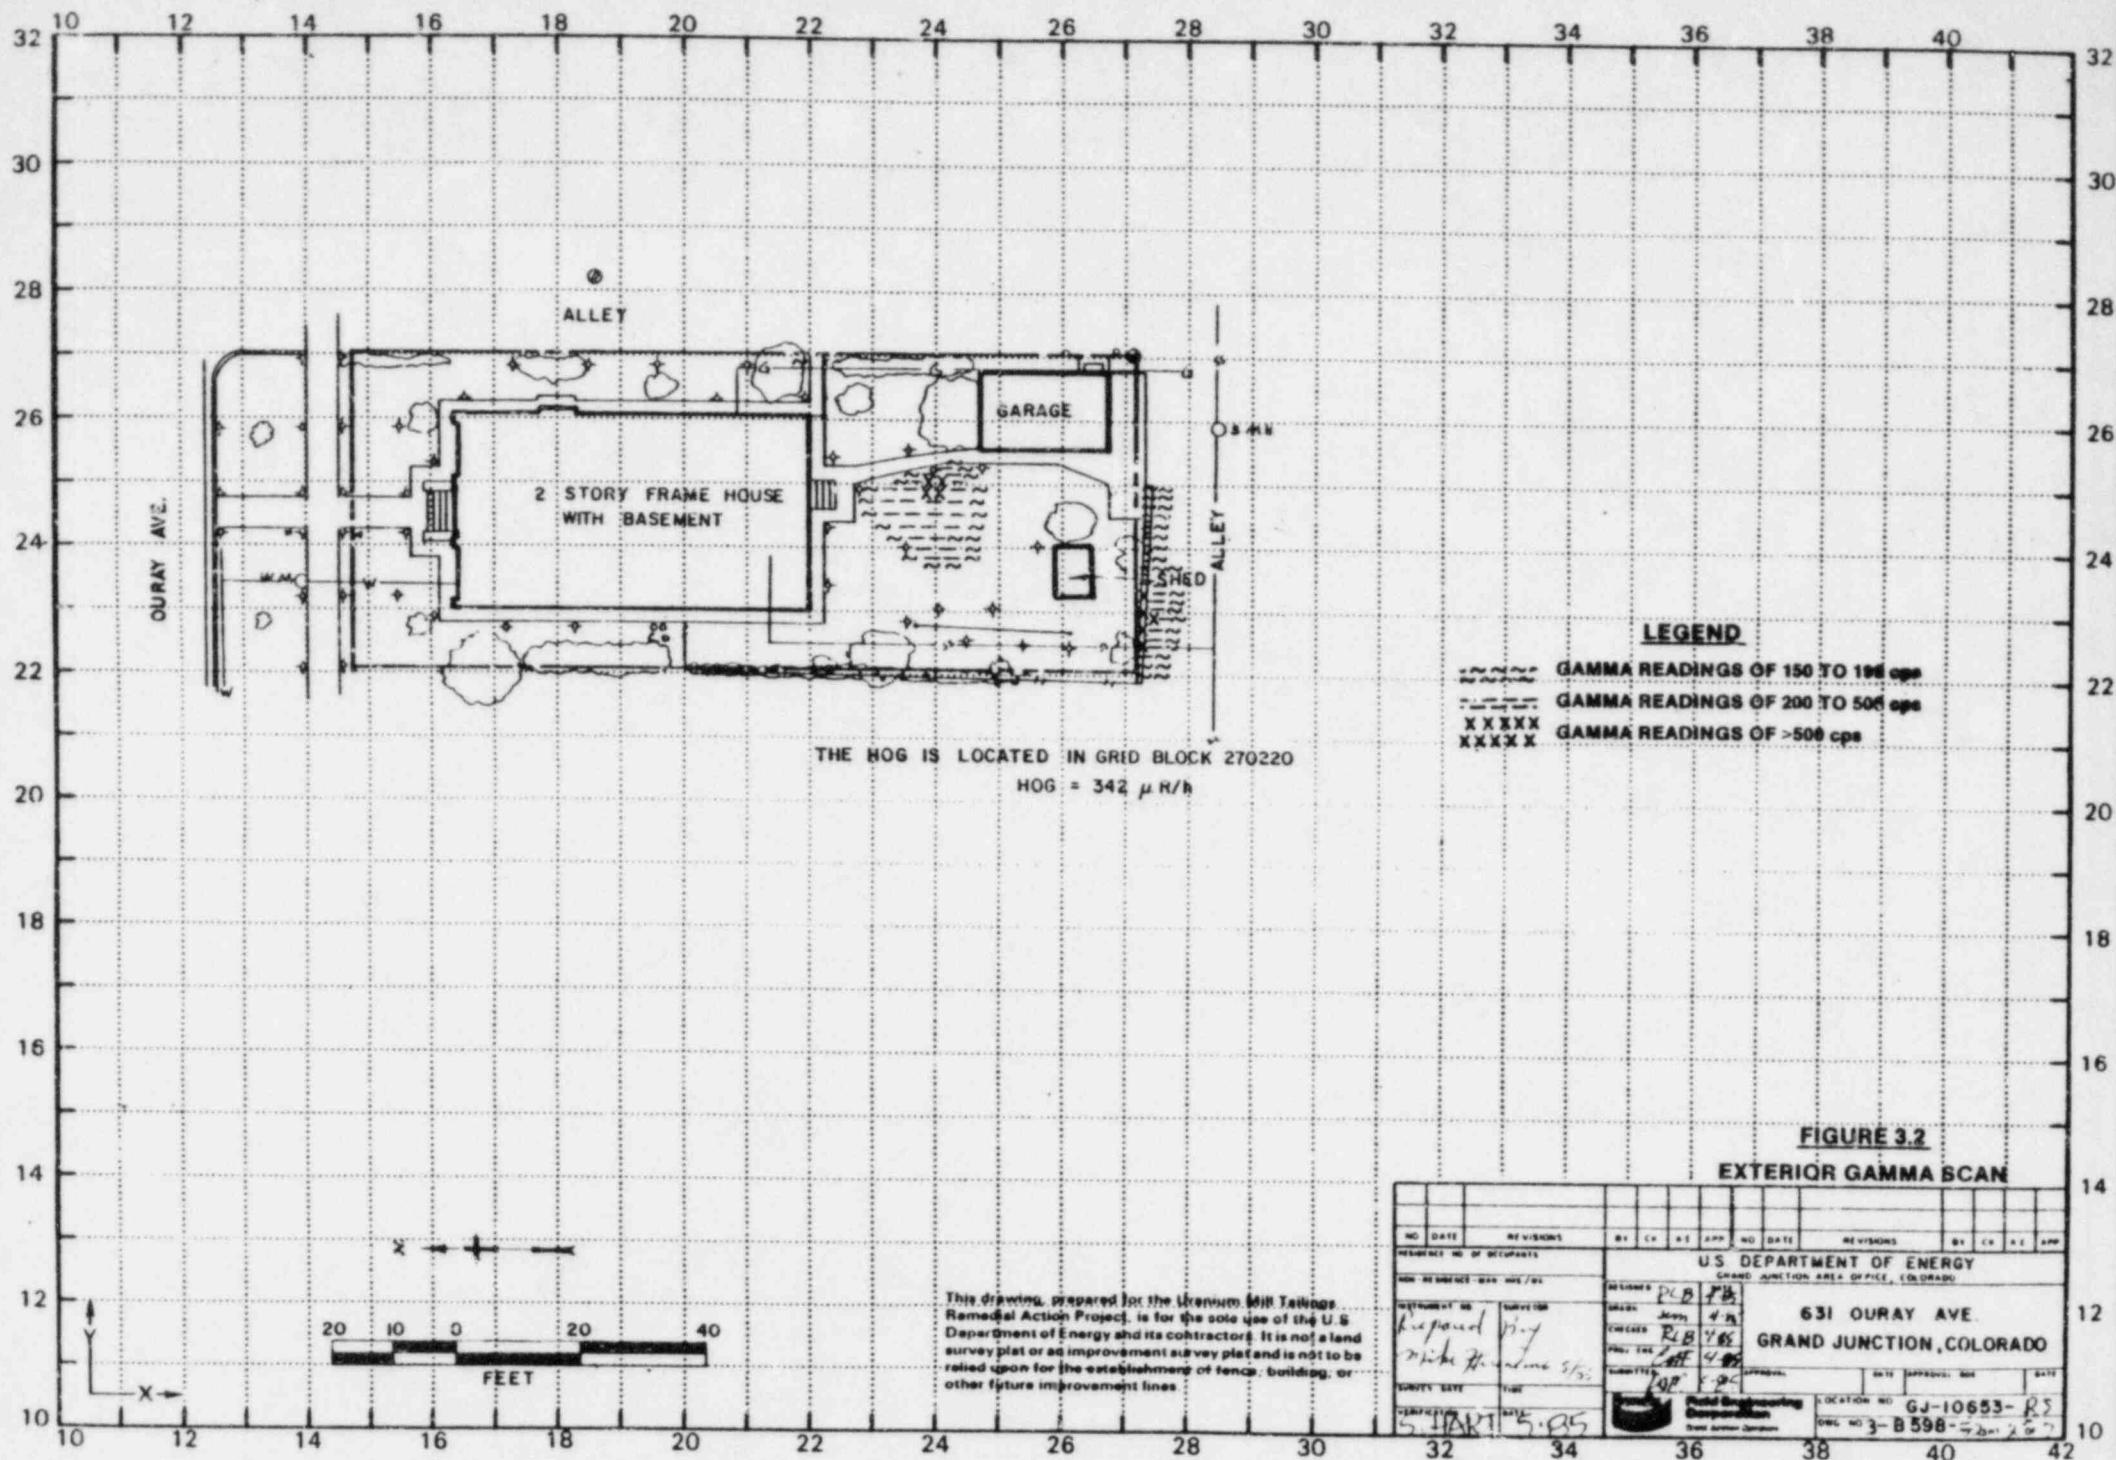
FIGURE 3.2
EXTERIOR GAMMA SCAN

Exterior radium-concentration measurements are presented in Appendix Table 3.1. Grid-point survey results are shown in Appendix Figure 3.1. Appendix Figure 3.2 presents the ranges of elevated gamma readings and indicates areas of possible contamination.

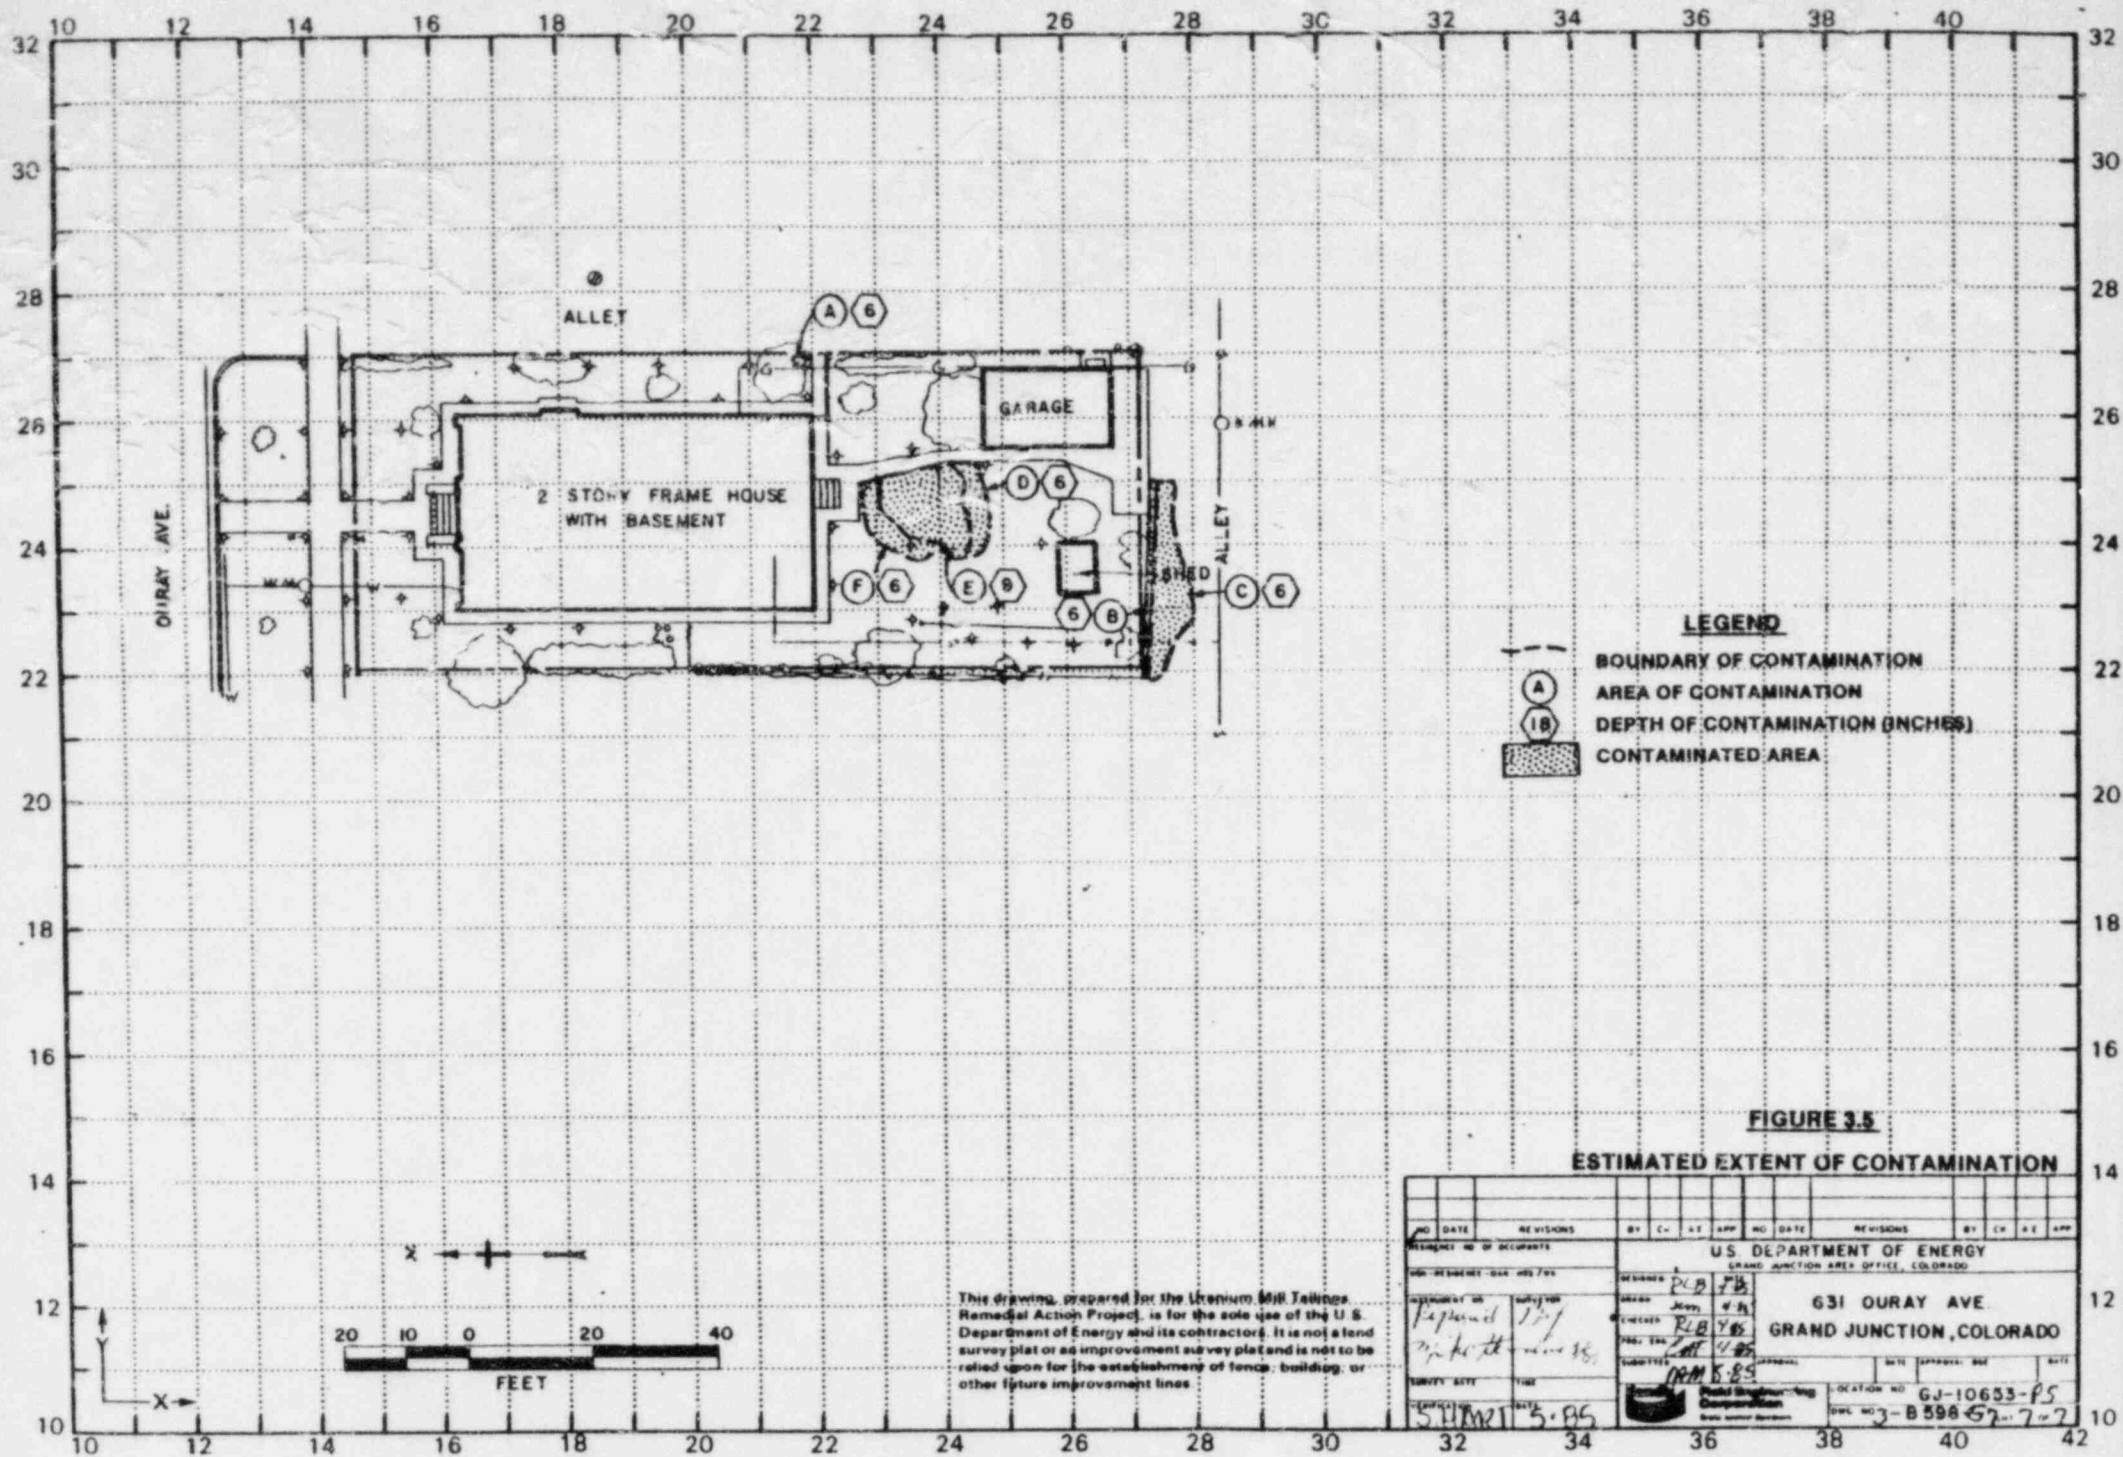
Appendix Figure 3.5 shows identified areas and estimated depths of contamination on this property, based on assessments of all measurements taken. As noted in this figure, areas recommended for remedial action that contain identified residual radioactive materials are:

- (AREA A) A small deposit east of the primary structure is contaminated to a depth of 6 inches (approximately 6 sf).
- (AREA B) There is 2 inches of contamination beneath the uncontaminated 4-inch-thick concrete fence footing. The deposit extends to a total depth of 6 inches (approximately 32 sf).
- (AREA C) A large deposit south of the south property line under the asphalt alley is contaminated to a depth of 6 inches (approximately 155 sf). This area shall not be removed because tailings are not removed when found under paved city streets and alleys.
- (AREA D) In the south yard, there is contamination to a depth of 6 inches (approximately 56 sf).
- (AREA E) A deposit in the center of the south yard is contaminated to a depth of 9 inches (approximately 154 sf).
- (AREA F) Contamination in the south yard extends to a depth of 6 inches (approximately 68 sf).

The recommended remedial action for this property, DOE ID No. GJ-10653-RS, includes removal of all areas identified as containing radioactive material (as discussed in Section 3.5 and shown in Appendix Figure 3.5) and transport of removed material to the disposal site.

After remedial action is completed, the areas involved will be restored to original condition in accordance with the Bendix drawings, Vicinity Properties General Construction Specification (Bendix Field Engineering Corporation, 1984), and Statement of Work for Construction Subcontractor.
