RADIOLOGIC AND ENGINEERING ASSESSMENT

DOE ID NO.: GJ-11585-RS
ADDRESS: 2010 ELM AVENUE

JUNE 1985

BENDIX FIELD ENGINEERING CORPORATION
P.O. Box 1569
Grand Junction, Colorado 81502

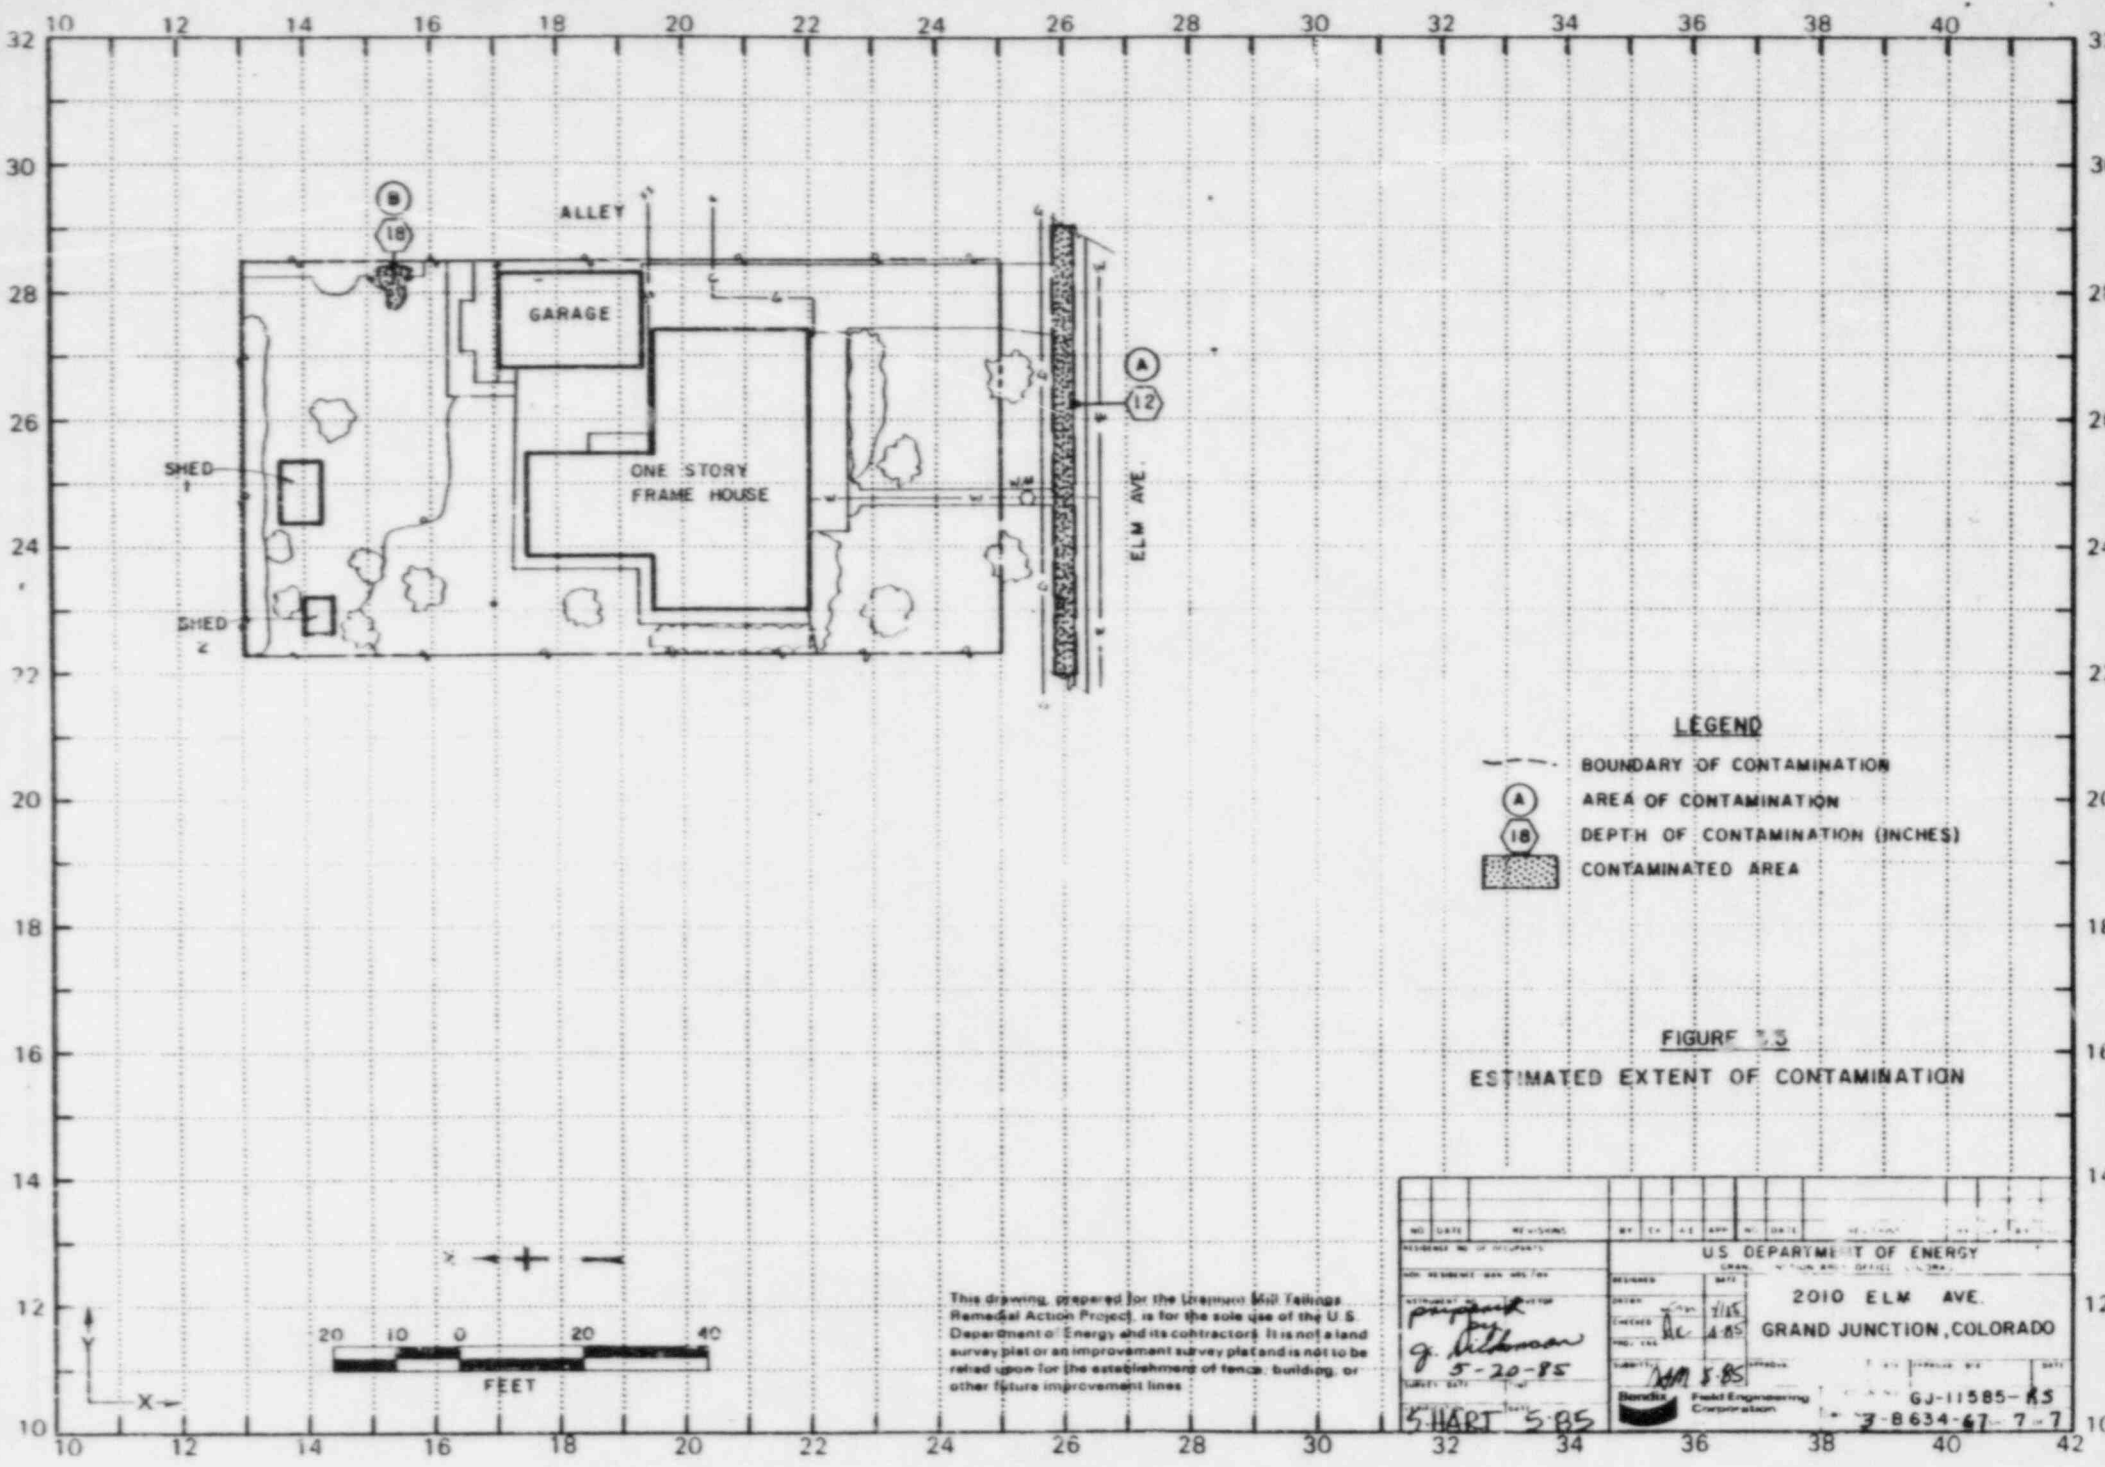
FIGURE 3.5

Appendix Figure 3.5 shows identified areas and estimated depths of contamination on this property, based on assessments of all measurements taken. As noted in this figure, areas recommended for remedial action that contain identified residual radioactive materials are:

(AREA A) The soil underlying the city sidewalk is contaminated. The total depth of the contamination is 12 inches (approximately 213 sf).

(AREA B) A small deposit is located north of the garage. The depth of contamination is 18 inches (approximately 42 sf).

The recommended remedial action for this property, DOE ID No. GJ-11585-RS, includes removal of all areas identified as containing radioactive material (as discussed in Section 3.5 and shown in Appendix Figure 3.5) and transport of removed material to the disposal site.
