RADIOLOGIC AND ENGINEERING ASSESSMENT

DOE ID NO.: GJ-11061-RS  
ADDRESS: 419 BELFORD AVENUE

JUNE 1985

BENDIX FIELD ENGINEERING CORPORATION  
P.O. Box 1569  
Grand Junction, Colorado 81502

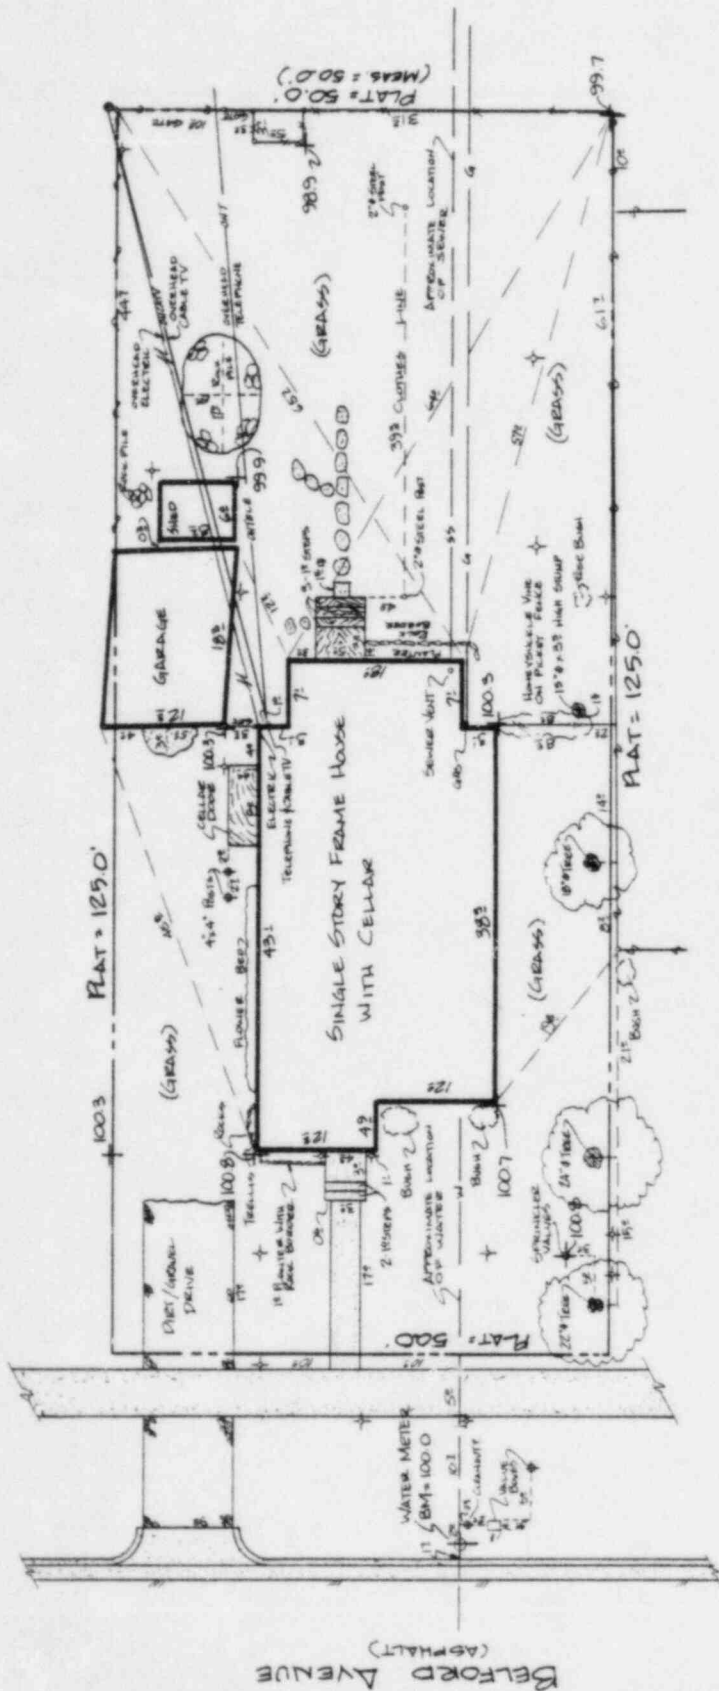
FIGURE 2.2 SITE PLAN

Front and rear yards are landscaped and well maintained. Structures, utilities, landscaping, and other special features of this property are included in Appendix Figure 2.2.

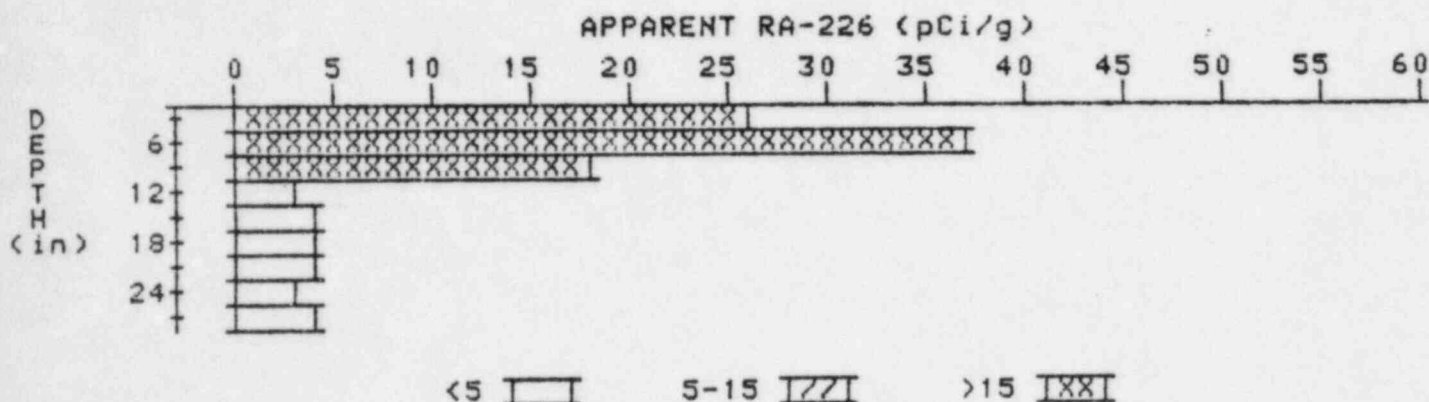
HOLE NUMBER: 19

Depth (in)	Apparent Radium-226 (pCi/g) Undeconvolved	Apparent Radium-226 (pCi/g) Deconvolved
3	25.6	25.6
6	25.1	37.0
9	17.9	18.4
12	10.4	3.1
15	7.0	4.0
18	5.3	3.9
21	4.4	3.5
24	4.0	3.5
27	3.9	3.9

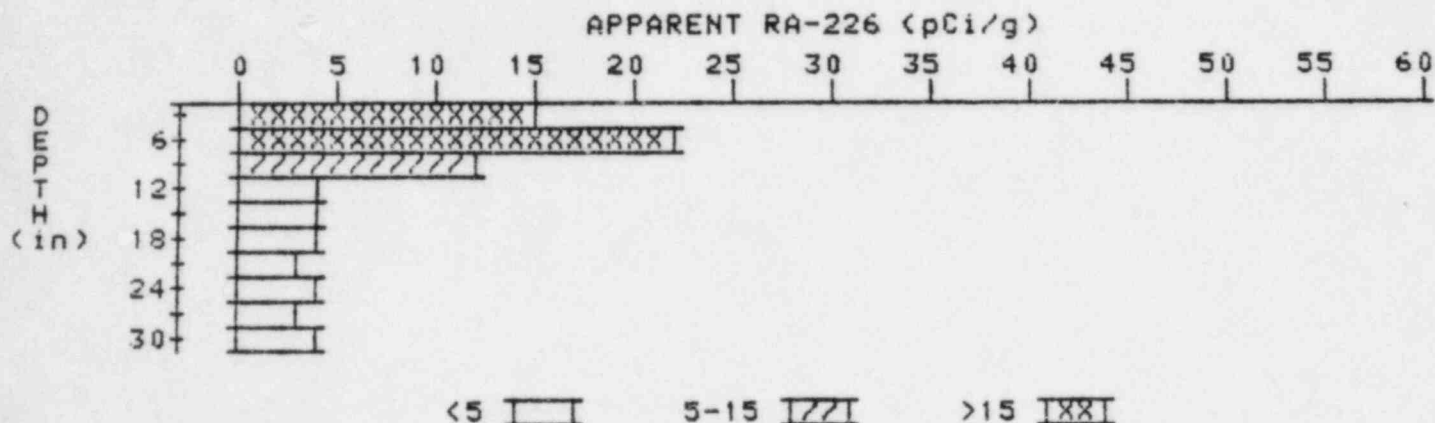
HOLE NUMBER: 21

Depth (in)	Apparent Radium-226 (pCi/g) Undeconvolved	Apparent Radium-226 (pCi/g) Deconvolved
3	15.1	15.1
6	15.2	22.0
9	11.5	12.0
12	7.5	3.8
15	5.6	3.8
18	4.7	4.3
21	4.0	3.1
24	3.8	3.8
27	3.6	3.2
30	3.6	3.6
