TEXAS UTILITIES GENERATING COMPANY
SKYWAY TOWER • 400 NORTH OLIVE STREET, L.H. 81 • DALLAS, TEXAS 75201

SUBJECT: COMANCHE PEAK STEAM ELECTRIC STATION
RESPONSE TO NRC NOTICE OF VIOLATION
INSPECTION REPORT NO.: 50-445/84-45

NOTICE OF VIOLATION
445/8445-02

Failure to provide adequate procedures appropriate to circumstances

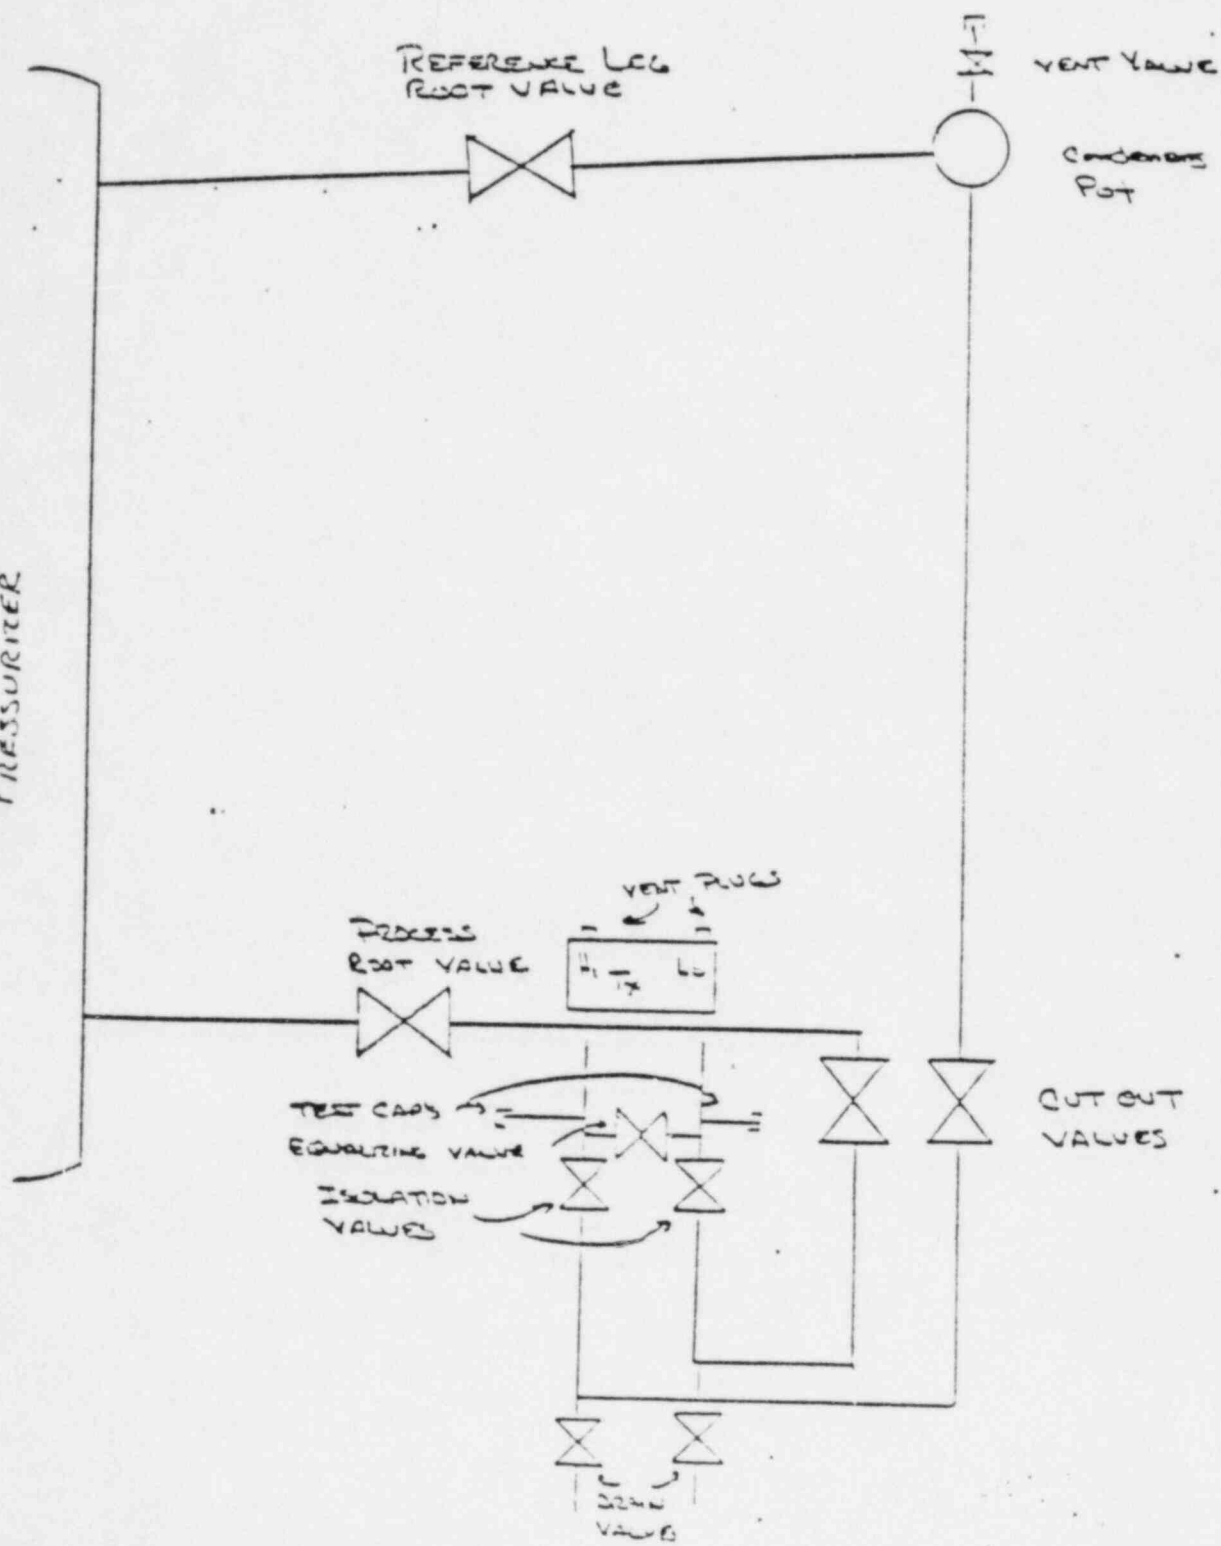
PRESSURIZER

Contrary to the above, an Instrument and Control (I&C) technician received a first degree thermal burn on his forearm while attempting to fill the reference leg on a pressurizer level detector (1-LT-0460) during hot plant conditions using a procedure that did not contain sufficient detail to accomplish the task. The I&C technician was using Instruction No. ICI-2007, "Filling and Venting Level Transmitters and Level Indicating Switches (Wet Leg)" which is a generic procedure that provides general guidelines for filling and venting level instruments. This use of a generic procedure is inappropriate for the circumstances, and appears to have directly contributed to the technician receiving thermal burns because he connected the low pressure fill equipment incorrectly and manipulated the wrong valves. This action resulted in the low pressure fill equipment being blown off and releasing hot reactor coolant to the containment atmosphere. The I&C technician received thermal burns to his arm from the hot reactor coolant.

The I&C technician had Operations close the reference leg root valve again while he isolated the transmitter by shutting both isolation valves and both cutout valves (see attached drawing). The vent valve cap was removed and the vent valve cracked open to depressurize the reference leg and to verify that the reference leg root valve was not leaking. The technician hooked up his low pressure fill rig to the process side test fitting instead of the reference side. The technician opened the process isolation valve instead of the reference isolation valve and was pumping up the fill rig when he noticed pressure was increasing (both cutout valves had been shut in previous steps). The technician then opened the process cutout valve instead of the reference leg cutout valve and the fill hose blew off the test fitting. The hot water struck him on the upper arm causing a minor first degree burn approximately 2" in diameter. The technician shut the process isolation valve and notified the Shift Supervisor of the problem.

The contributing factors to the incident were:

1. The reference leg valves were not adequately identified.
2. The procedure did not require the technician to verify system pressure prior to hooking up the low pressure fill rig.

Positively identify all reference leg instrument valves on Barton and Rosemount non-capillary electronic level transmitters for which normal system operating pressure is greater than 500 psig or normal system operating temperature is greater than 200°F. Specifically, hang metal tags that read "REF LEG" or "REFERENCE LEG" on the applicable valves for the following transmitters:

Revise ICI-2007 to require sequential performance of the procedure and to specifically apply to Barton transmitters on pressurizer and steam generator level instruments.
