RADIOLOGIC AND ENGINEERING ASSESSMENT

DOE ID NO.: GJ-00713-MR  
ADDRESS: 1535 ELM AVENUE

JUNE 1985

BENDIX FIELD ENGINEERING CORPORATION  
P.O. Box 1569  
Grand Junction, Colorado 81502

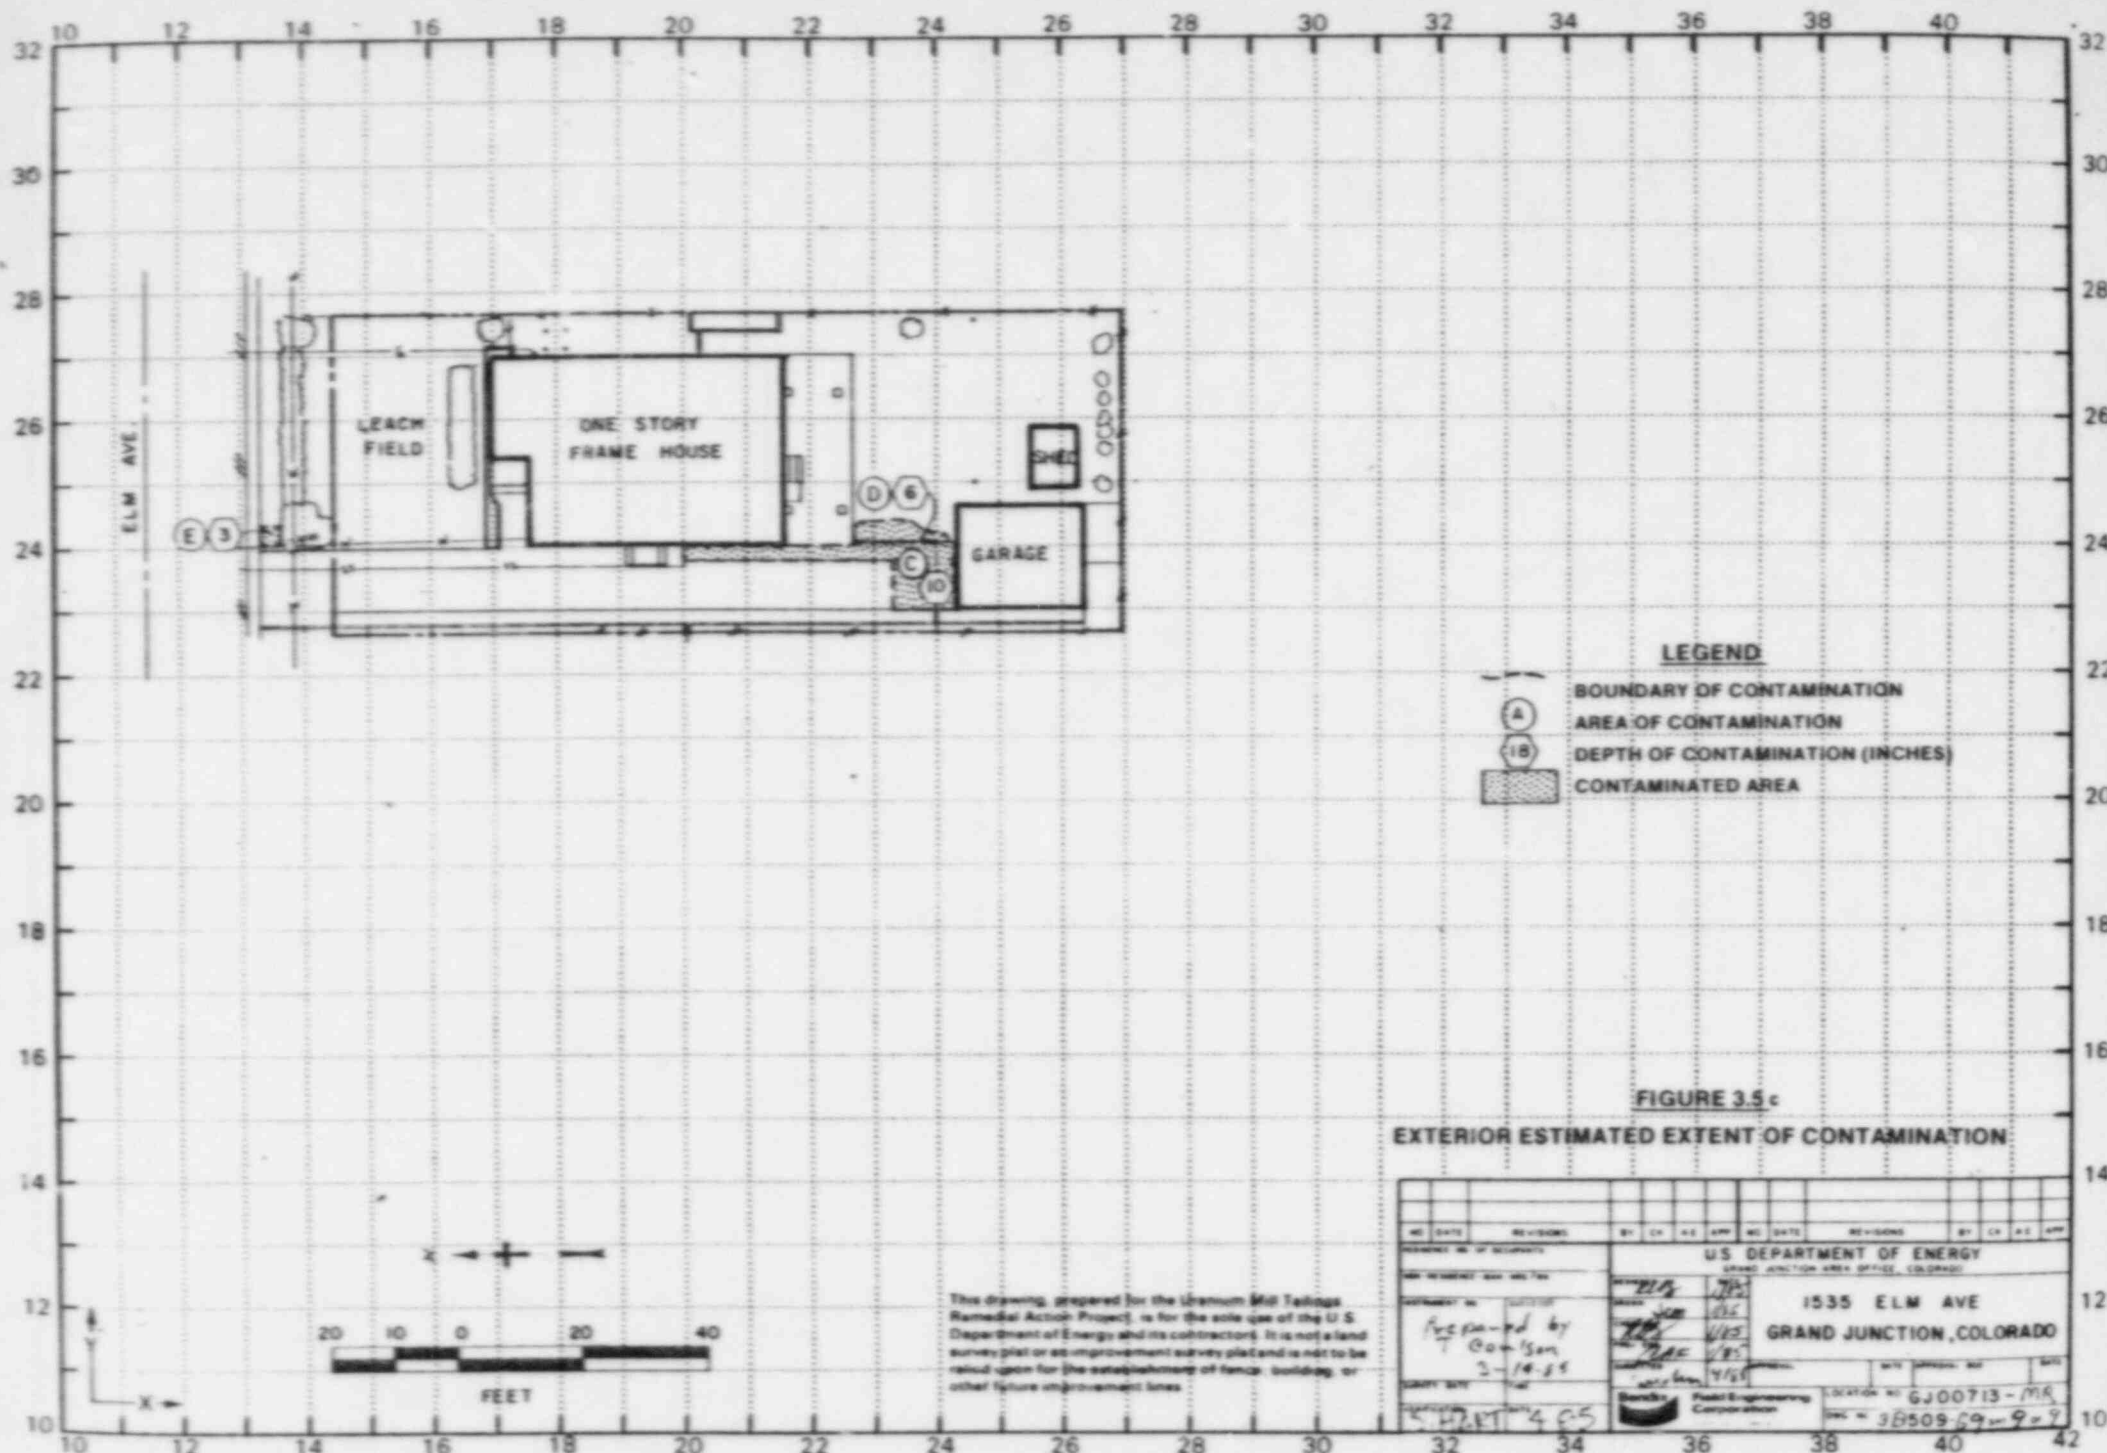
**FIGURE 3.5c**

- (AREA A) The concrete wall at the north side of the basement is contaminated. The wall is approximately 72 inches high, 144 inches wide, and 4 inches thick. This area is not recommended for remedial action because the EPA Standards for gamma or RDC are not exceeded.
- (AREA B) The 4-inch-thick concrete floor pad in the garage is contaminated (approximately 320 sf).
- (AREA C) A portion of the 4-inch-thick concrete driveway and sidewalk slabs is contaminated. The fill material beneath the concrete is also contaminated. The total depth of contamination is 10 inches (approximately 209 sf).
- (AREA D) The lawn adjacent to the driveway is contaminated to a depth of 6 inches (approximately 60 sf).
- (AREA E) An isolated section of concrete on the north edge of the property is contaminated. The concrete is 3 inches thick (approximately 16 sf).

**EXTERIOR ESTIMATED EXTENT OF CONTAMINATION**

The recommended remedial action for this property, DOE ID No. GJ-00713-MR, includes removal of select areas identified as containing radioactive material (as discussed in Section 3.5 and shown in Appendix Figures 3.5b and 3.5c) and transport of removed material to the disposal site.
