RADIOLOGIC AND ENGINEERING ASSESSMENT

DOE ID NO.: GJ-05979-RS
ADDRESS: 648 26 ROAD

MAY, 1985

URANIUM MILL TAILINGS REMEDIAL ACTION PROJECT OFFICE

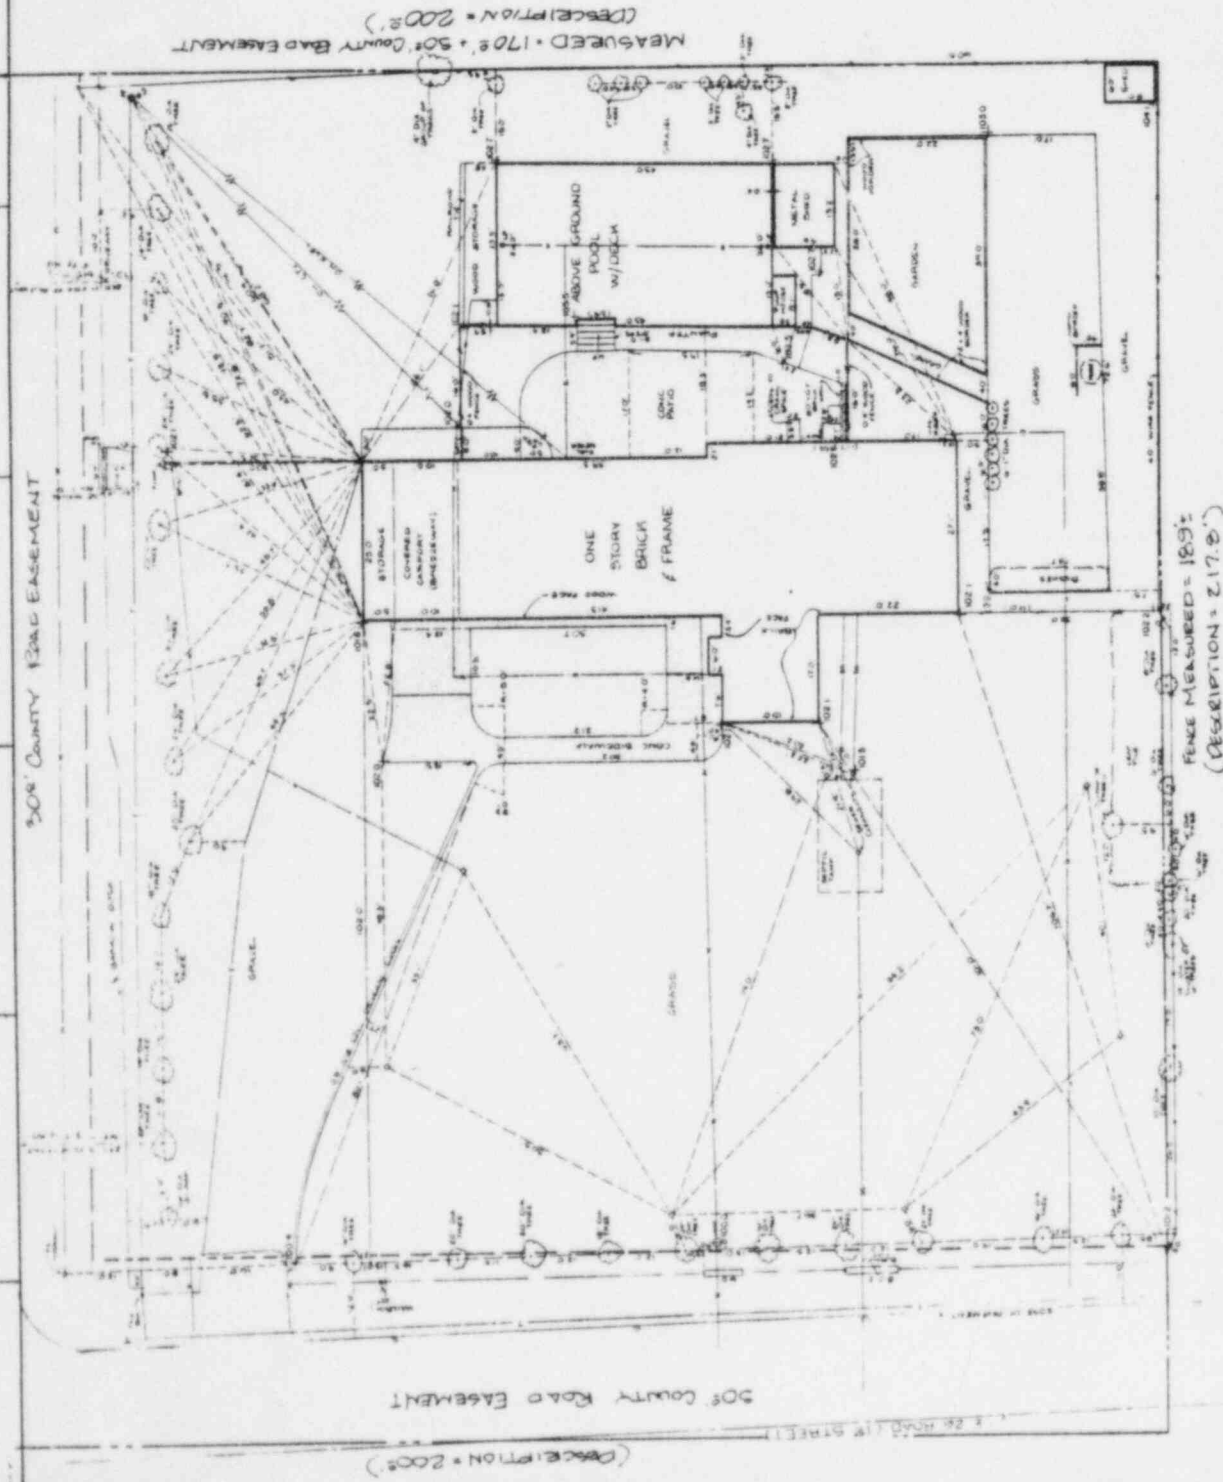
FIGURE 2.2
SITE PLAN

Structures, utilities, landscaping, and other special features of this property are included in Appendix Figure 2.2.

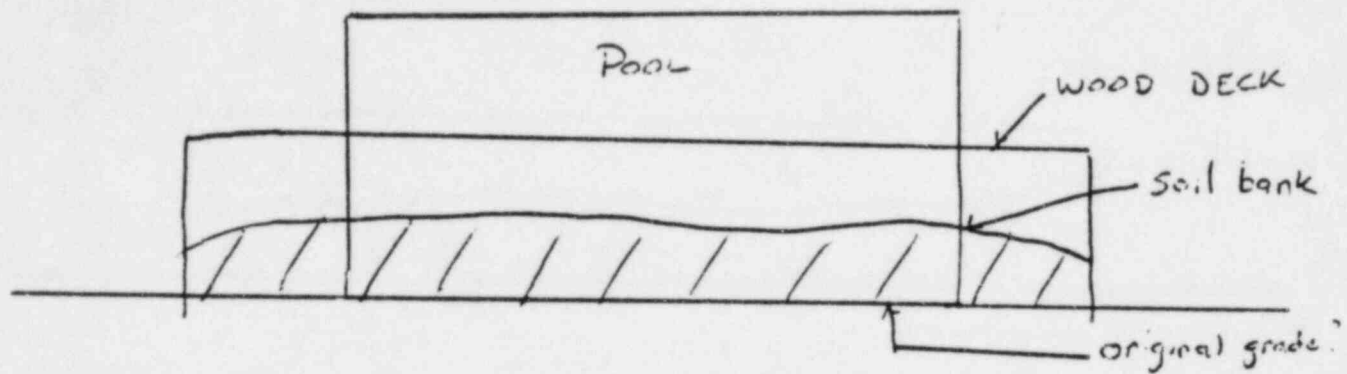
Bank Around Pool

- (AREA A) An 18-inch-high soil embankment surrounds the pool. The embankment is contaminated, as well as the soil beneath. The estimated total depth of contamination is 30 inches (approximately 684 sf).

The pool has a raised wooden deck (36 inches high). The pool appears to sit at grade and is surrounded by a soil bank (18 inches high). Because of the low clearance and the frozen ground conditions, subsurface deltas were not feasible (attempts were made with no success). (See attached sketch of pool).

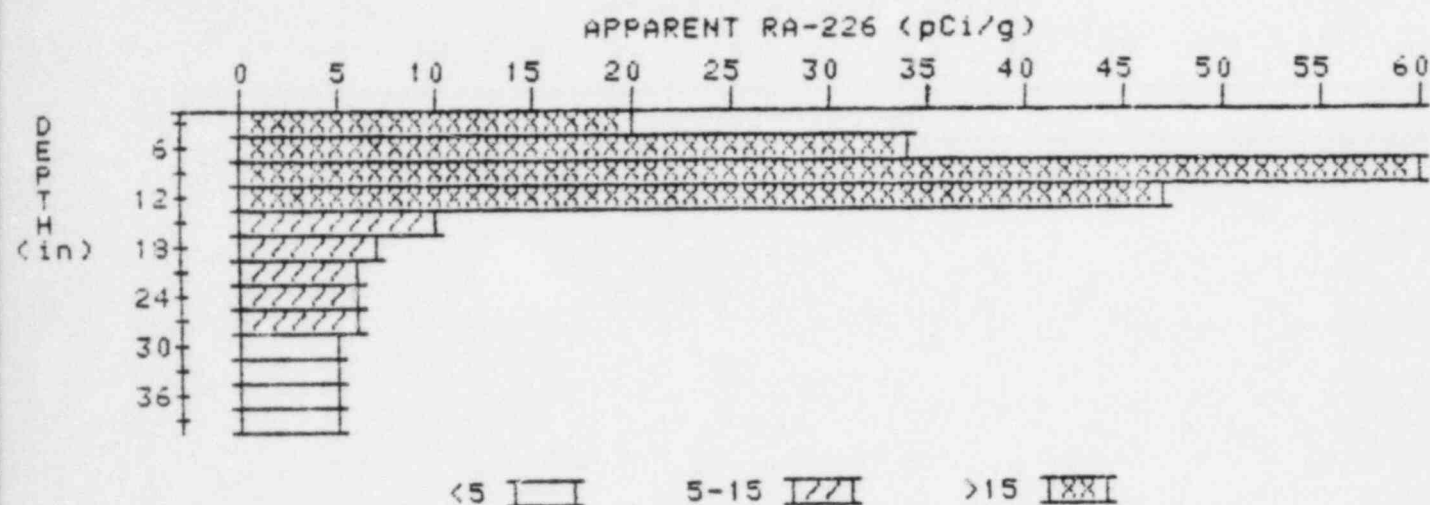
PROPERTY NUMBER: GJ-05979-RS
HOLE NUMBER: 55
LOCATION: 288298

Depth (in)	Apparent Radium-226 (pCi/g) Undeconvolved	Apparent Radium-226 (pCi/g) Deconvolved
3	19.8	19.8
6	31.7	34.0
9	42.3	73.8
12	35.2	47.5
15	21.2	10.2
18	13.4	6.6
21	9.4	5.8
24	7.4	5.8
27	6.3	5.8
30	5.5	5.0
33	5.0	4.6
36	4.7	4.5
39	4.5	4.5

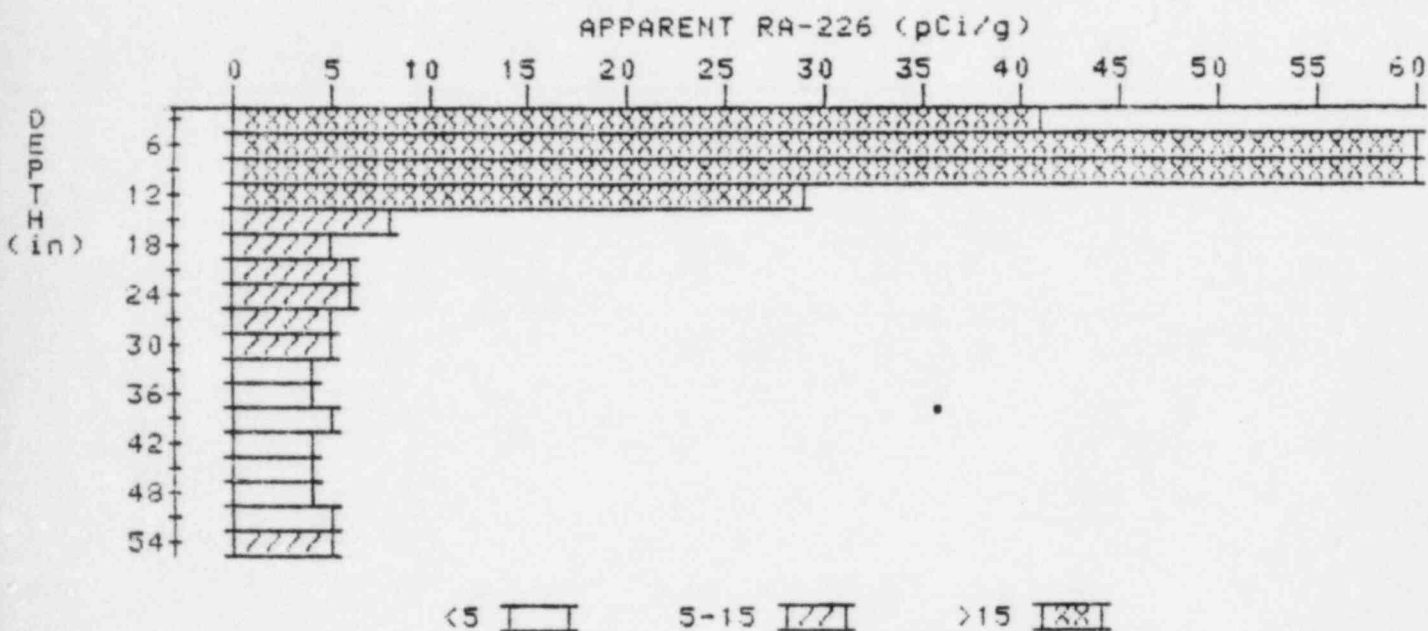
PROPERTY NUMBER: GJ-05979-RS
HOLE NUMBER: 59
LOCATION: 307296

Depth (in)	Apparent Radium-226 (pCi/g) Undeconvolved	Apparent Radium-226 (pCi/g) Deconvolved
3	41.4	41.4
6	56.9	91.0
9	53.2	79.0
12	35.0	29.0
15	20.2	7.6
18	12.5	5.2
21	8.9	5.9
24	7.0	5.6
27	5.9	5.0
30	5.3	5.1
33	4.8	4.3
36	4.6	4.4
39	4.5	4.5
42	4.4	4.2
45	4.4	4.2
48	4.5	4.3
51	4.7	4.5
54	5.0	5.0
