TENNESSEE VALLEY AUTHORITY

Enclosed is our response to R. D. Walker's letter to H. G. Parris dated May 21, 1985 requesting a supplemental response for Inspection Report 84-52 for our Browns Ferry Nuclear Plant.

ENCLOSURE  
SUPPLEMENTAL RESPONSE  
NRC INSPECTION REPORT NOS.  
50-259/84-52, 50-260/84-52, AND 50-296/84-52  
ROGER D. WALKER'S LETTER TO H. G. PARRIS  
DATED MAY 21, 1985

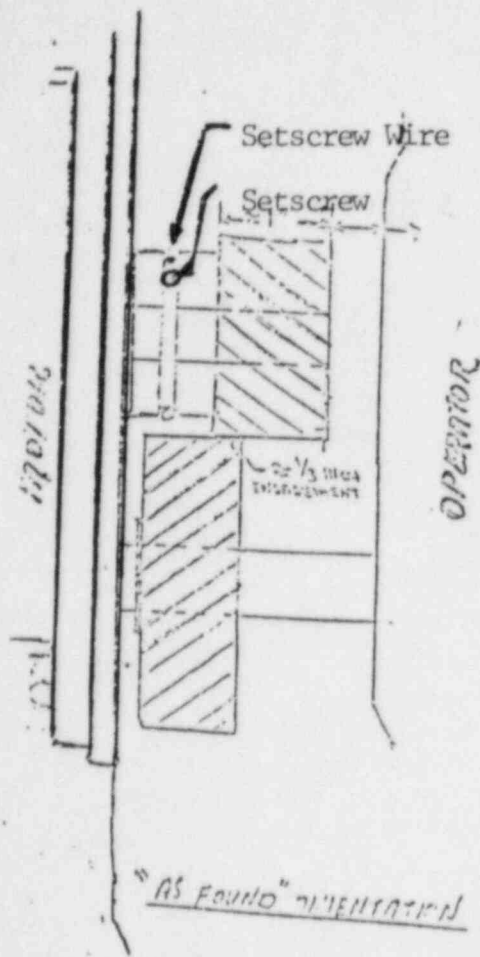
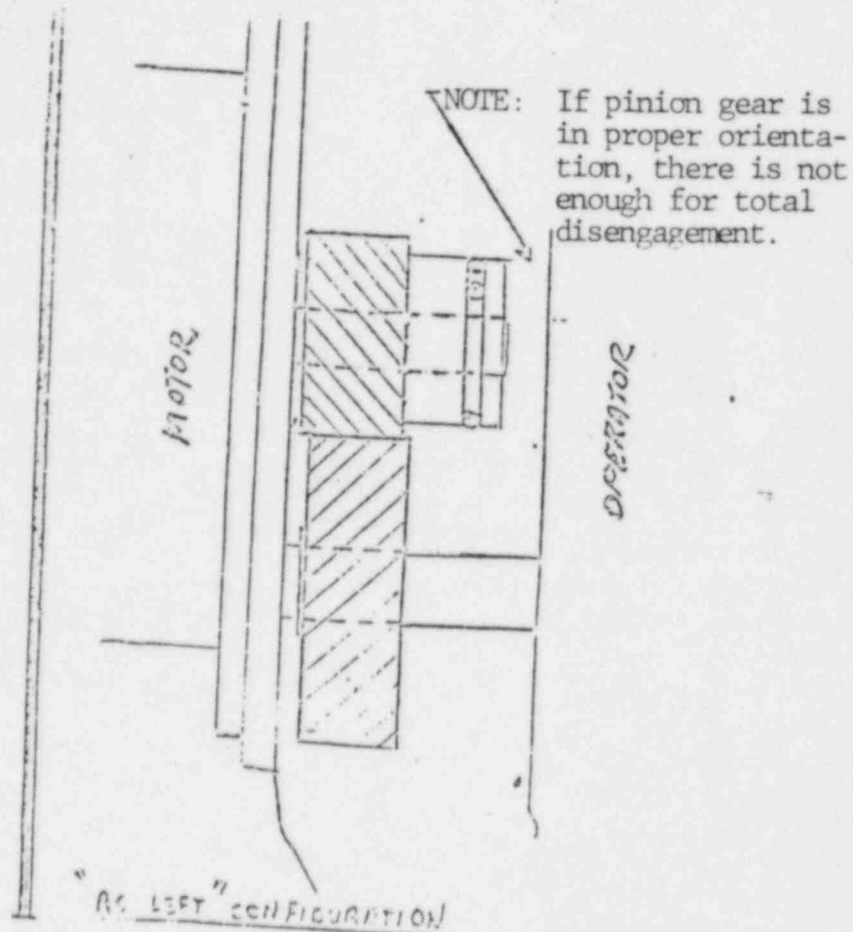
During testing of FCV 74-12 on unit 3, the valve failed to pass timing requirements, and a maintenance request was initiated to investigate the problem. The drive motor was removed, and a loose setscrew used to secure the motor pinion gear to the shaft was discovered. The setscrew was tightened, and the valve reassembled. The pinion gear was not removed from the motor shaft during the maintenance.

Maintenance activities associated with Limitorque operators are controlled by Mechanical Maintenance Instruction (MMI) 87 (Corrective and Preventative Maintenance of Limitorque Operators). To verify motor pinion gear orientation, an exploded view of the operator (attached) is provided in the instruction. The correct pinion gear orientation is, as shown, dependent on the size and model of the Limitorque operator involved. The craftsmen involved with verifying orientation in this case misinterpreted the sketch and, consequently, verified the orientation of the gear incorrectly.

In regards to the relationship to valve operability and pinion gear setscrew tightness, it must be noted that both subject valves had motor pinion gears installed backwards. In this configuration, enough clearance is available for total disengagement of the motor pinion and worm shaft clutch gear (see attached figure).

Sketch showing engagement between motor pinion gear and worm shaft clutch gear. Orientation shown at right is correct for a SMB-1 Limitorque operator like the one on FCV 74-12.

If the pinion gear installation is correct, valve operability would only be affected if the setscrew was loose and the key slipped out of the key slot (or the key sheared). This is an unlikely situation. MMI-87 is being revised to ensure the key is kept in position (if loose) by pricking the end of the pinion key.
