RADIOLOGIC AND ENGINEERING ASSESSMENT

DOE ID NO.: GJ-07856-RS
ADDRESS: 225 SHERMAN DRIVE

JUNE 1985

BENDIX FIELD ENGINEERING CORPORATION
P.O. Box 1569
Grand Junction, Colorado 81502

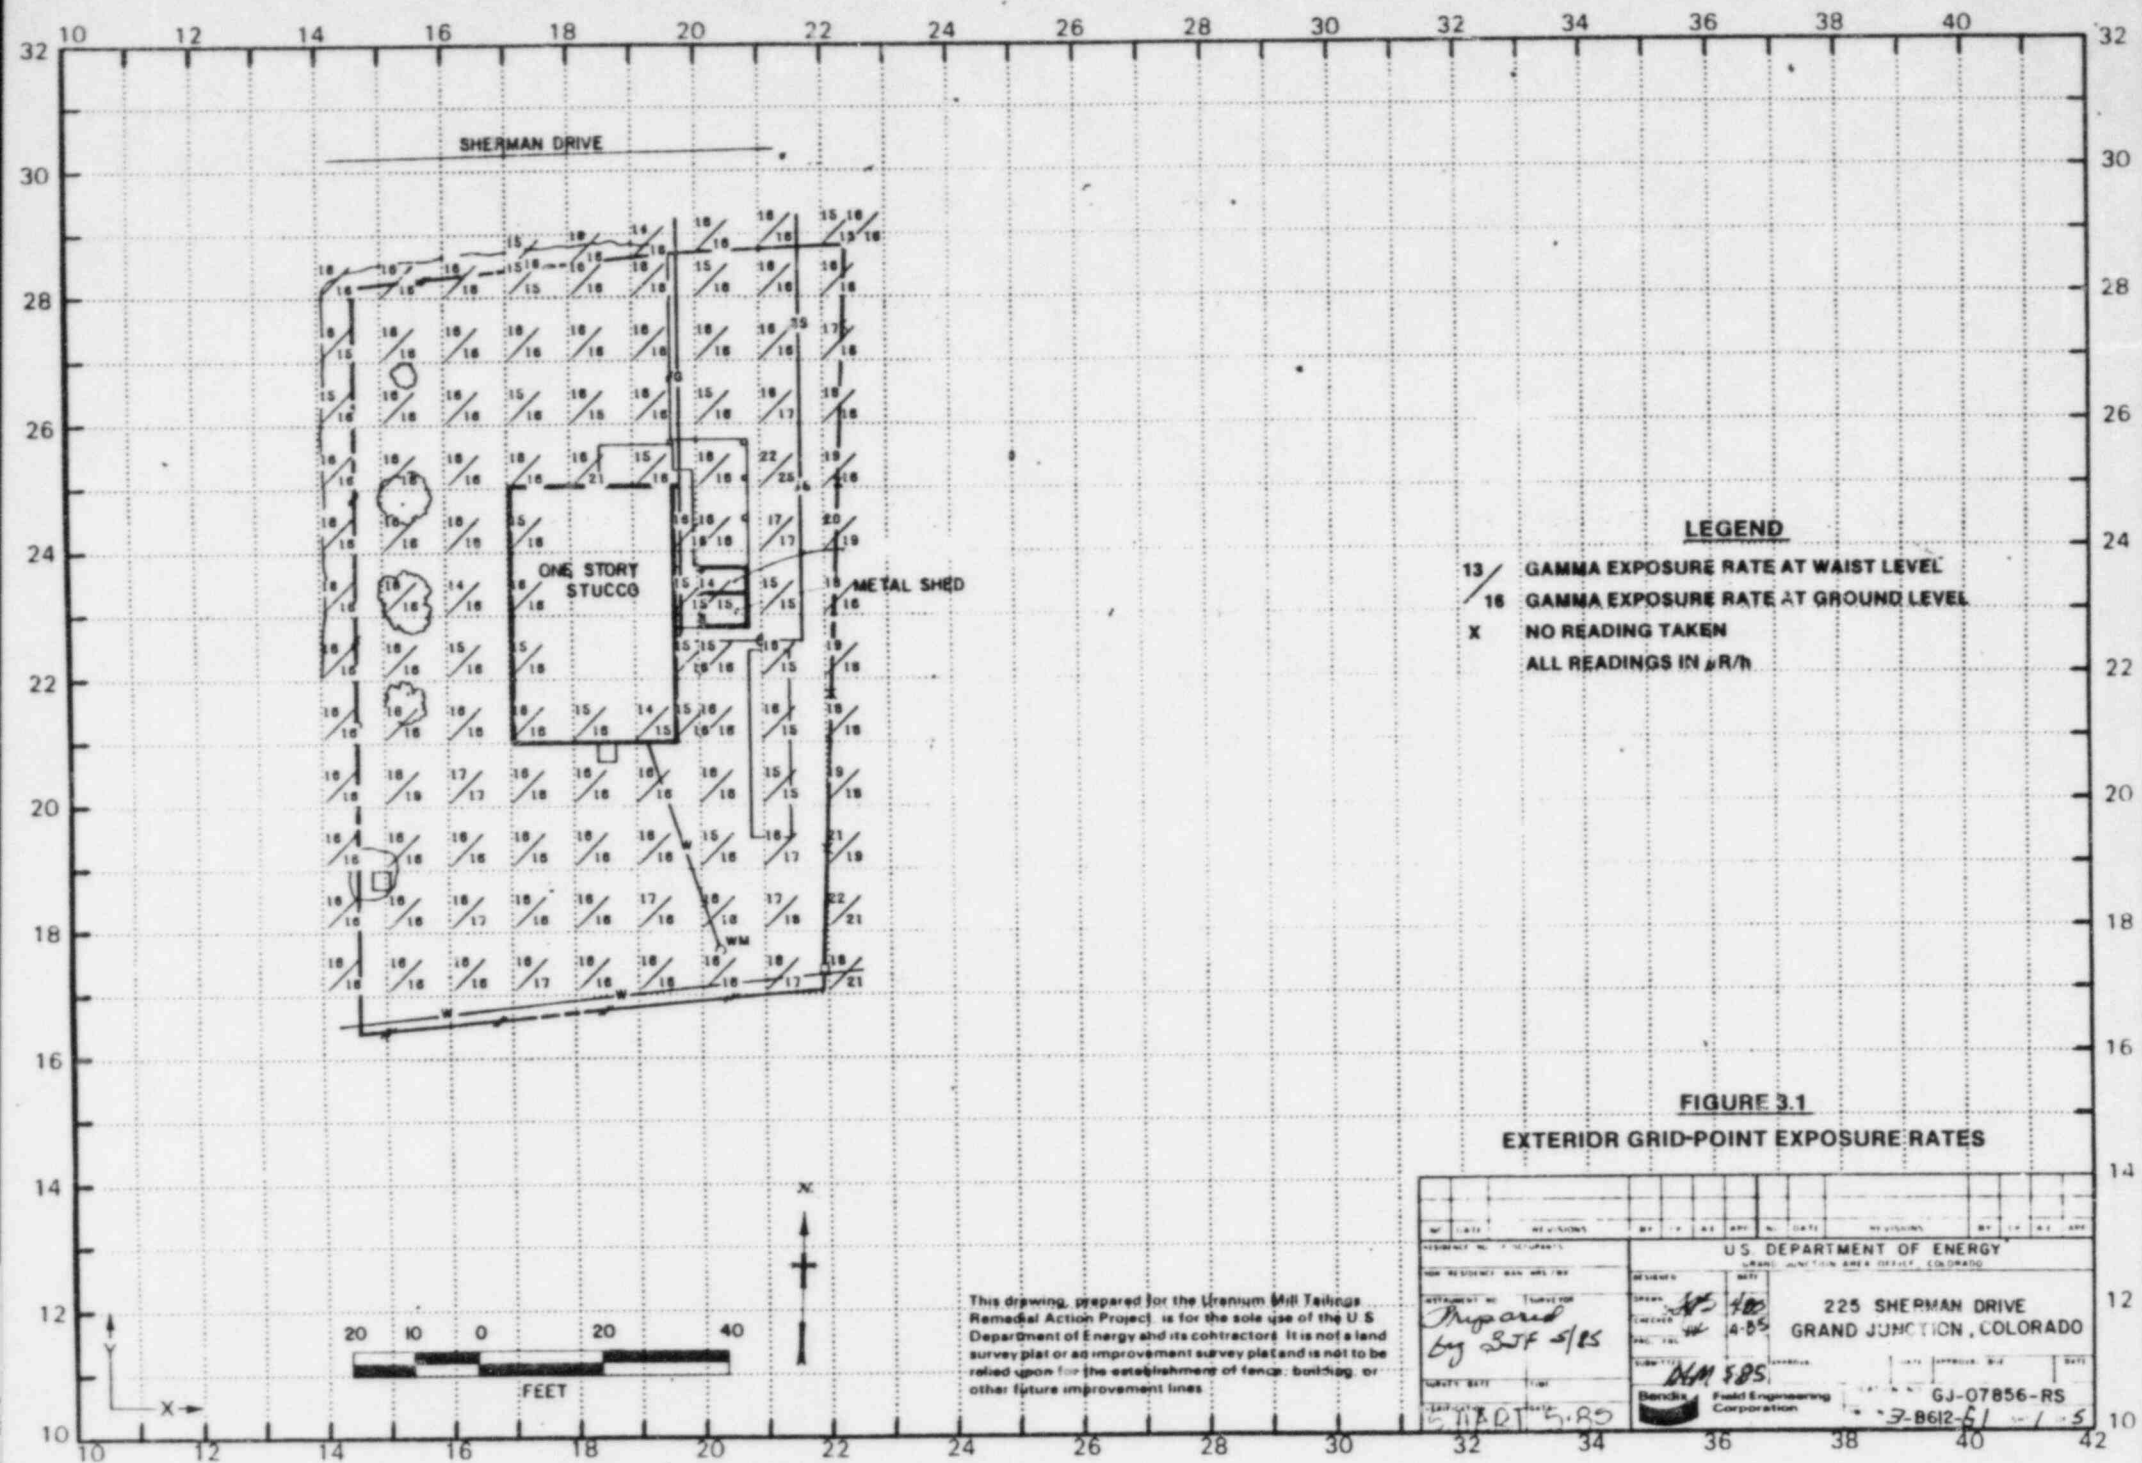
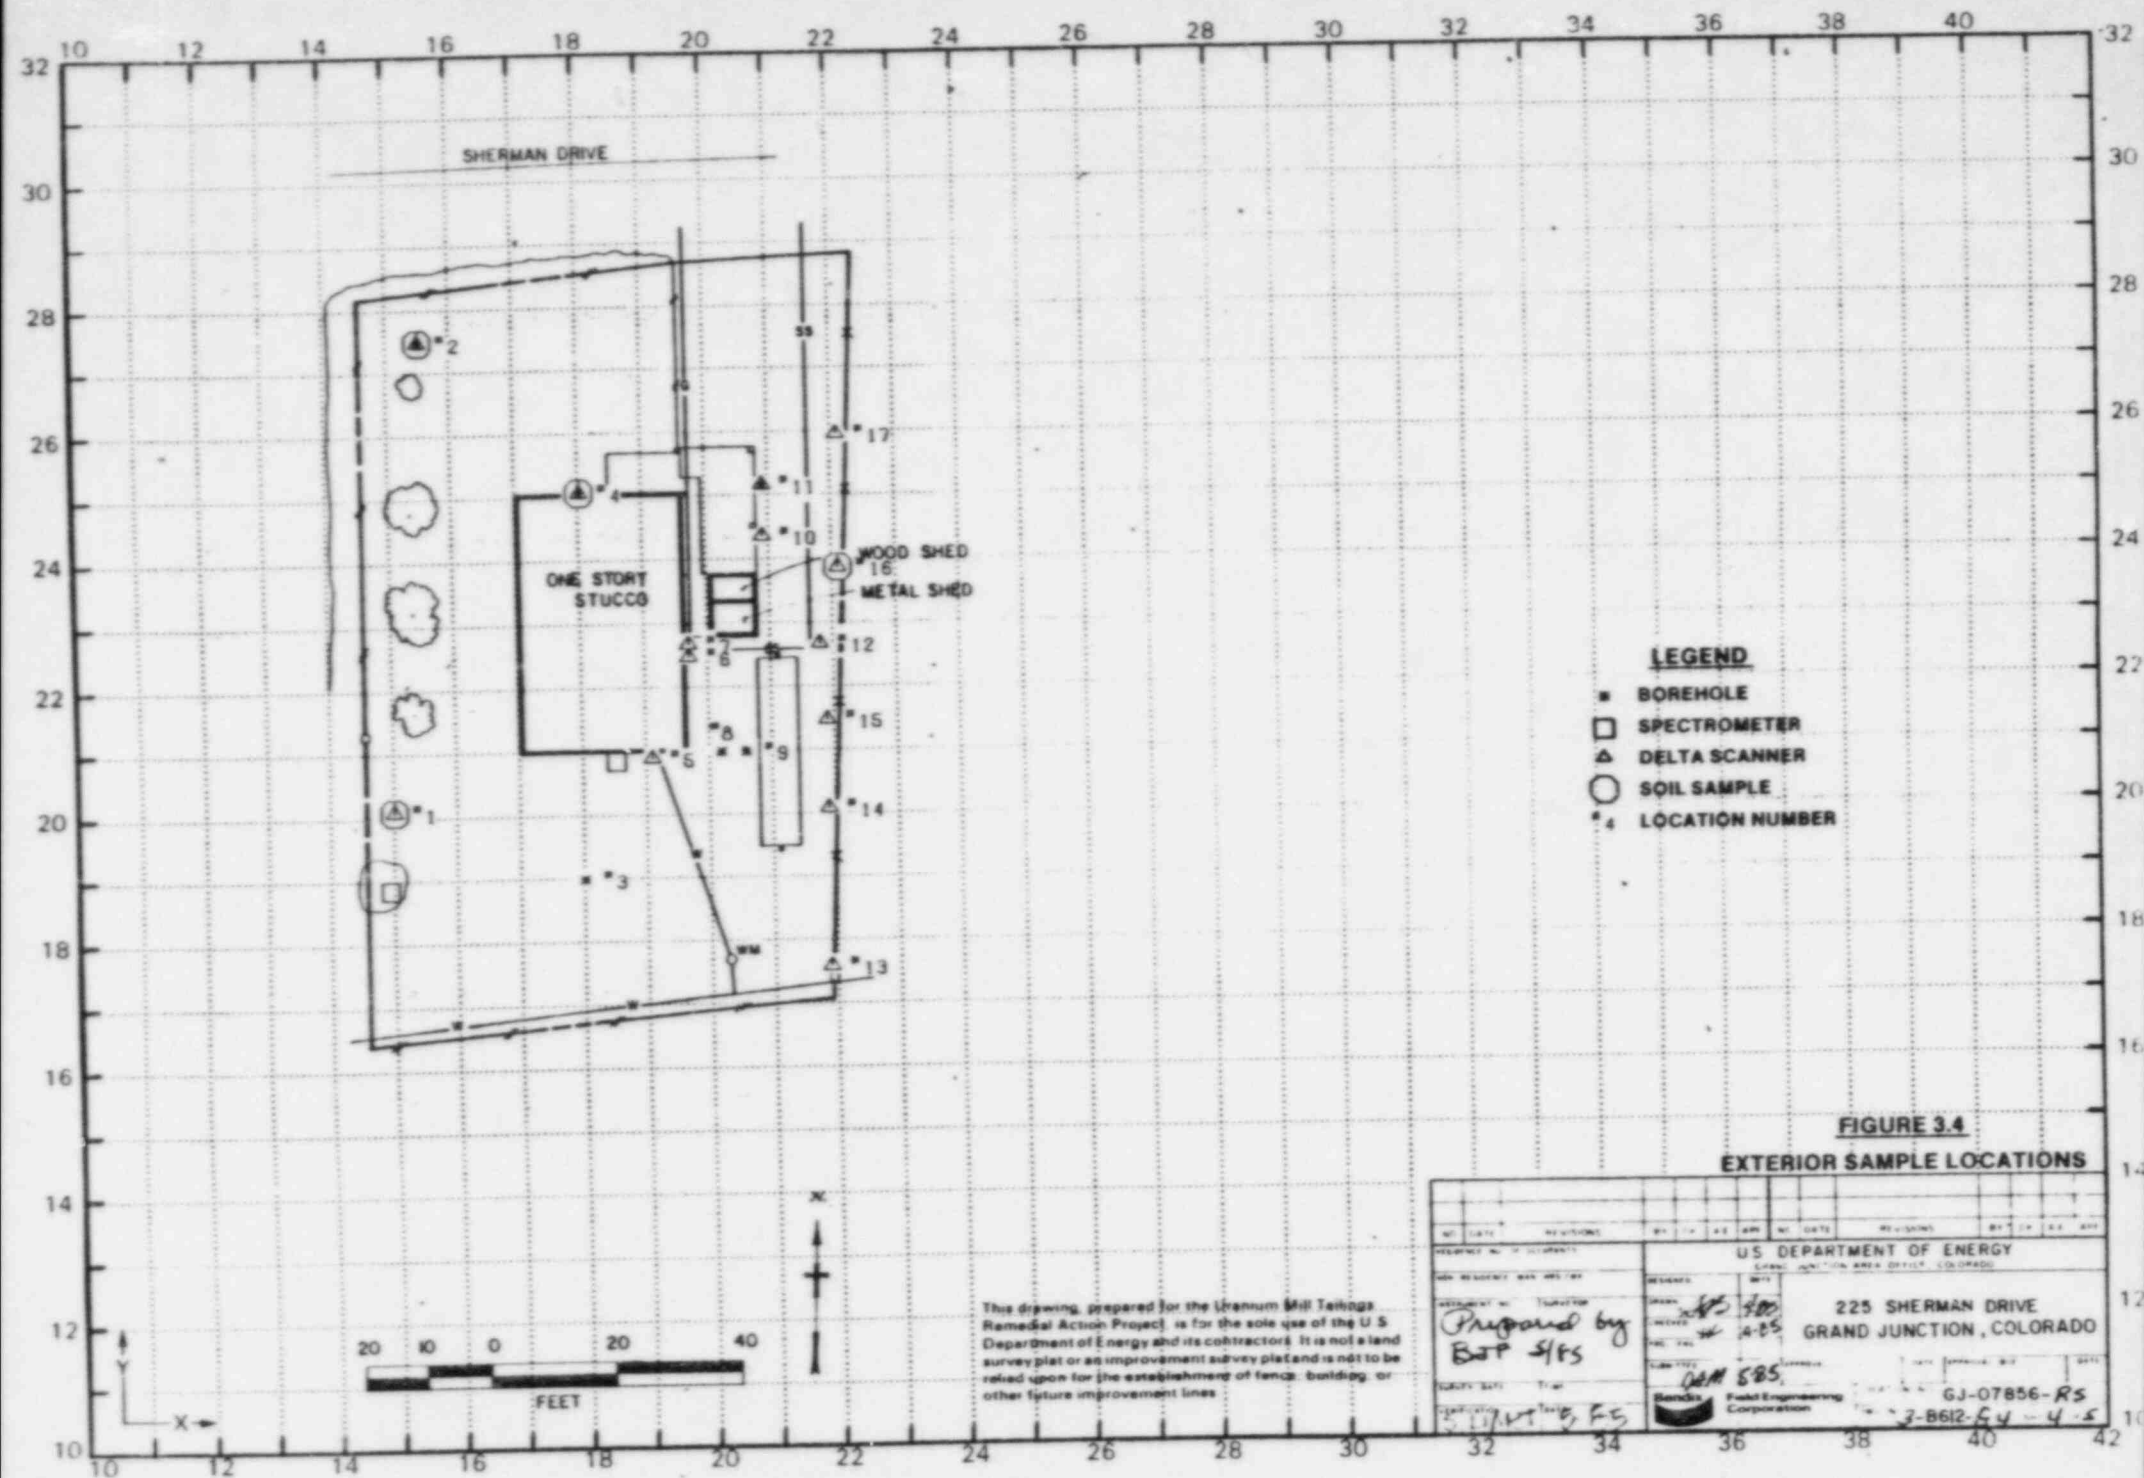
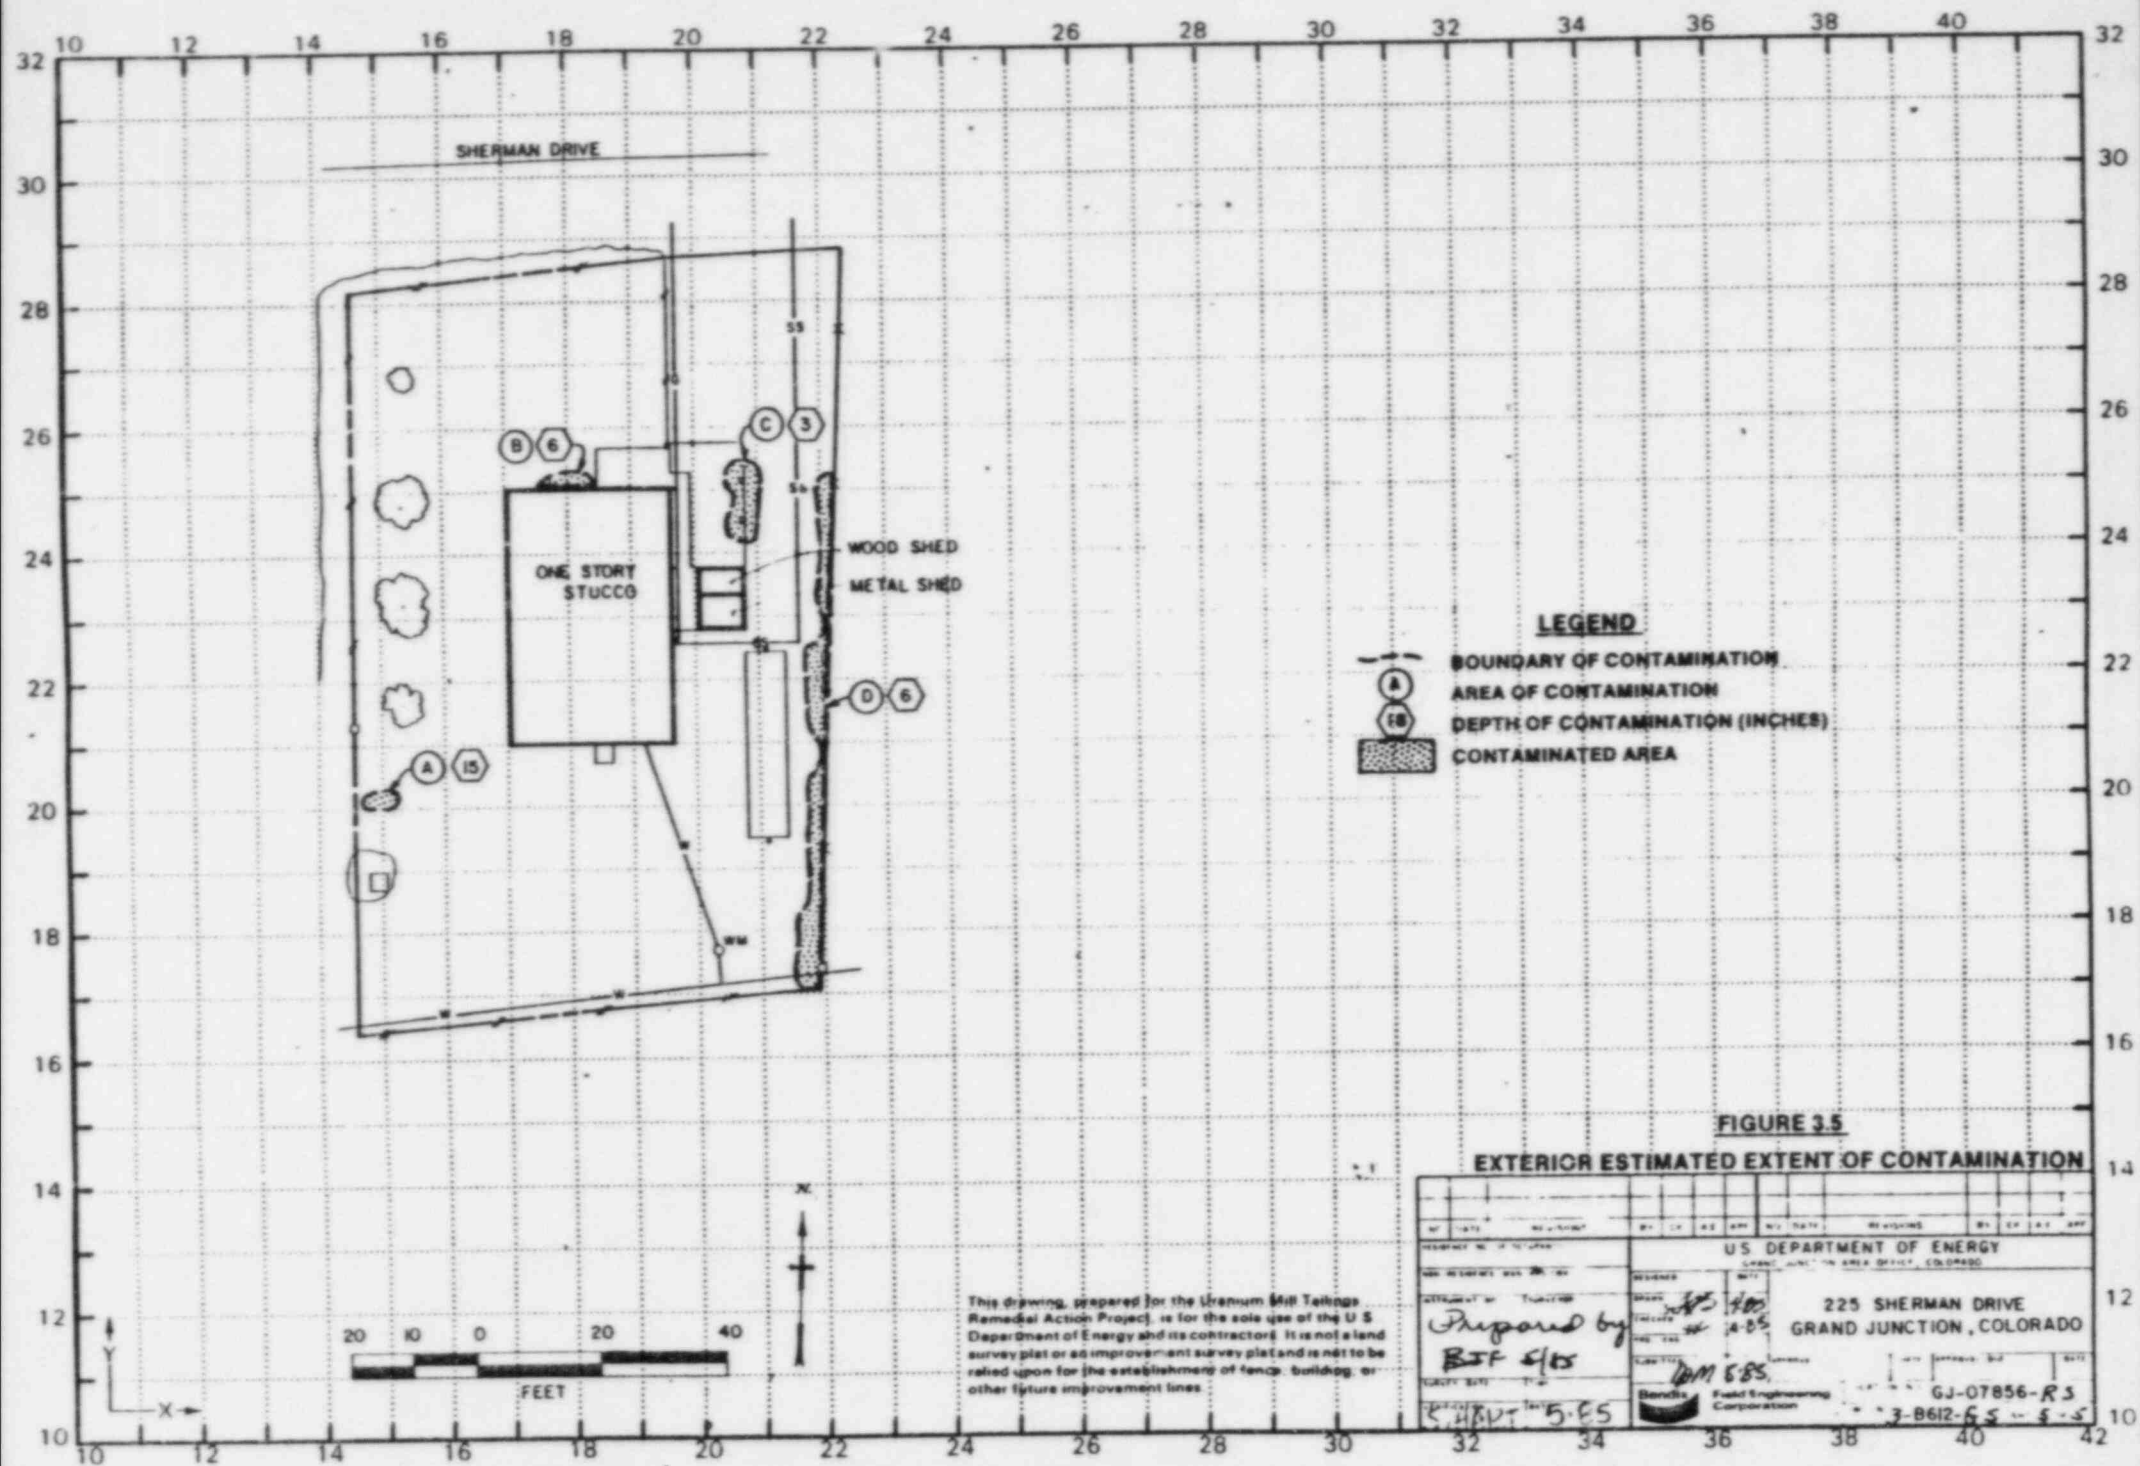
Appendix Figure 3.5 shows identified areas and estimated depths of contamination on this property, based on assessments of all measurements taken. As noted in this figure, areas recommended for remedial action that contain identified residual radioactive materials are:

- (AREA A) Southwest of the primary structure, an isolated deposit is contaminated to a depth of 15 inches (approximately 18 sf).
- (AREA B) A small deposit along the north foundation of the primary structure has contamination extending to a depth of 6 inches (approximately 30 sf).
- (AREA C) North of the attached shed, contamination extends to a depth of 3 inches. Small pieces of crushed uranium ore are scattered in this area (approximately 70 sf).
- (AREA D) The depth of contamination along the east property boundary is 6 inches (approximately 246 sf).

The recommended remedial action for this property, DOE ID No. GJ-07856-RS, includes removal of all areas identified as containing radioactive material (as discussed in Section 3.5 and shown in Appendix Figure 3.5) and transport of removed material to the disposal site.

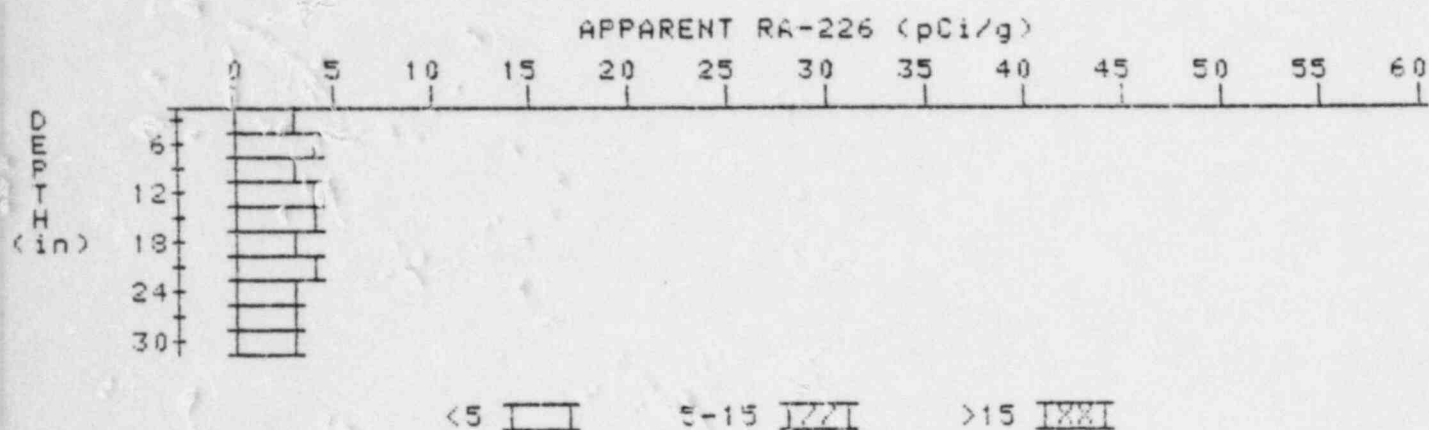
HOLE NUMBER: 2

Depth (in)	Apparent Radium-226 (pCi/g) Undeconvolved	Apparent Radium-226 (pCi/g) Deconvolved
3	3.2	3.2
6	3.5	4.0
9	3.5	3.3
12	3.6	4.0
15	3.5	3.5
18	3.4	3.2
21	3.4	3.6
24	3.3	3.3
27	3.2	3.2
30	3.1	3.1

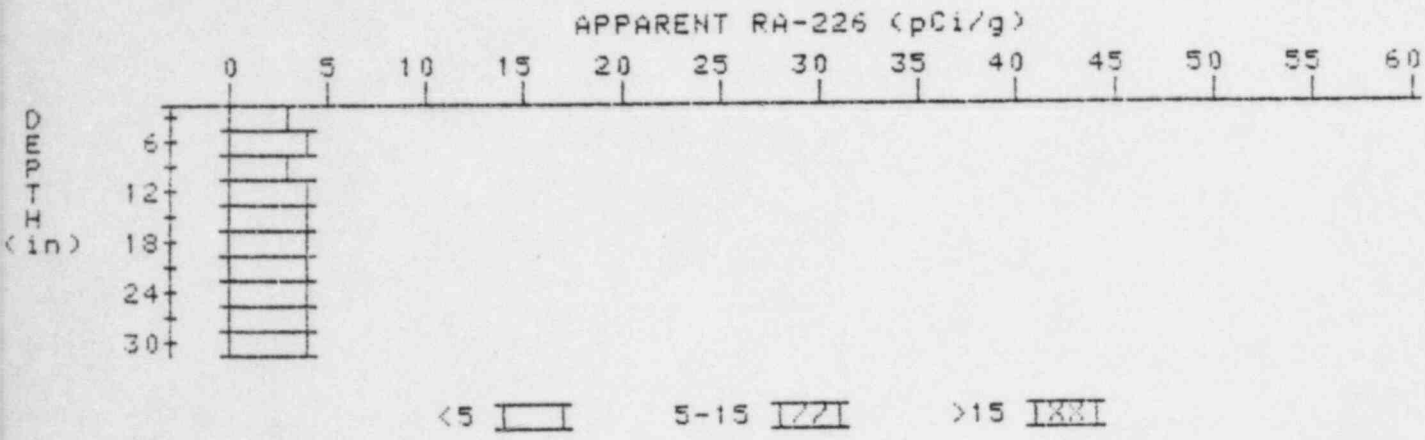
PROPERTY NUMBER: GJ-07856-RS
HOLE NUMBER: 3
LOCATION: 180190

Depth (in)	Apparent Radium-226 (pCi/g) Undeconvolved	Apparent Radium-226 (pCi/g) Deconvolved
3	3.4	3.4
6	3.7	4.2
9	3.7	3.3
12	3.9	3.9
15	4.1	4.3
18	4.2	4.4
21	4.2	4.2
24	4.2	4.4
27	4.1	4.3
30	3.9	3.9

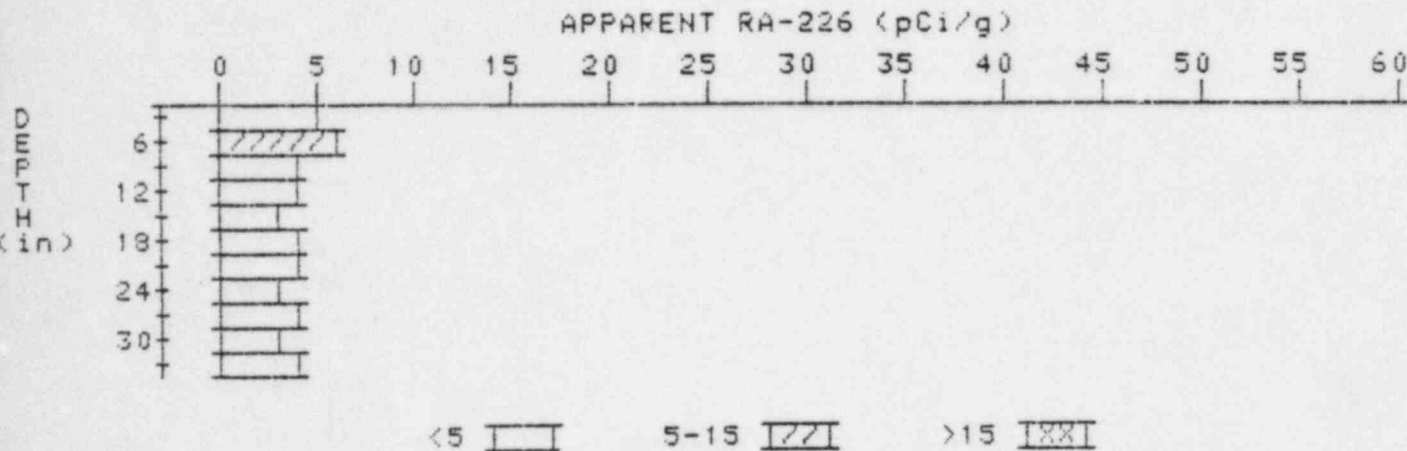
PROPERTY NUMBER: GJ-07356-RS
HOLE NUMBER: 4
LOCATION: 180251

Depth (in)	Apparent Radium-226 (pCi/g) Undeconvolved	Apparent Radium-226 (pCi/g) Deconvolved
3	4.6	4.6
6	4.8	5.7
9	4.5	4.3
12	4.3	4.5
15	4.0	3.5
18	4.0	4.2
21	3.9	4.1
24	3.7	3.3
27	3.7	3.9
30	3.6	3.1
33	3.8	3.8

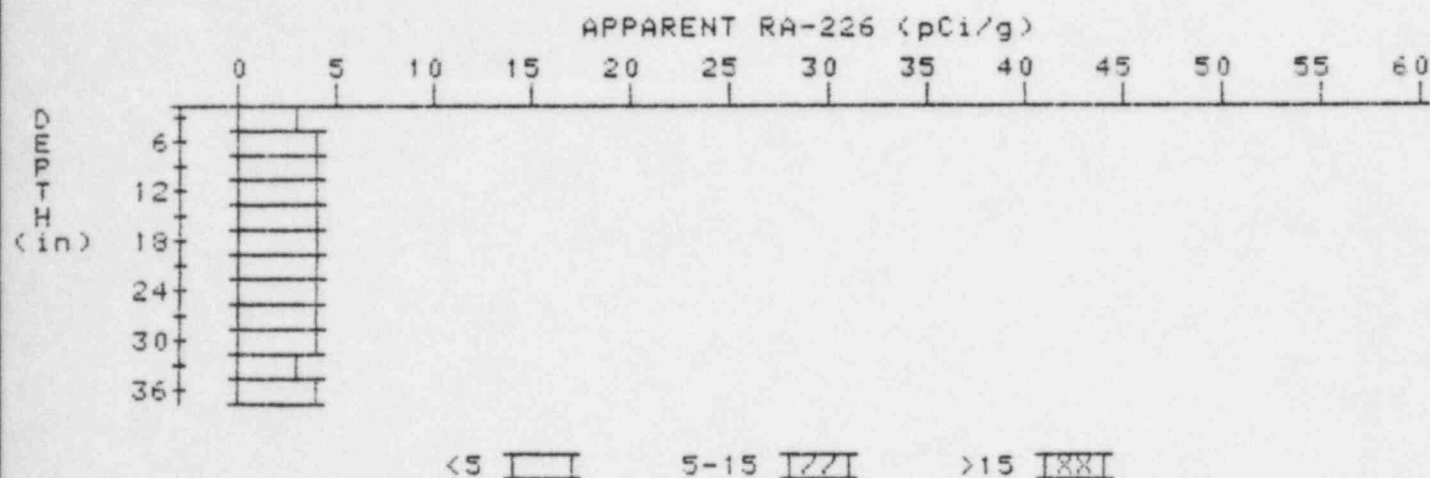
HOLE NUMBER: 8

Depth (in)	Apparent Radium-226 (pCi/g) Undeconvolved	Apparent Radium-226 (pCi/g) Deconvolved
3	3.1	3.1
6	3.6	4.0
9	3.9	4.1
12	4.1	4.5
15	4.1	4.3
18	4.0	3.8
21	4.0	4.2
24	3.9	4.1
27	3.7	3.5
30	3.6	3.6
33	3.5	3.3
36	3.5	3.5

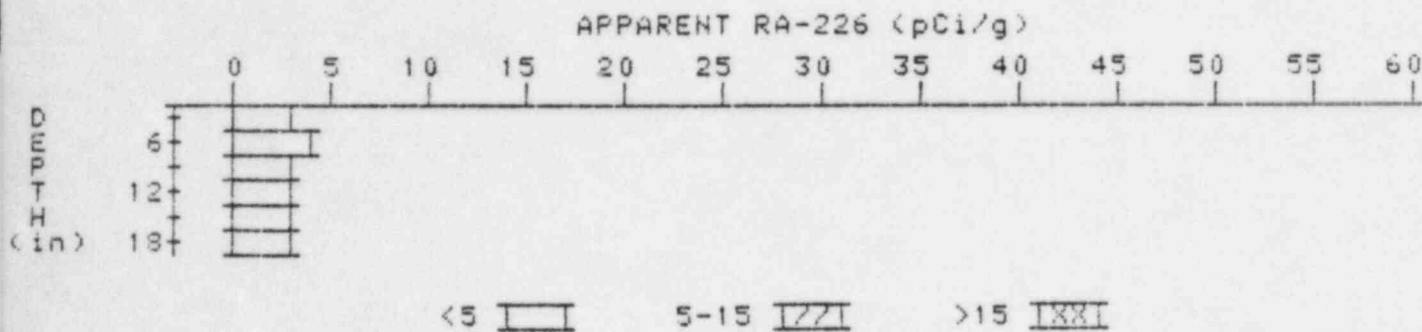
PROPERTY NUMBER: GJ-07856-RS
HOLE NUMBER: 9
LOCATION: 206210

Depth (in)	Apparent Radium-226 (pCi/g) Undeconvolved	Apparent Radium-226 (pCi/g) Deconvolved
3	3.0	3.0
6	3.3	3.8
9	3.3	3.5
12	3.2	3.2
15	3.1	2.9
18	3.1	3.1

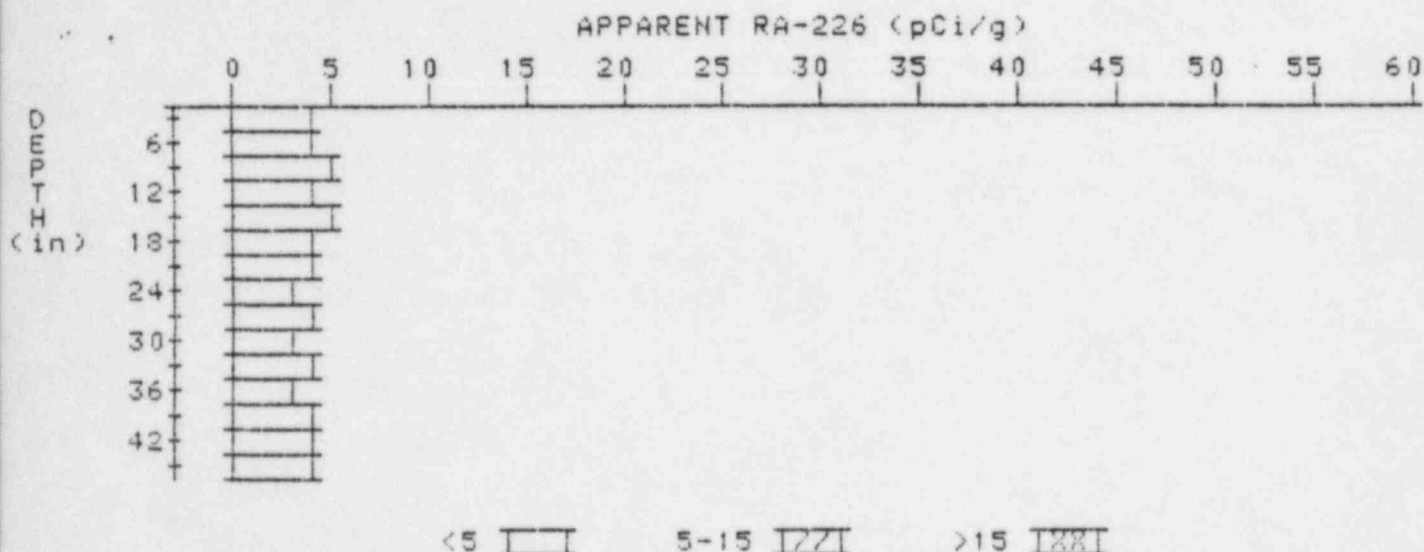
HOLE NUMBER: 11

Depth (in)	Apparent Radium-226 (pCi/g) Undeconvolved	Apparent Radium-226 (pCi/g) Deconvolved
3	3.9	3.9
6	4.1	4.1
9	4.3	4.7
12	4.3	4.3
15	4.3	4.7
18	4.1	4.1
21	3.9	3.9
24	3.7	3.3
27	3.7	4.1
30	3.5	3.1
33	3.5	3.5
36	3.5	3.3
39	3.6	3.6
42	3.7	4.1
45	3.6	3.6
