LICENSEE EVENT REPORT (LER)

FACILITY NAME (1) McGuire Nuclear Station - Unit 2										DOCKET NUMBER (2) 0 5 0 0 0 3 7 0					PAGE (3) 1 OF 1							
TITLE (4) Pipe in Auxiliary Letdown System Damaged by Water Hammer																						
EVENT DATE (5)			LER NUMBER (6)				REPORT DATE (7)			OTHER FACILITIES INVOLVED (8)												
MONTH	DAY	YEAR	YEAR	SEQUENTIAL NUMBER	REVISION NUMBER	MONTH	DAY	YEAR	FACILITY NAMES				DOCKET NUMBER(S)									
0	8	0	6	8	4	8	4	0	1	7	0	1	0	6	2	4	8	5	0 5 0 0 0			
OPERATING MODE (9)		THIS REPORT IS SUBMITTED PURSUANT TO THE REQUIREMENTS OF 10 CFR § (Check one or more of the following) (11)																				
5		20.402(b)				20.405(c)				50.73(a)(2)(iv)				73.71(b)								
POWER LEVEL (10)		0 0 0				20.405(a)(1)(i)				50.73(a)(2)(v)				73.71(c)

Subject: McGuire Nuclear Station, Unit 2
Docket No. 50-370
LER 370/84-17

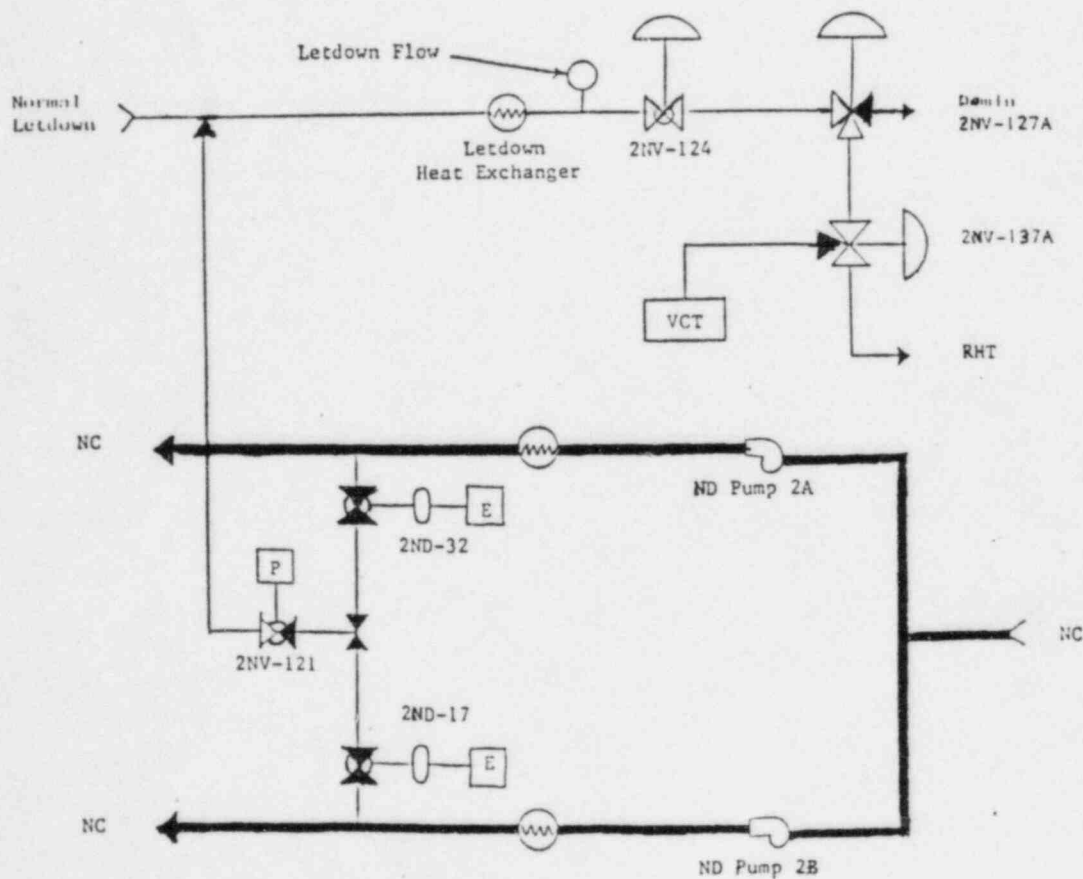
FIGURE 1
SIMPLIFIED DRAWING
OF
AUXILIARY LETDOWN LINE

EVALUATION: The auxiliary ND to NV letdown path consists of two ND headers (see Figure 1) to the normal NV letdown line. The path is isolated from each header by motor operated Kerotest valves, 2ND-17 and 2ND-32. Flow to the letdown line is controlled by piston operated, Fisher regulating valve, 2NV-121. The weld that was broken was immediately downstream of 2ND-17, following the break, the pipe was completely separated. Maintenance personnel also found the packing assembly on 2NV-121 had moved away from the valve body, along the valve stem. The two nuts that secure the packing flange were completely off of the studs and were later found on the floor of the B ND Heat Exchanger Room. Both of the studs were undamaged, indicating that it was forced from the stud during the event. Since the nuts were relatively undamaged, the packing flange must have been loose prior to the event.

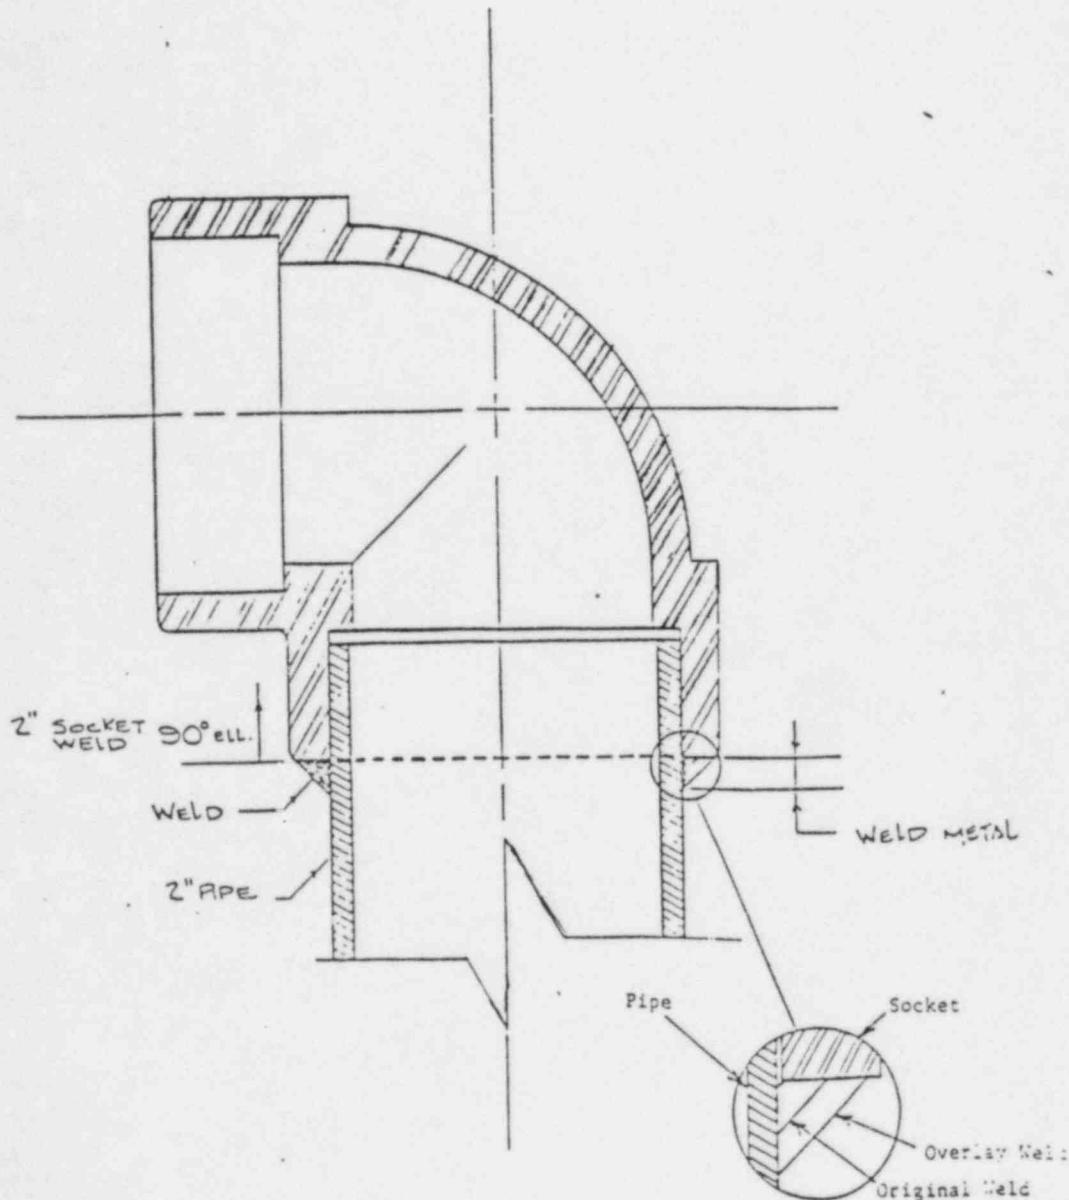
FIGURE 2

The broken weld was a 2 inch socket weld. It was properly installed and tested, using dye penetrant. Proper gap was maintained between the end of the pipe and the socket during the fitup. Although there was some lack of penetration of the weld metal, this was very small and not unusual for this type of weld. The weld was found to be satisfactory in all aspects. The weld was inspected at McGuire, following the event, using a glove box and unmagnified observation. It was then further decontaminated and sent to a research laboratory for more detailed examination. Although the final report

has not been received, a preliminary report showed the weld broke in a ductile fashion, probably due to one high stress event; however, they also found a majority of the weld break area had been fatigued. A crack had started on the inside diameter of the weld and progressed radially outward. Although the crack appeared to have included 360° of the weld, it had not penetrated the outer surface of the weld at any point. Therefore, the welded area was not leaking prior to the failure. Since the weld was found to have been degraded by the fatigue induced crack prior to the event, other welds in the system that might have been subjected to the same vibration were examined. A section of pipe downstream of the broken weld was cut out for examination. The section included four welds. All four of the welds were radiographed by QA, and the films were inspected for cracks. No cracks were found. Two of the welds were cut radially into four section, polished as necessary, and tested with dye penetrant. No indications of cracks were found.

SOCKET WELD
(NO SCALE)
