Draft Radiological and Engineering Assessment

Vicinity Property No. DUR 030

DURANGO PROPERTY

April 2, 1985

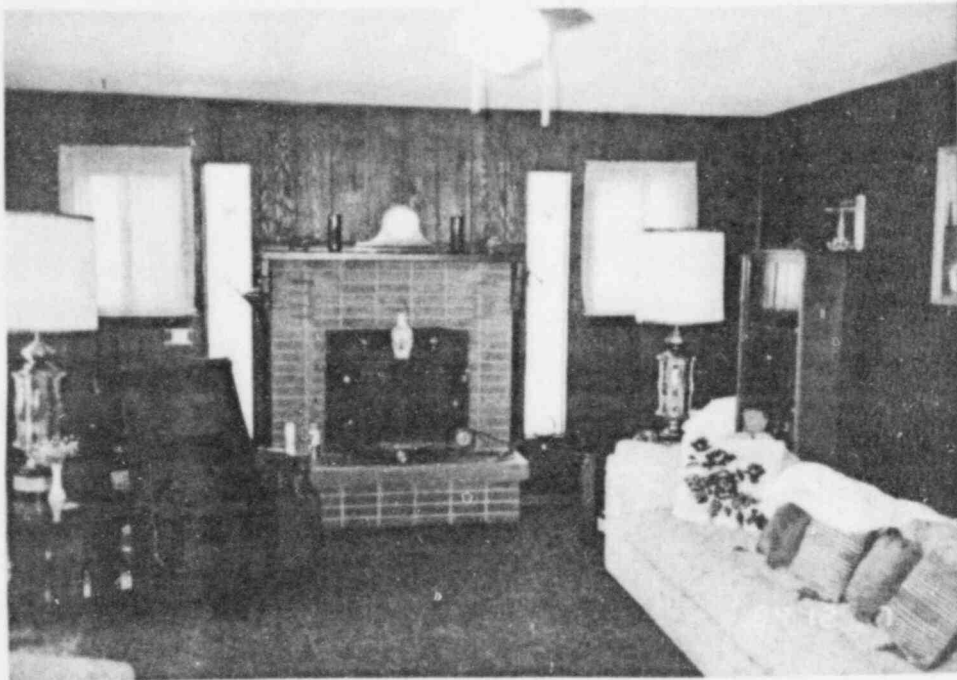
House Addition Looking West

Area D is contaminated to a depth of 24 inches. It is behind the garage under the addition to the house.

- REMOVE AND STORE HOUSEHOLD ITEMS DURING EXCAVATION.
- REMOVE, SALVAGE AND REPLACE PATIO COVER.
- PROTECT CONCRETE PATIO DURING EXCAVATION.
- REMOVE AND SALVAGE ITEMS AS NOTED IN FIGURE 4.3.
- DEMOLISH AND REMOVE ROOM ADDITION AS PER FIGURE 4.2.
- DEMOLISH AND REMOVE CONCRETE SLAB AND STEPMALL AND EXCAVATE AREA "D" TO A DEPTH OF 24 INCHES.
- CONSTRUCT NEW ROOM ADDITION AS PER FIGURE 4.3.

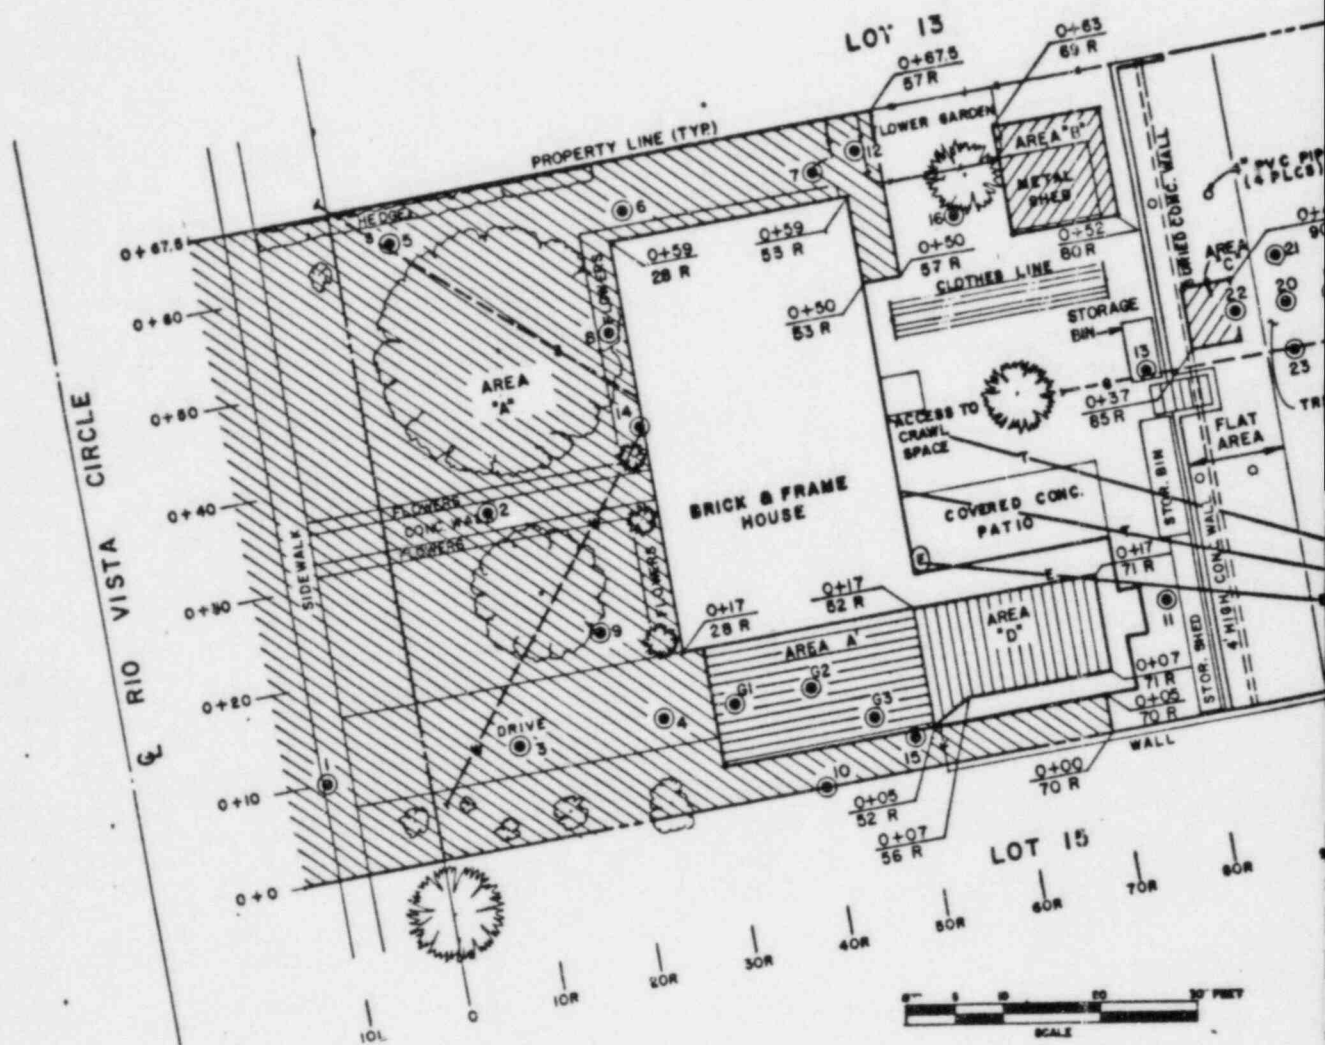
Contamination was found in 16 of the 24 outdoor holes and all three of the holes augered in the garage. The location and depth of the contamination is described in Table 3.3 and is shown in Figure 3.1.

No contamination was found in any of the five basement boreholes. These holes are described in Table 3.4 and are shown in Figure 3.1. Two of the three angled boreholes under the shed showed low-level contamination. It is probable that contamination above EPA standards is found under this shed. The holes are described in Table 3.4 and are shown in Figure 3.1.

Three areas of contamination were identified in the survey.

Area A is the major contaminated area of this property. It includes the entire front yard, the area on both sides of the house, and under the garage. The estimated depth of contamination is 30 inches throughout the area. Boreholes were augered in the garage, and the depth of contamination is 24 inches near the east wall and 42 inches deep at the main door.

The depth of contamination in Area B could not be ascertained but is probably about 12 inches.

Area C is a small area with an estimated depth of contamination of 12 inches.

Areas B and C are small, relatively low-level areas and if these were isolated spots, they could safely be left in place. However, since remedial action is definitely needed in Area A on this property, it is prudent to excavate Areas B and C at the same time as Area A.
