# **Draft Radiological and Engineering Assessment**

Vicinity Property No. DUR 031

THE RADIOLOGICAL AND ENGINEERING ASSESSMENT

DURANGO PROPERTY

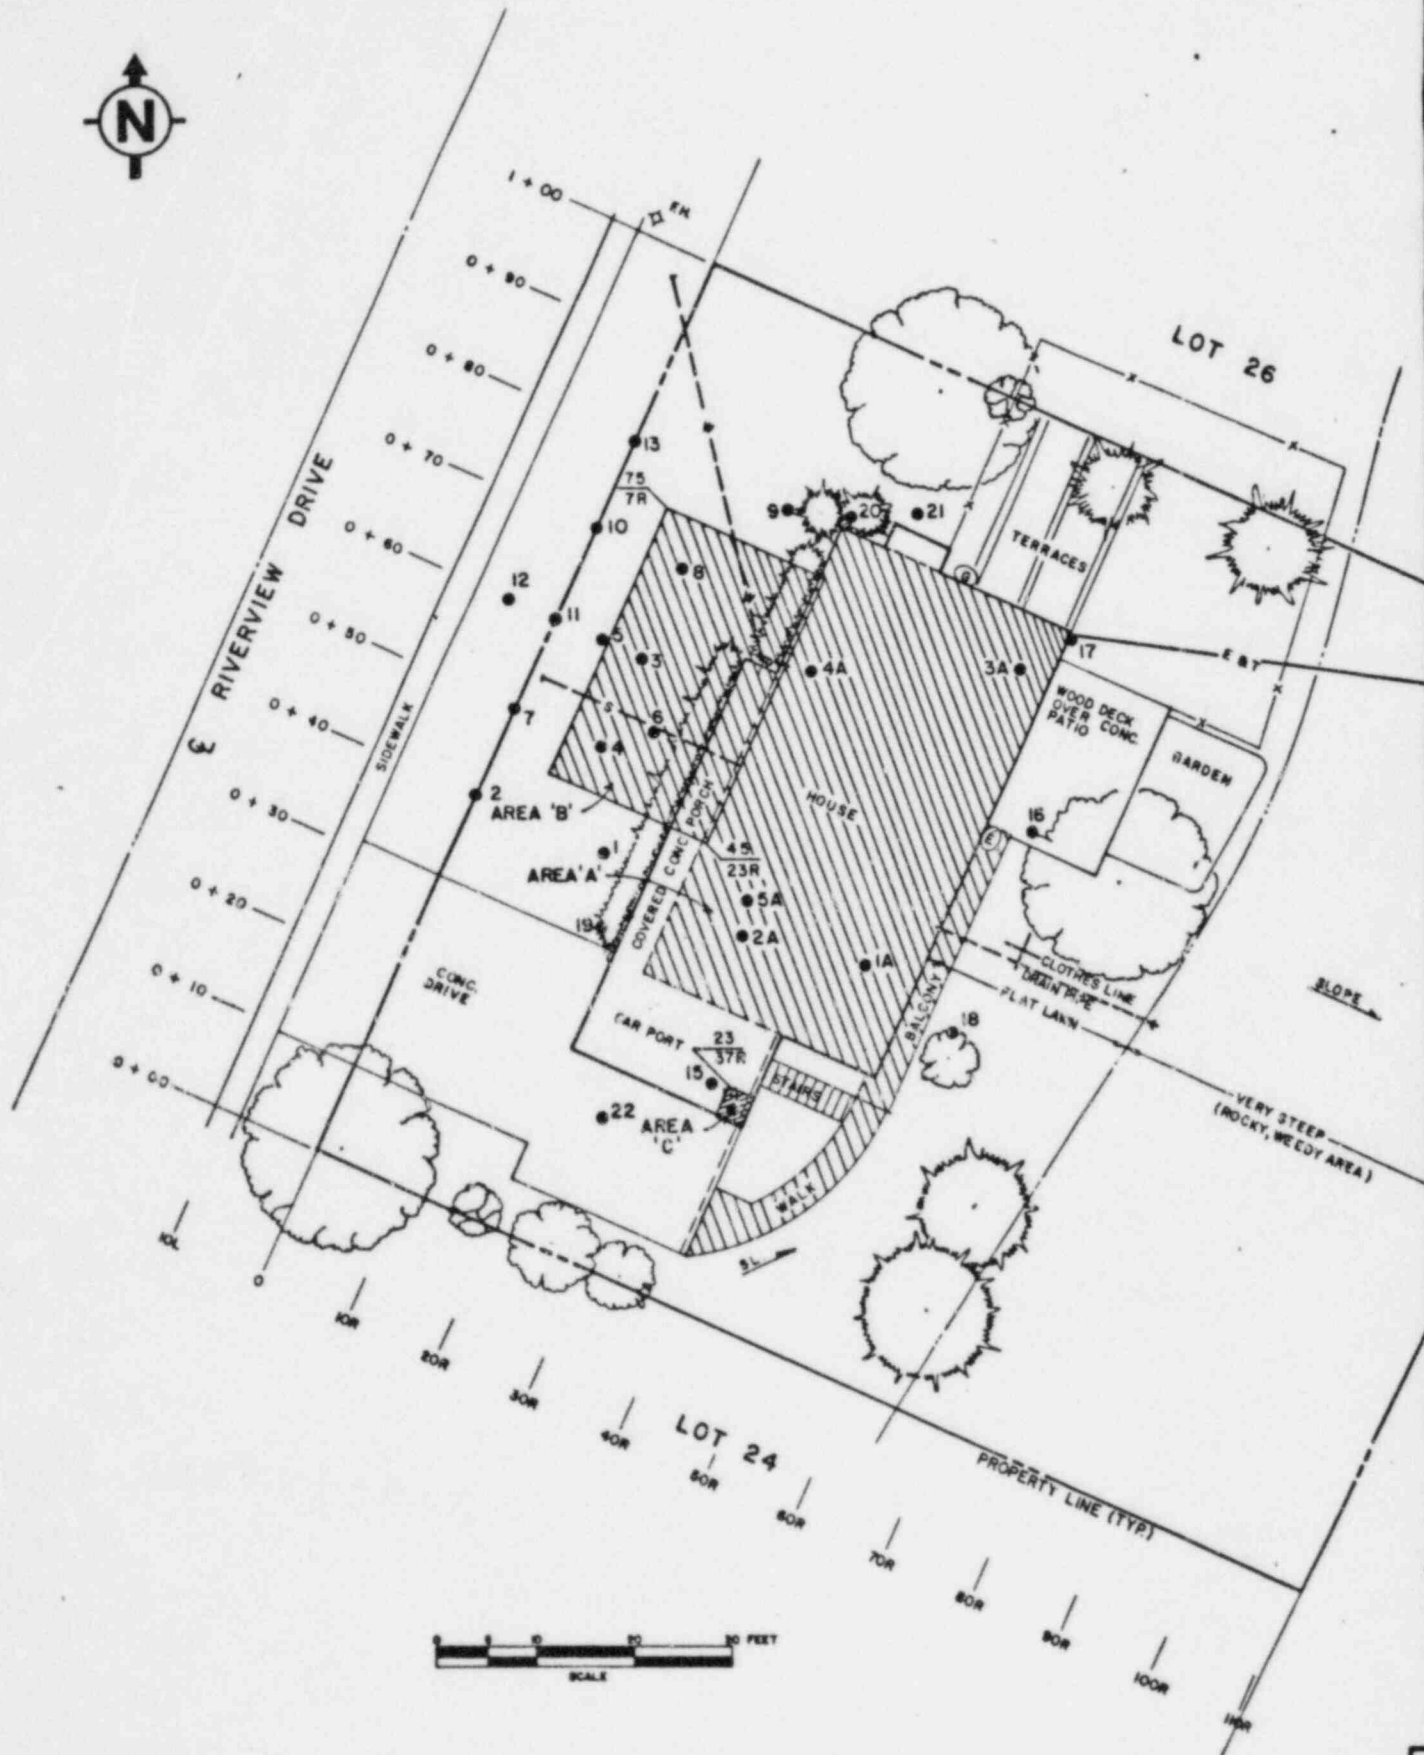
Contamination was found in 4 of the 22 outdoor holes and in all of the 5 indoor holes augered. The location and depth of the contamination is described in Tables 3.3 and 3.4 and is shown in Figure 3.1. Large rocks prevented drilling through the vertical extent of contamination at all drilling

locations. Contamination extends more than 15 inches below the surface. Gamma readings in boreholes were not diminishing with increasing depth, suggesting that contamination may be 30 inches deep or more. The indoor boreholes demonstrate that contamination is underneath the basement floor.

Three areas of contamination were identified in the survey. Area A consists of the entire area underneath the house and concrete walk east and south of the house. Contamination does not appear to be inside the house itself. The known depth of contamination is 15 inches; however, contamination may extend to 30 inches or more.

Area B is adjacent to the house and is actually an extension of Area A; it is treated separately here for convenience. As with Area A, the depth of contamination is at least 15 inches and may be 30 inches or more.

Area C consists of a small area at the back of the carport. The depth of contamination in this area is greater than 15 inches. (The retaining wall is approximately 3 feet high).
