Draft Radiological and Engineering Assessment

Vicinity Property No. DUR 048

THE RADIOLOGICAL AND ENGINEERING ASSESSMENT

DURANGO PROPERTY

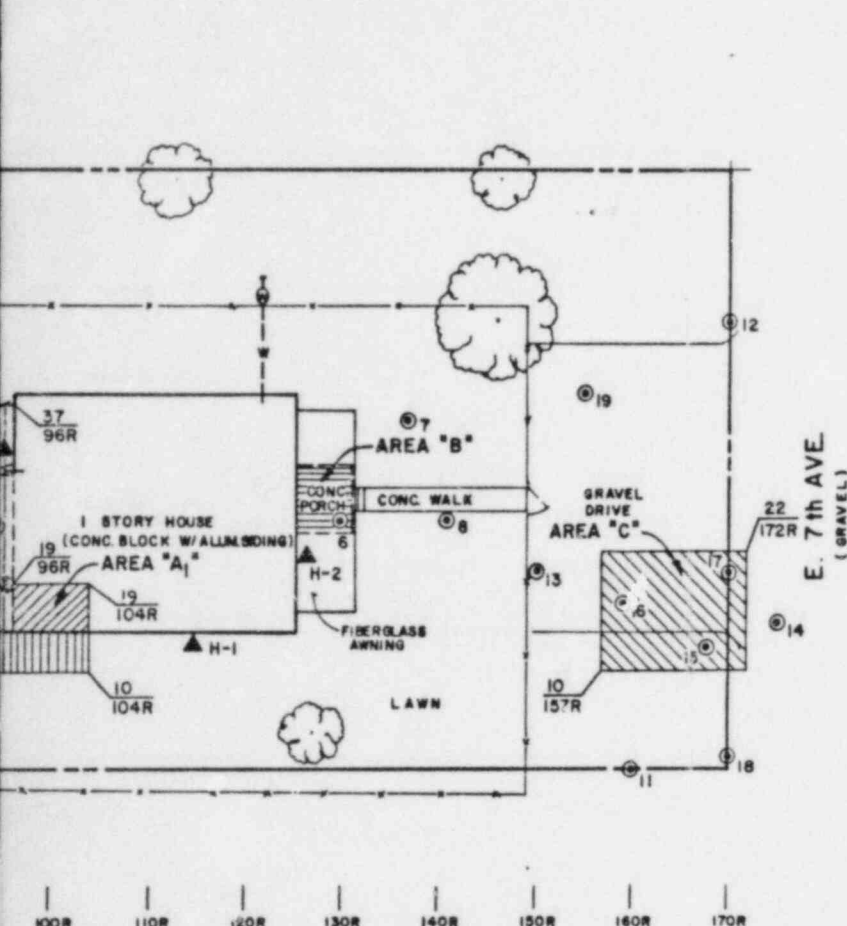
FIGURE 3.1

Contamination was found in 3 of the 19 outdoor holes augered. Low-level contamination was found in an additional two holes. The location and depth of the contamination is described in Table 3.3 and is shown in Figure 3.1.

The only contaminated angle hole was by the west wall. This is near the area of contamination described in Section 4.0 as Area A.

Three areas of contamination were identified in the survey.

Area A consists of the area directly in back of the house, under the rear addition to the house, and in the crawl space under the house. The frame house addition will have to be removed in order to gain access to the materials, but the tailings which are in the crawl space under the house itself can be removed without further damage to the structure. Because of the looseness of the tailings, it was not possible to maintain a borehole for logging; the estimated depth is 42 inches under the porch, and 6-24 inches in the crawl space.

Area B consists of the concrete front porch to the house and the material below it. The borehole in the porch reached a depth of 8 inches and was stopped by a large rock, but it is estimated that the overall depth of contamination is 36-42 inches.

Area C has an estimated depth of contamination of 12 inches.
