Draft Radiological and Engineering Assessment

Vicinity Property No. DUR 029

THE RADIOLOGICAL AND ENGINEERING ASSESSMENT

DU-029

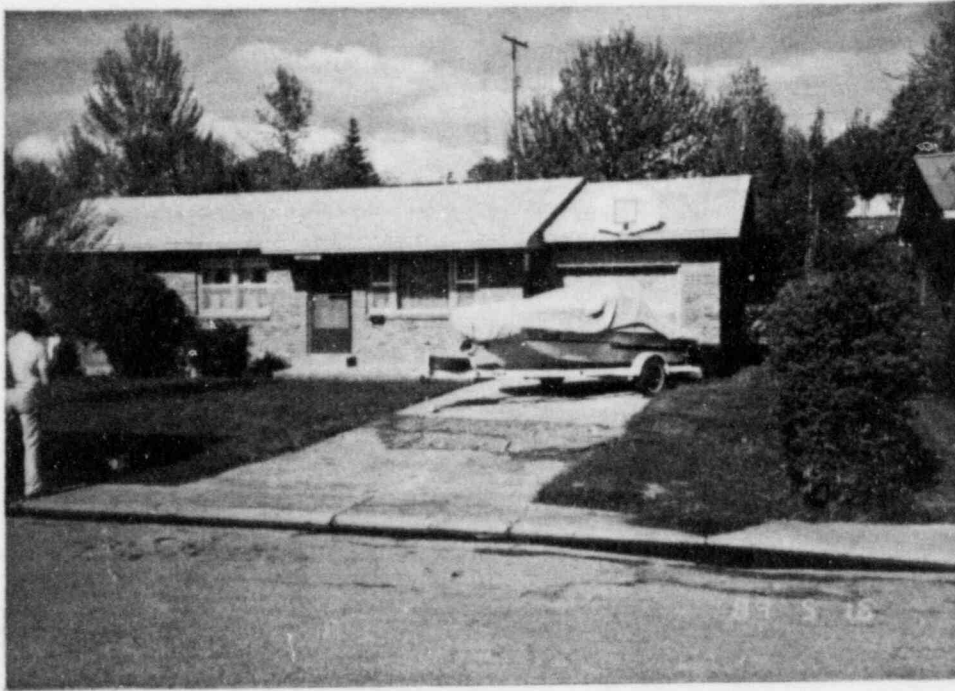
Front of House Looking Northeast

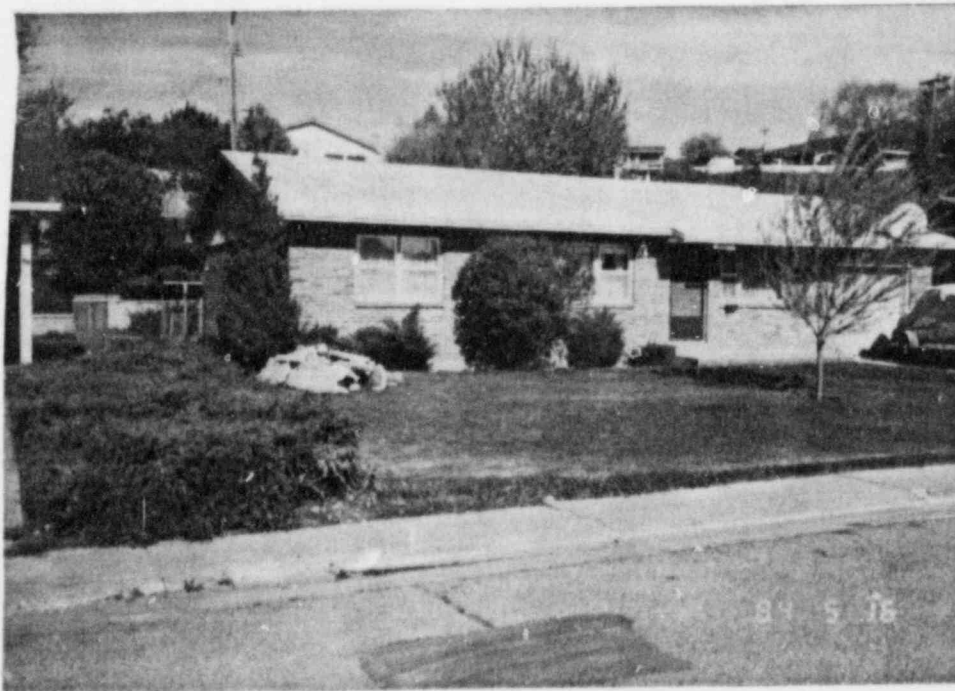
Front of House Looking Southeast

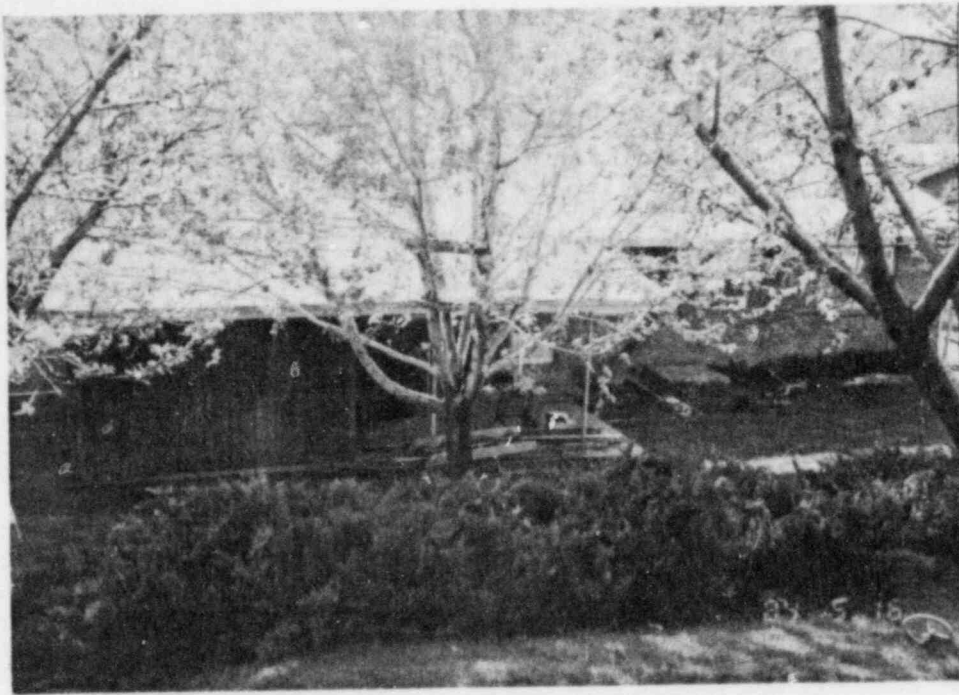
Rear of House Looking Northwest

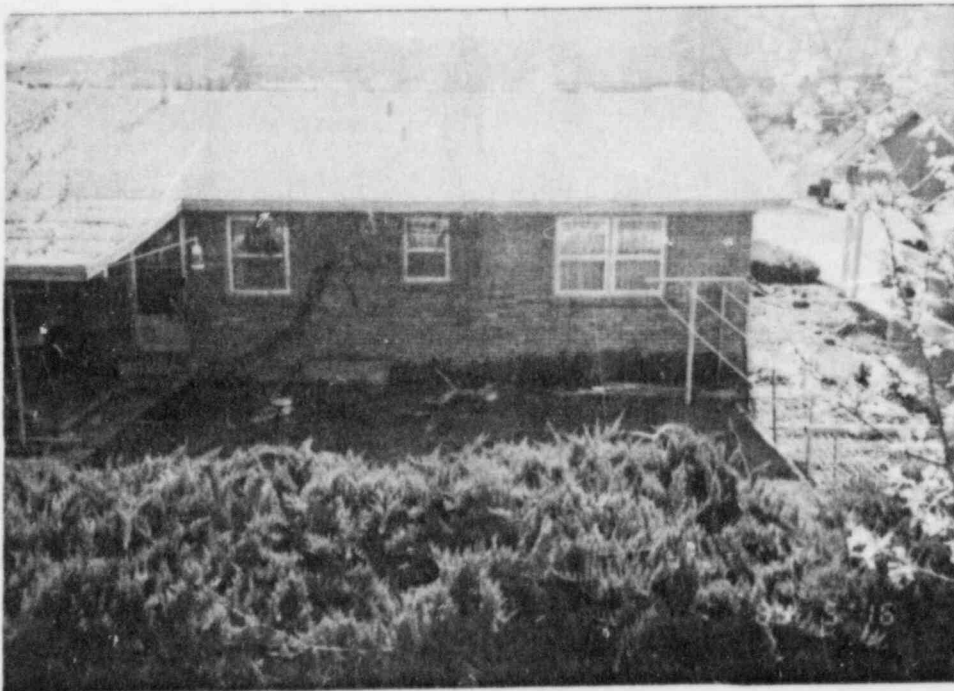
Rear of House Looking Southeast

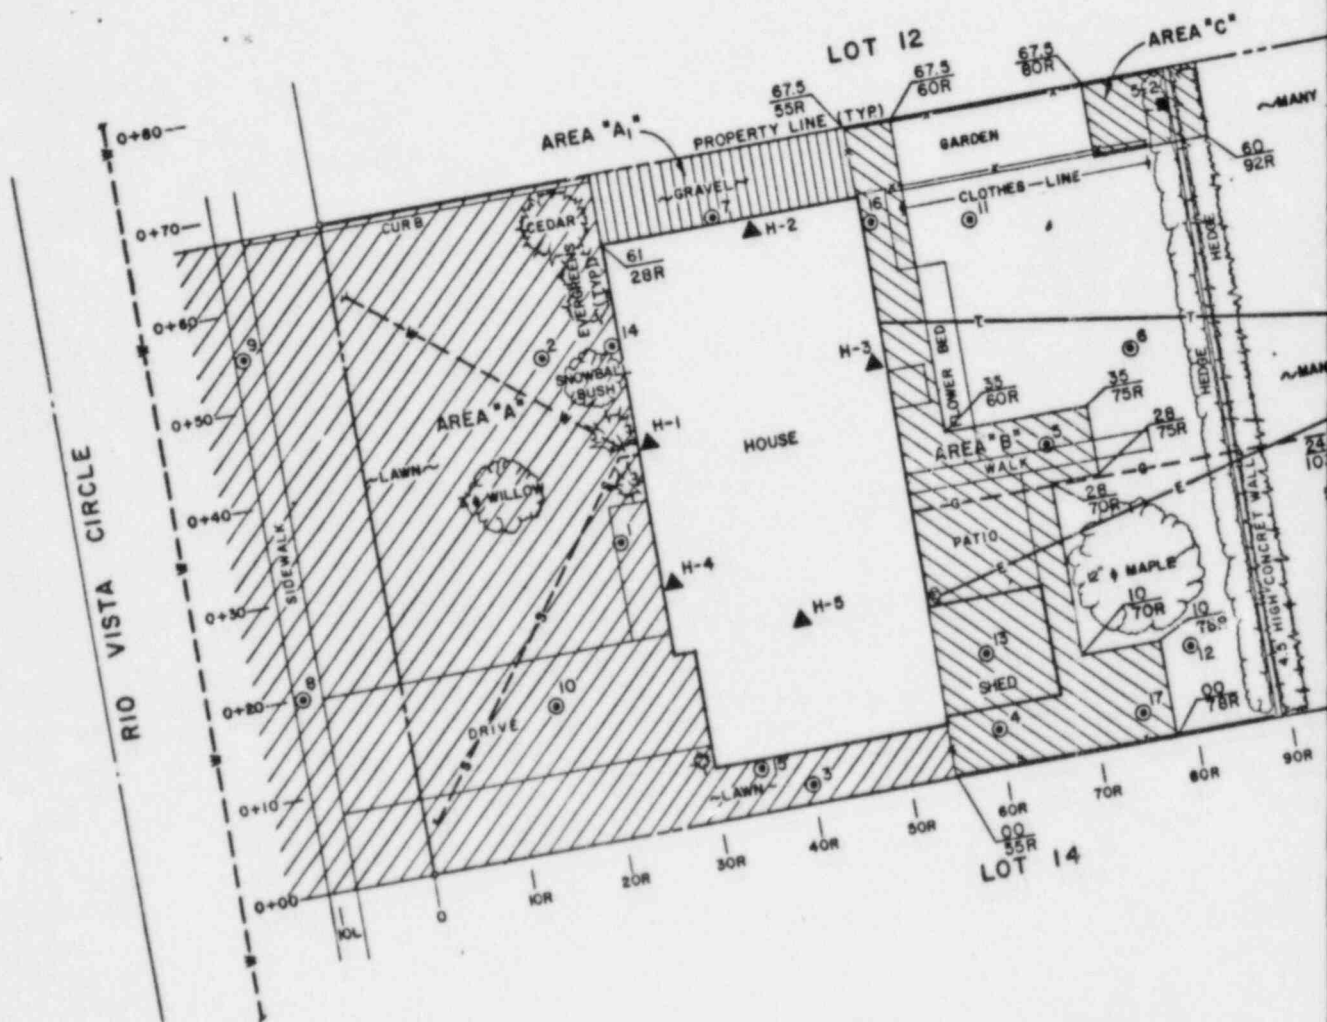
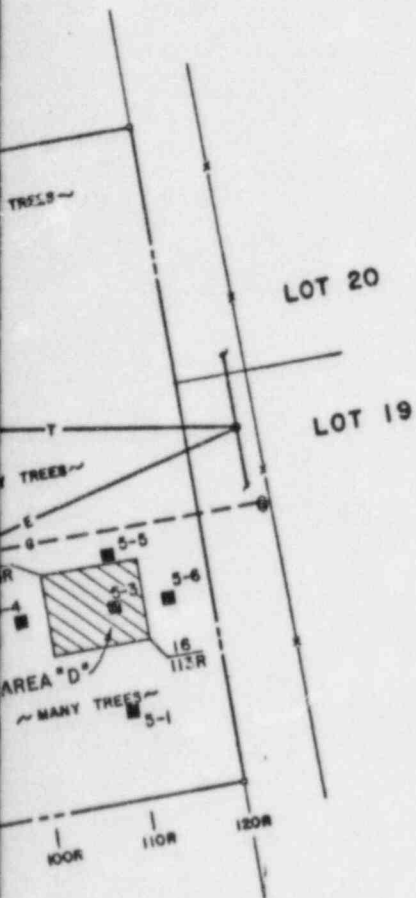
Contamination was found in 14 of the 17 outdoor holes augered. The location and depth of the contamination is described in Table 3.2 and is shown in Figure 3.1. Boreholes augered by ORNL in the inclusion survey are also shown in Figure 3.1.

Contamination was found in 2 of the 6 shovel holes. The location and depth of these holes are described in Table 3.3 and are shown in Figure 3.1.

None of the 5 crawl space angle holes showed contamination. This demonstrates that contamination does not extend beneath the house on this property. The hole locations are described in Table 3.3 and are shown in Figure 3.1.

One major area of contamination was identified in the survey and two smaller areas were also identified. The major area will be divided into two contiguous areas for convenience in this assessment.

Area A consists of the entire front yard of the property and along both sides of the house as far as the back wall of the house. The house and the area under the house are not included in Area A. The west boundary of Area A is undefined; contamination is known to extend into the street. The estimated depth of contamination in Area A is 24 inches, except that along the north side of the house, the estimated depth is 30 inches.

Area B is in the back yard of the property and includes the back sidewalk, the patio, and the shed. The estimated depth of contamination is 18 inches.

Area C has a depth of contamination that is known to be greater than 6 inches, and is estimated to be about 18 inches.

Area D has a depth of contamination that is known to be greater than 6 inches and is estimated to be about 18 inches.
