Meeting Title: Brief by ITT on Loss of Indium - 1992 Source
Therapy Administration at Indiana
Regional Cancer Center, Indiana, PA
November 16, 1992

Title: BRIEFING BY IIT ON LOSS OF IRIIDIUM-192
SOURCE AND THERAPY MISADMINISTRATION AT
INDIANA REGIONAL CANCER CENTER, INDIANA,
PA., NOVEMBER 16, 1992

Date: FEBRUARY 8, 1993

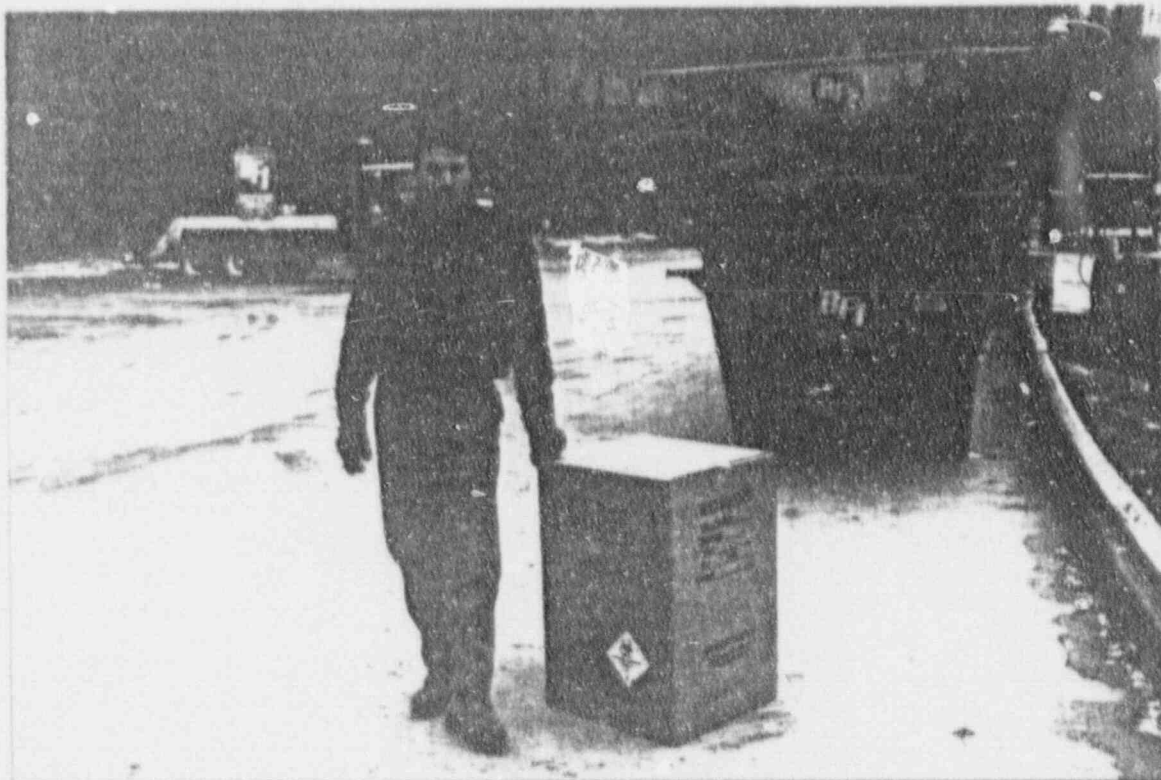
Figure 2.19 Location of Isolated Biohazard Box Containing Source

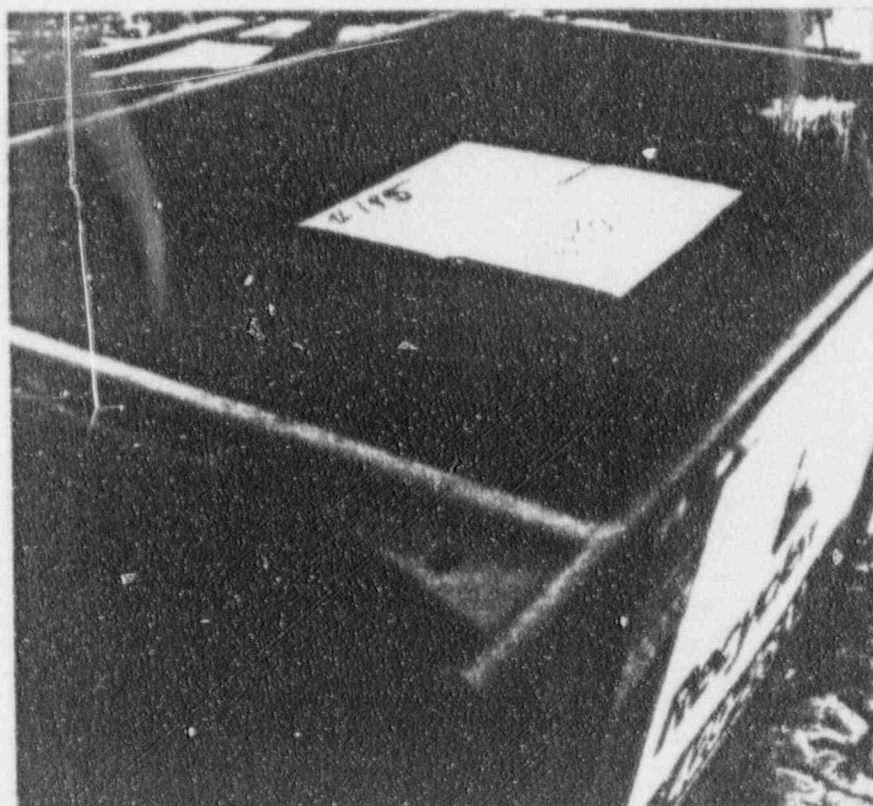
Figure 2.21 Interior of BFI Waste Container Where Radioactive Source Was Stored

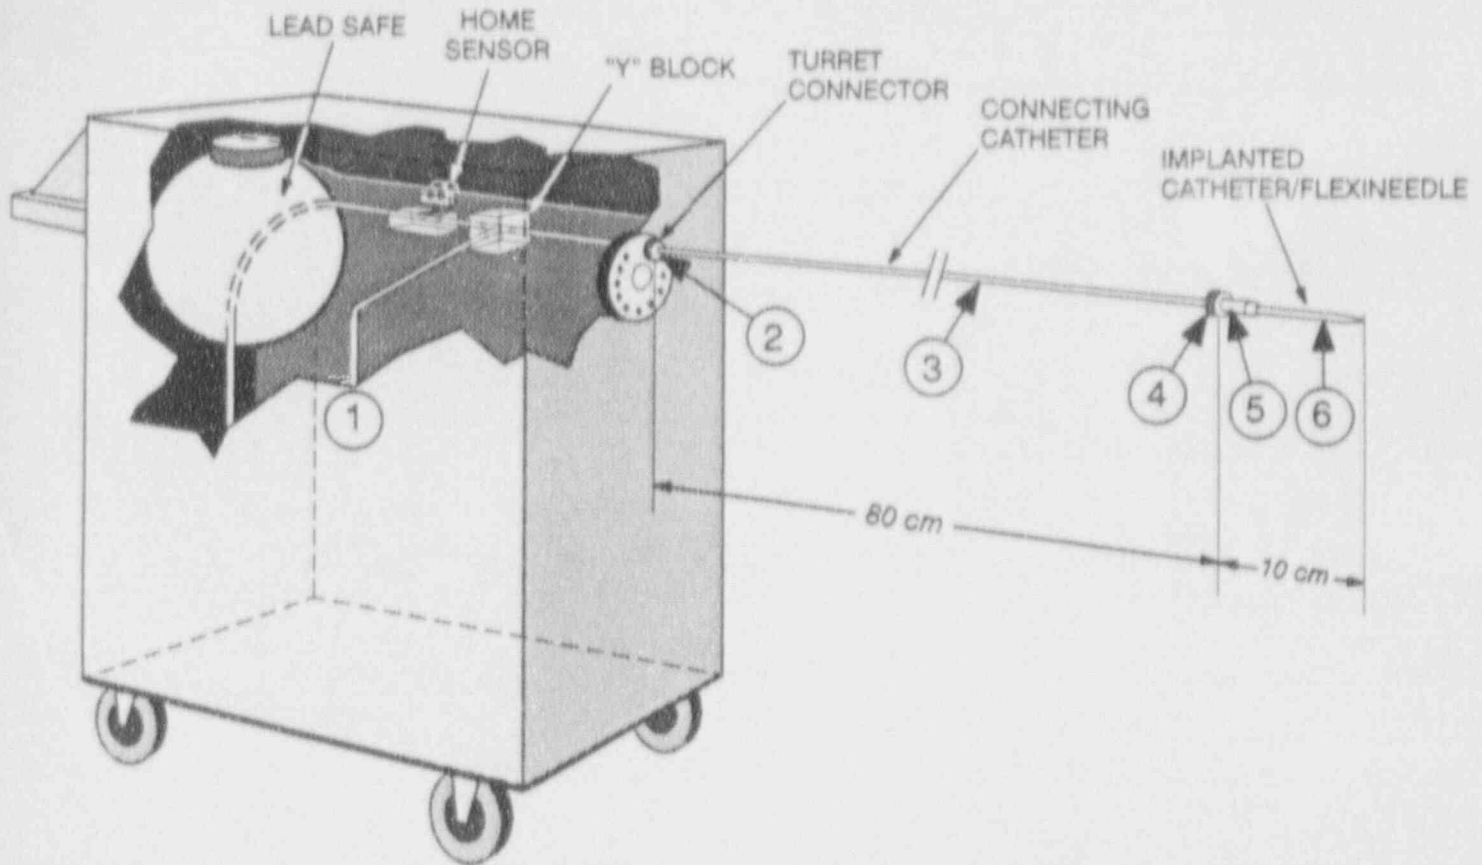
Figure 4.1 Source Wire – Possible Failure Areas

11 In May of 1992, the wires in use were
12 changed from stainless steel to a metal called
13 Nitinol, that is your nickel-titanium alloy, for new
14 wires. We found when we looked at the breaks under a
15 microscope, looked at x-rays of the cavities, that
16 some of the cavities were eccentric. They weren't
17 centered, they were tilted. We're not sure this
18 contributed to the break, but we did see that.

1 the cavity. The current hypothesis being evaluated is
2 that storage of a source wire in teflon in the
3 presence of moisture causes decomposition of the
4 teflon and formation of either fluorine or
5 hydrofluoric acid. This, either directly or
6 indirectly, results in embrittlement of the wire.

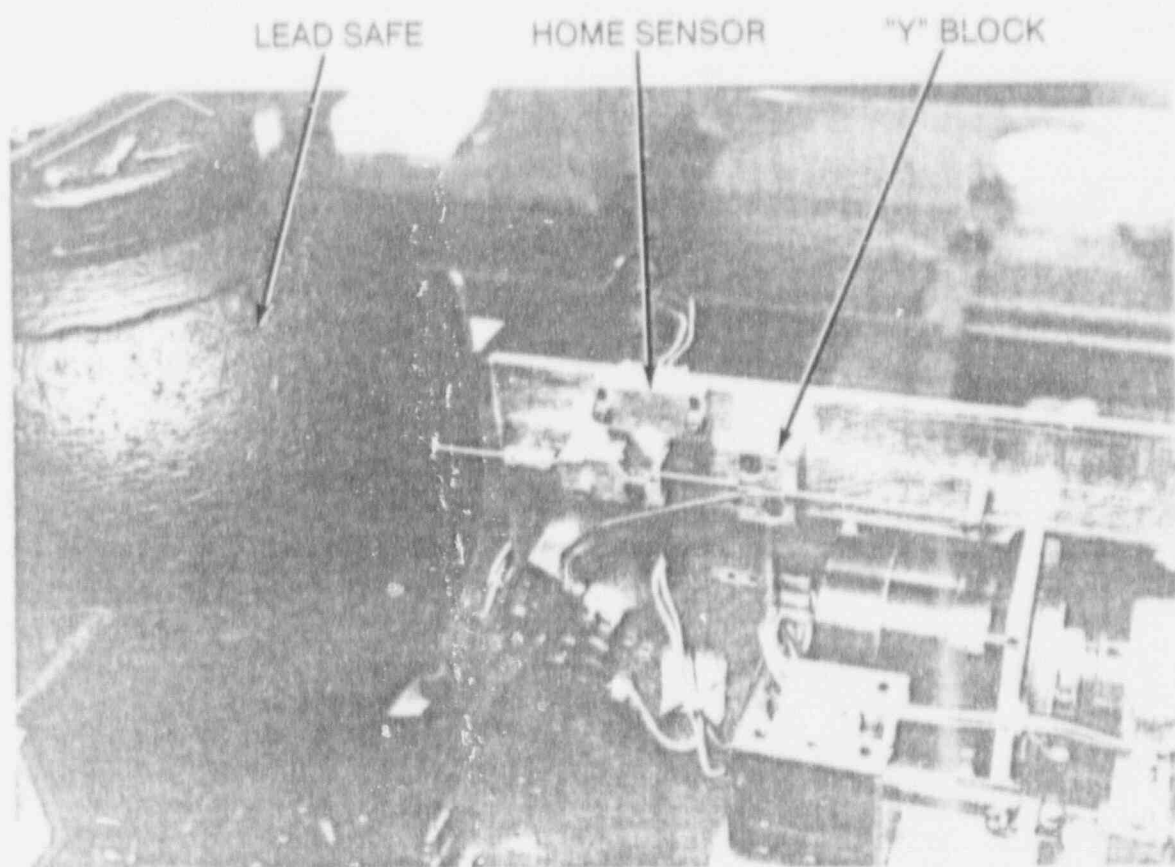
Figure 4.2 Track Where Source Tip May Have Contacted Parts of the Afterloader

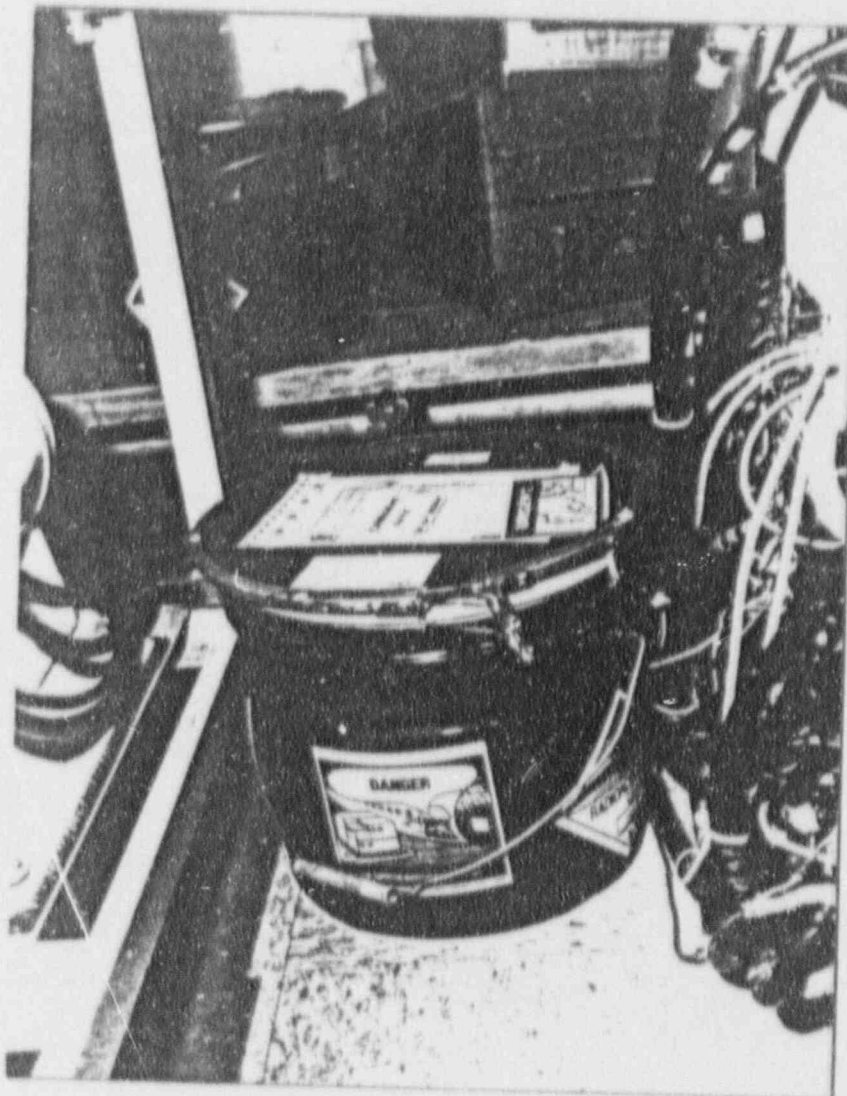
19 In September of 1992, Omnitron, this is a
20 couple months before these breaks occurred, Omnitron
21 identified degradation of the teflon liner in source
22 shipping containers and started to replace teflon with
23 stainless steel. At the end of December, Omnitron
24 looked at an old used wire that had been stored in a
25 teflon-lined shipping container and found it broken at

Figure 4.4 Shipping Container for Iridium-192 Source

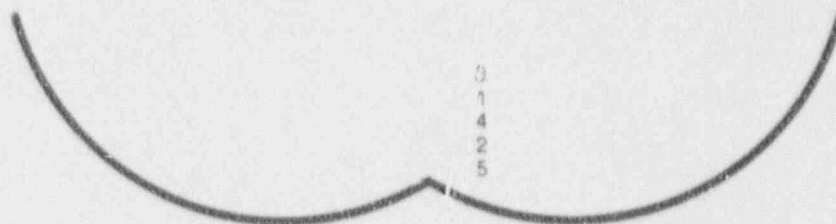
Numbers represent placement of implanted catheters within the patient and correspond to the treatment channel number indicated on the turret head.

Figure 7.1 Treatment Plan Catheter Location

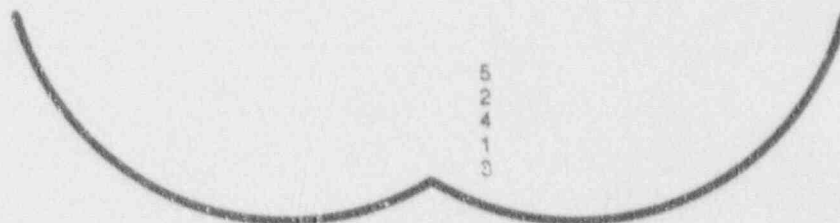
Numbers represent placement of implanted catheters within the patient and correspond to the treatment channel number indicated on the turret head.

Figure 7.2 Actual Catheter Location
