Draft Radiological and Engineering Assessment

Vicinity Property No. DUR 027

THE RADIOLOGICAL AND ENGINEERING ASSESSMENT

February 6, 1985

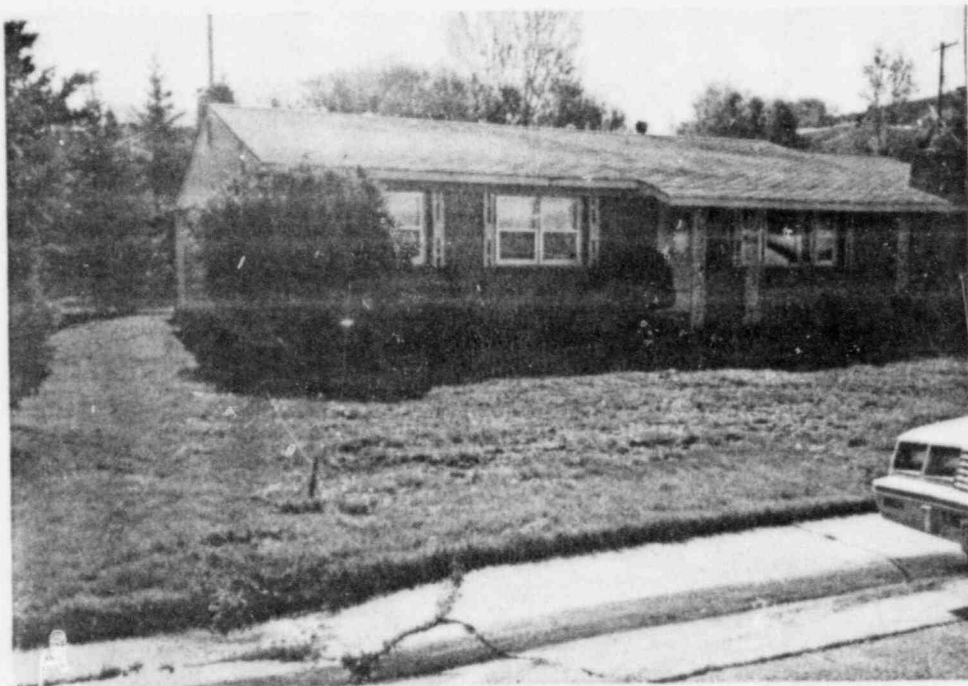
Front of House Looking Southeast

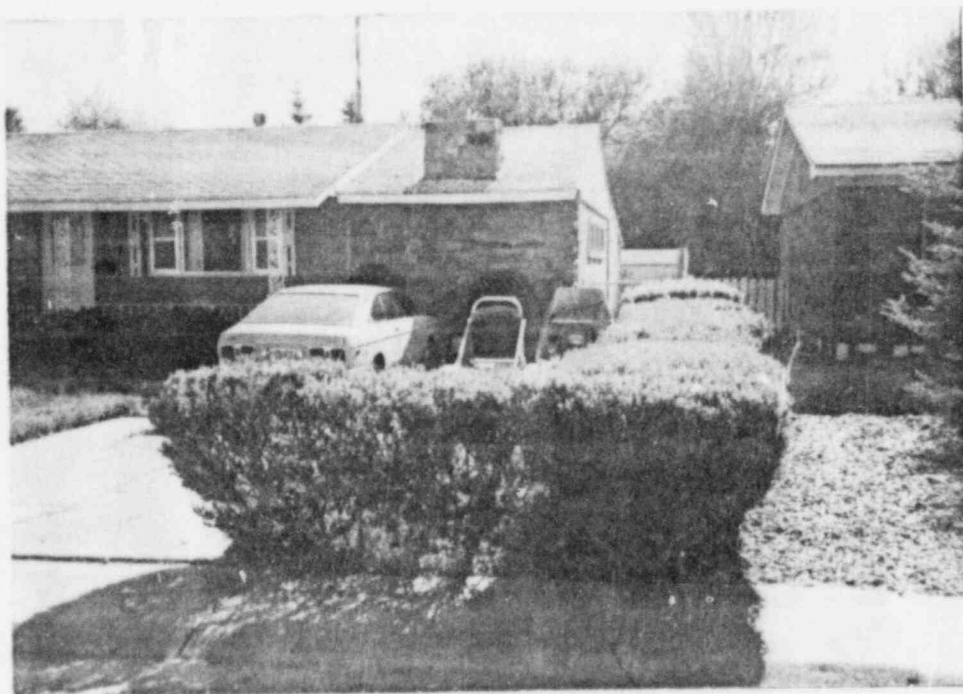
Front of House Looking East

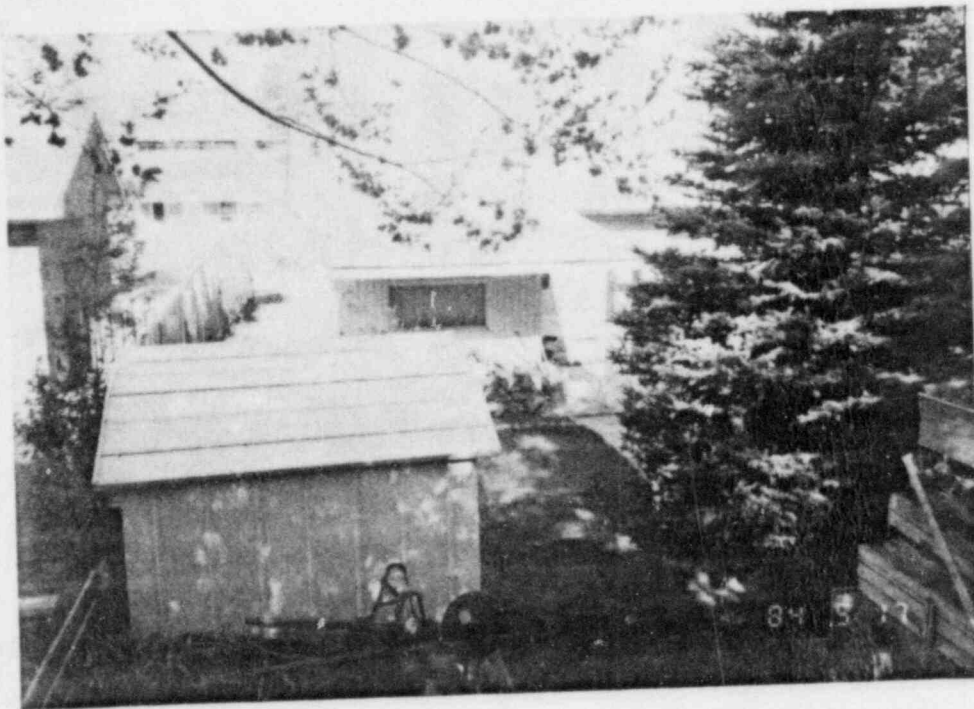
Rear of House Looking West

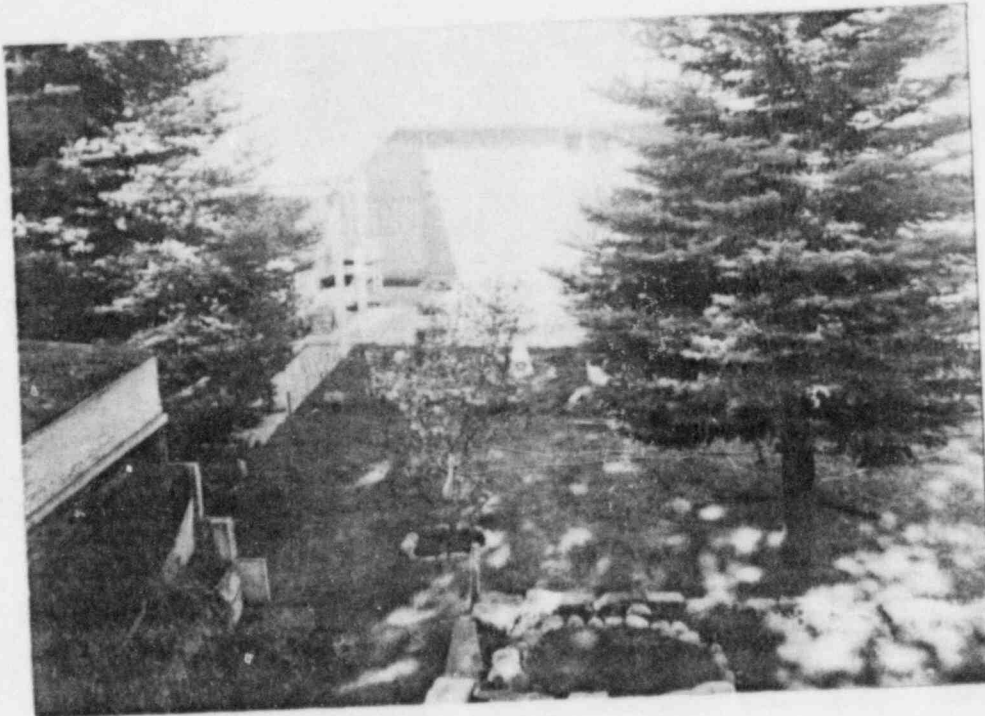
Rear of House Looking Southwest

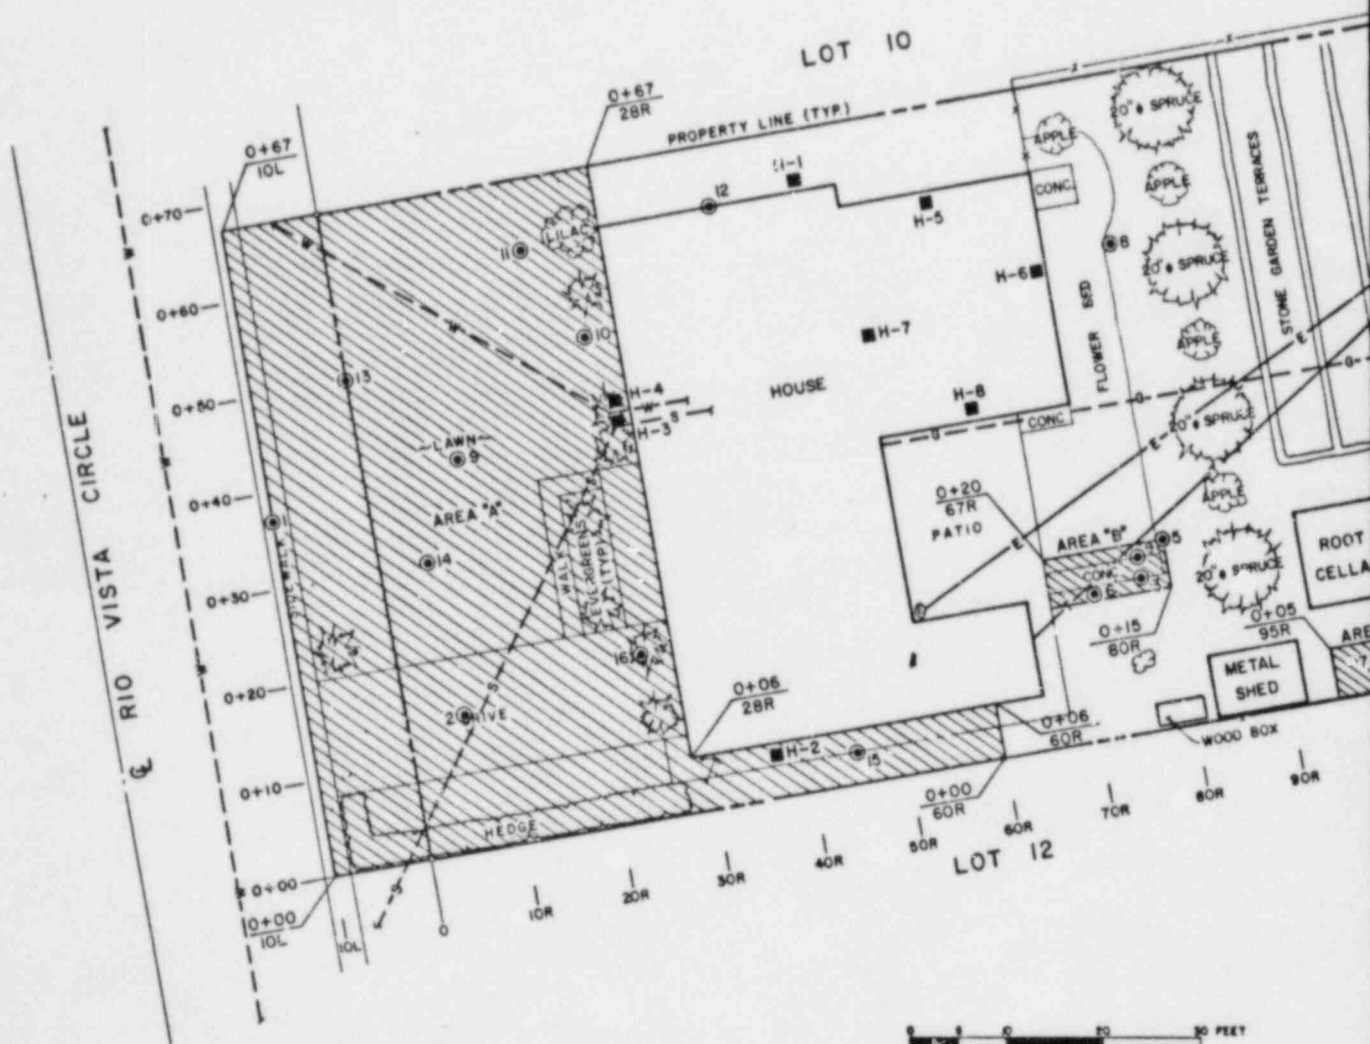
Contamination was found in 9 of the 16 outdoor holes augered. The location and depth of the contamination is described in Table 3.2 and is shown in Figure 3.1.

No contamination was found in any of the 8 crawl space holes. The location and activity of these holes are described in Table 3.3, and the locations are shown in Figure 3.1.

Areas A, B, and C, shown on Figure 3.1, are contaminated to an approximate depth of 24 inches. (Pockets of contamination may extend to 36 inches). Portions of the northeast corner of the front yard may not require excavation as deep. This will be handled per Note 3 on Construction Drawing DU-027-020.

Supplemental Standards apply to the contamination under the sidewalk (Figure 3.1) per 40 CFR 192.21(c), "Criteria for Applying Supplemental Standards," and, therefore, no excavation is required in this area.
