Draft Radiological and Engineering Assessment

Vicinity Property No. DUR 024

DURANGO PROPERTY

February 5, 1985

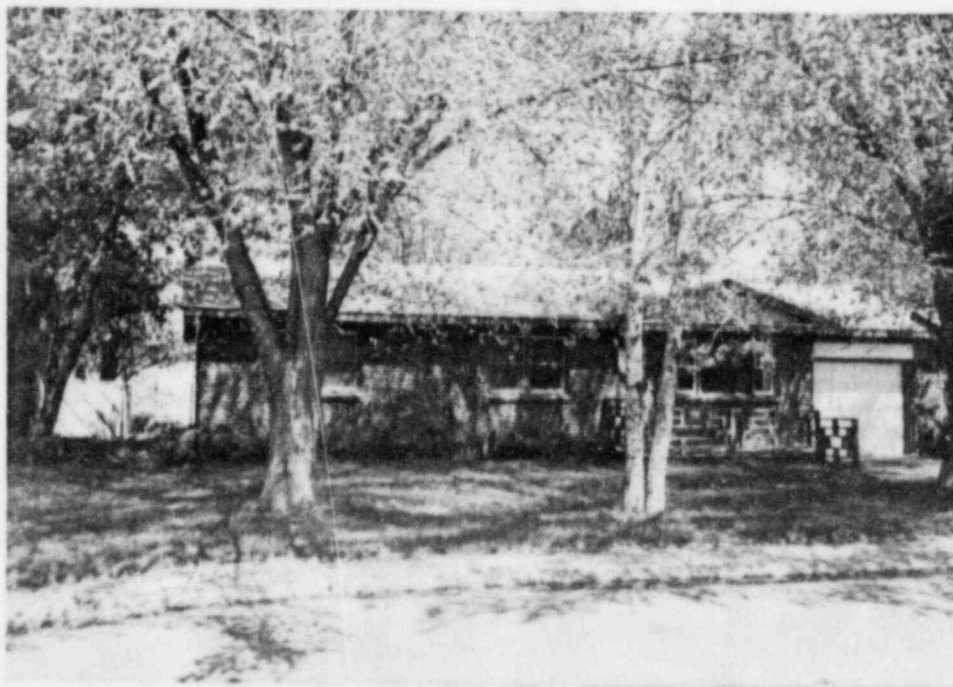
Front of House Looking Southeast

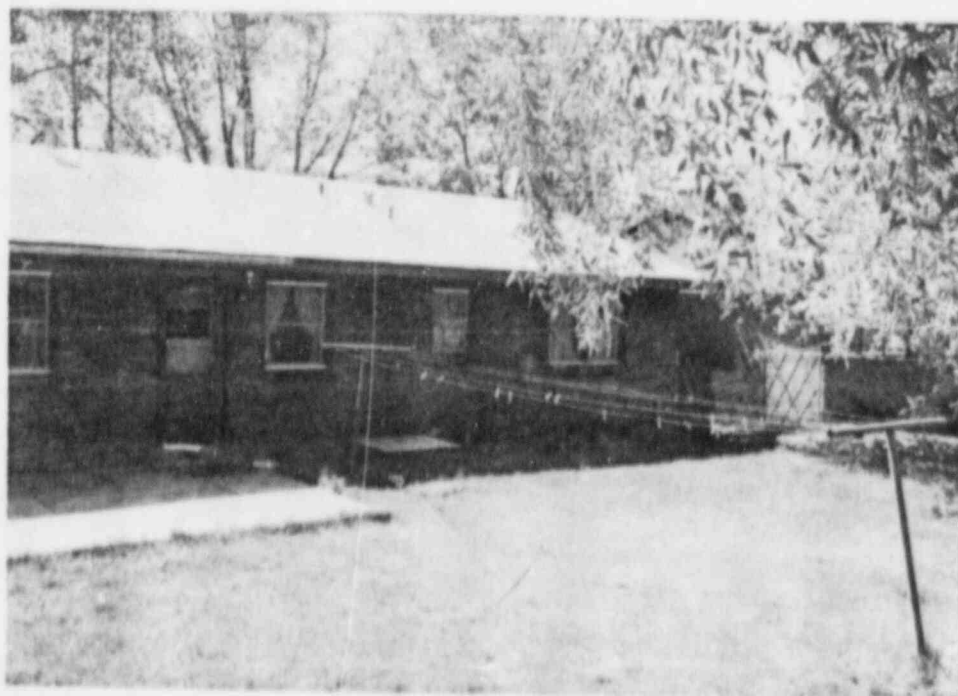
Rear of House Looking Northwest

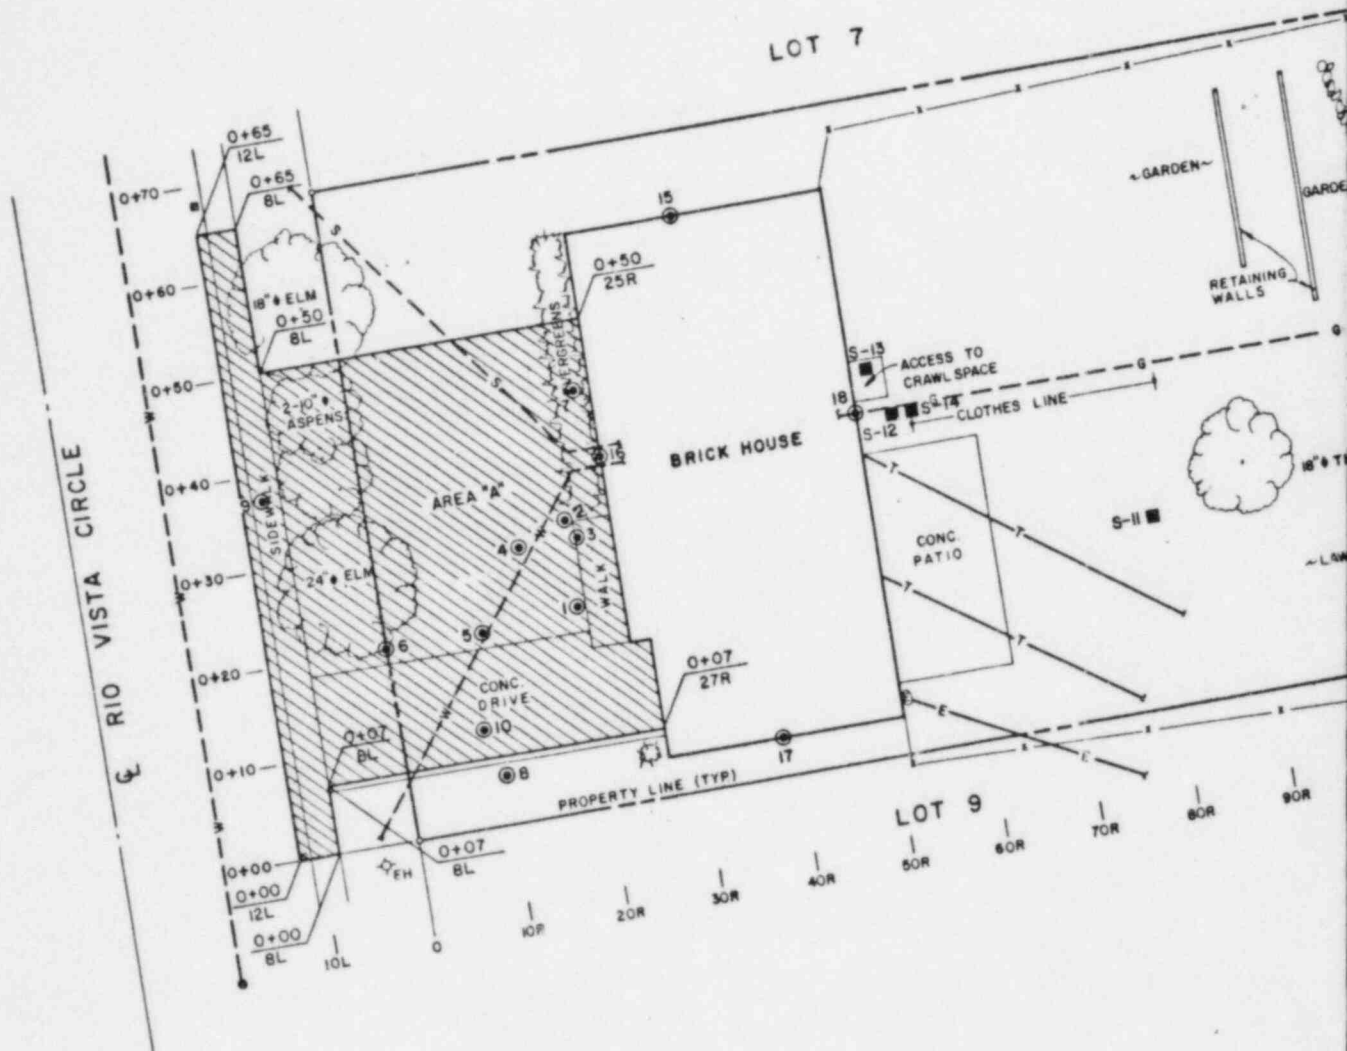
Contamination was found in 7 of the 10 outdoor holes augered. The location and depth of the contamination is described in Table 3.2 and is shown in Figure 3.1.

Four shovel holes were dug east of the house, as shown in Figure 3.1. Three of these holes were in a small area just north of the concrete patio, where the Colorado Department of Health had previously reported elevated gamma readings. One small patch of low-level contamination was identified, but this is well below standards for removal.

The possibility that contamination could be underneath the house was investigated by digging four holes, one on each side of the house, and then augering an angled hole underneath the house. These holes are shown in Figure 3.1. One hole was dug at the point where the main water line and the sewer line enter the house. No contamination was found in any of these holes. It is concluded that no contamination is found underneath the house on this property.

As shown on Figure 3.1, the front yard is contaminated to an approximate depth of 18 inches. Pockets of contamination may extend to 30 inches deep. Because of the extreme difficulty of drilling in this area, the depth could not be completely defined, and a resurvey of the property after initial excavation will be indicated.

Supplemental Standards, per 40 CFR 192.21(c), apply to the contamination under the sidewalk and, therefore, no excavation is required in this area.
