# **Draft Radiological and Engineering Assessment**

Vicinity Property No. DUR 020

THE RADIOLOGICAL AND ENGINEERING ASSESSMENT

DU-020

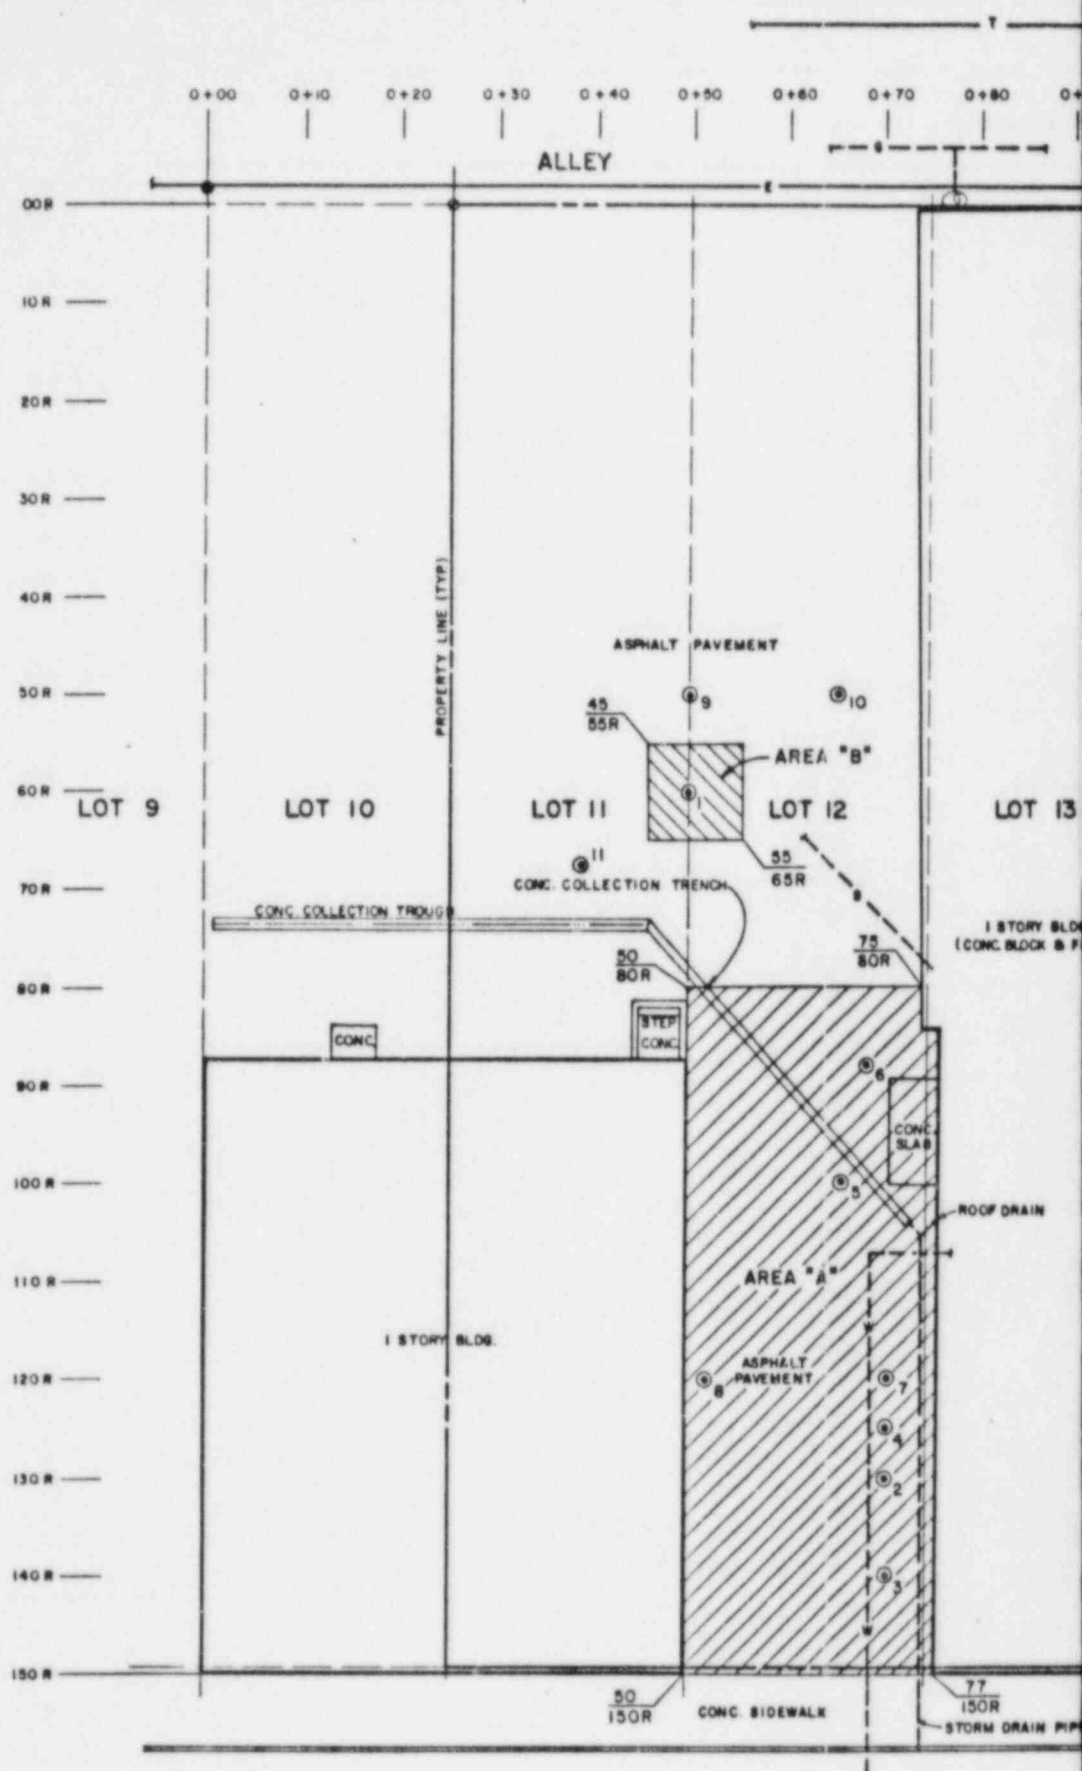
3.2.2 Contamination was found in 7 of the 14 outdoor holes augered. The location and depth of the contamination is described in Table 3.2 and is shown in Figure 3.1. Borehole 9, along the buried sewer line, showed no activity above normal background.

Based on information presently available, two areas of contamination have been identified at the property, as shown on Figure 3.1.

The estimated depth of contamination is 18 inches in Area A. One borehole (#5) indicated a depth of 24 inches. However, the activity count rate was lowering in intensity by 18 inches, and it is unlikely that contamination above EPA standards exists deeper than 18 inches.

In Area B the estimated depth of contamination is 12 inches.
