Draft Radiological and Engineering Assessment

Vicinity Property No. DUR 026

DURANGO PROPERTY

DU-026

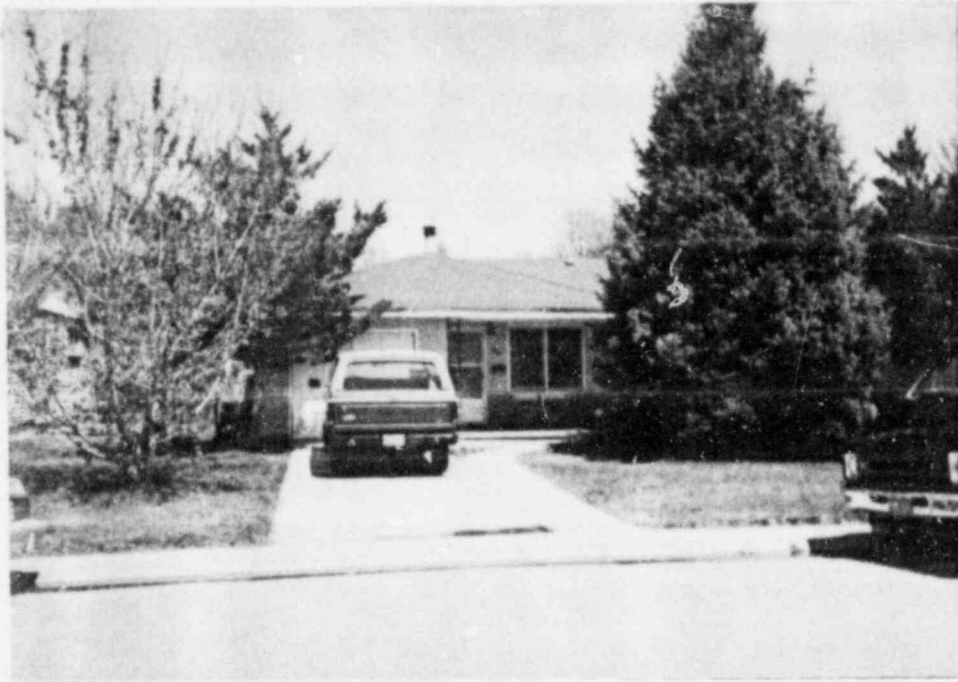
Front of House Looking East

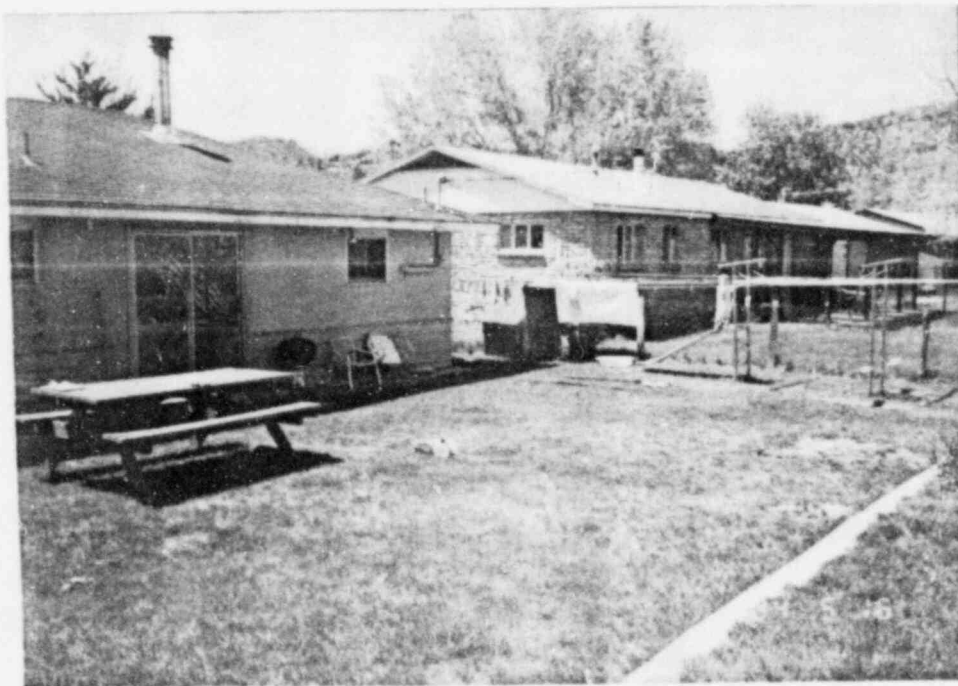
Rear of House Looking Northwest

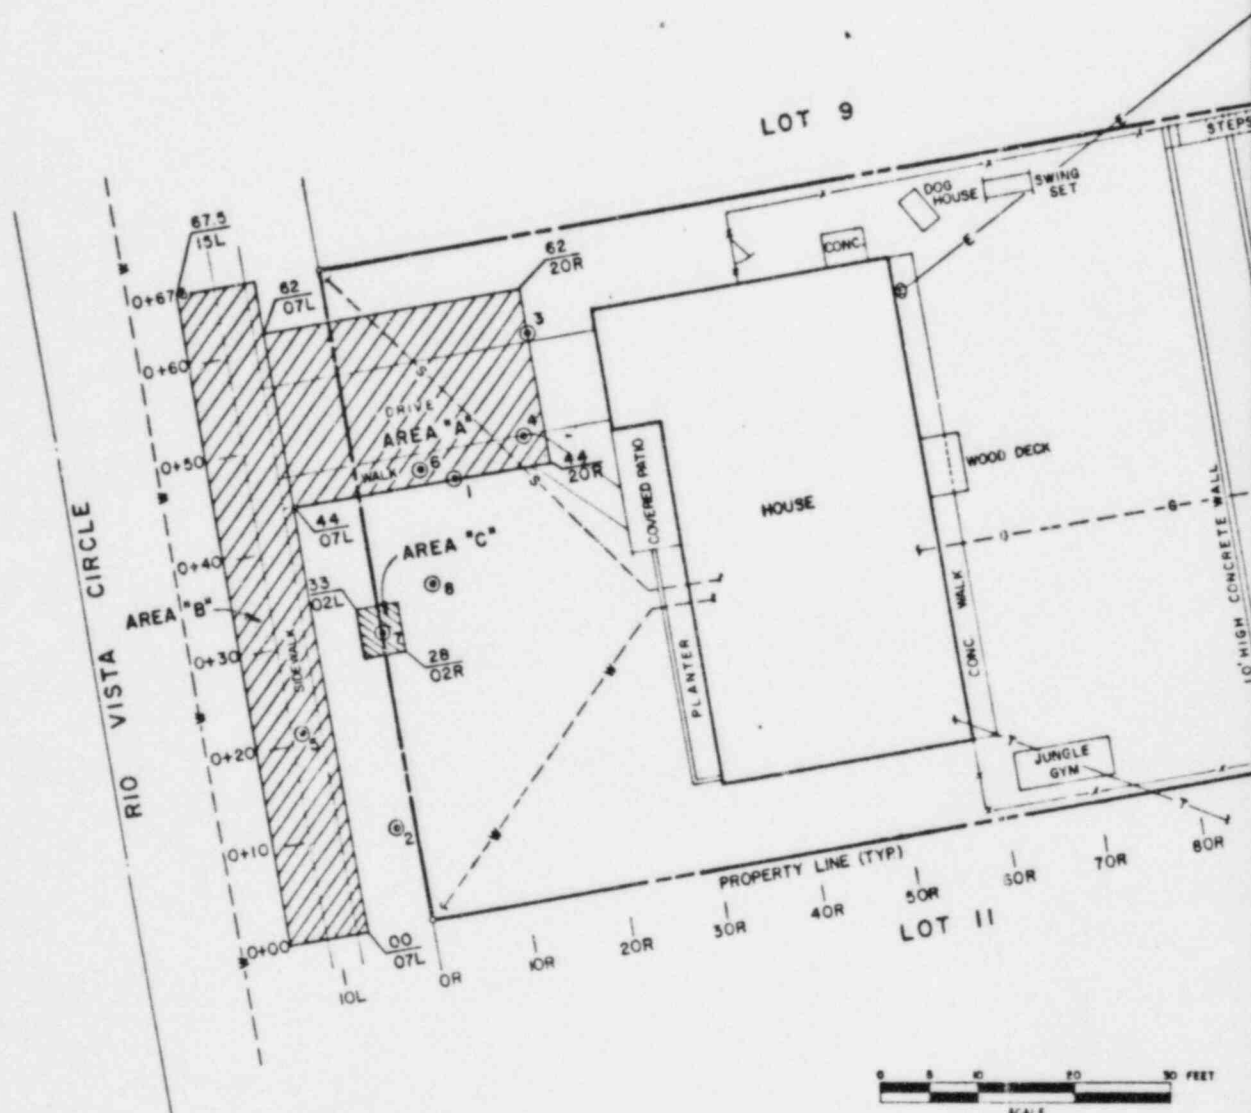
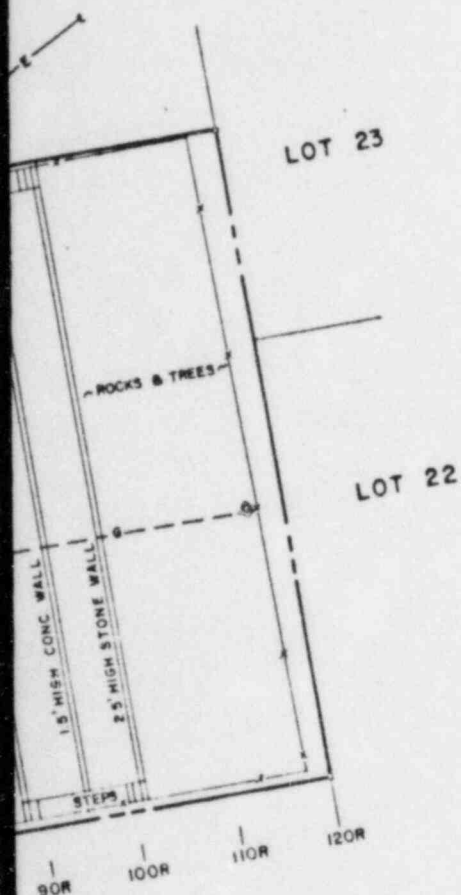
Contamination was found in 4 of the 8 outdoor holes augered. The location and depth of the contamination is described in Table 3.2 and is shown in Figure 3.1.

No contamination was found in any of the angle holes. The location and depth of these holes are described in Table 3.3 and are shown in Figure 3.1. The only contamination observed along the utility lines is within Area A, described below.

Three areas of contamination were identified in the survey.

In Area, A the depth of contamination could not be determined because of the difficulty of drilling, but it is known to be greater than 27 inches. (A depth of 36 inches should be assumed for estimating purposes.) Area A includes the driveway. According to the present owner, the tailings have been removed from under the driveway. However, as shown on Figure 3.1, contamination has been identified to a depth of more than 2 feet on either side of the driveway. The depth at which any materials under the driveway may have been removed is unknown. It is not radiologically necessary to remove the two trees associated with Area A.

The west boundary of Area B is undefined since contamination is known to extend into the street. The depth of contamination is known to be more than 18 inches and is expected to be about 30 inches. (See Section 3.5 below).

Area C is a small area with an estimated depth of contamination of 12 inches. Area C consists only of low-level contamination and its surface area is much less than 100 m². However, since remedial action is indicated for this property anyway, it is prudent to clean up Area C along with Area A.

Supplemental Standards apply to Area B (Figure 3.1) per 40 CFR 192.21(c), "Criteria for Applying Supplemental Standards," and, therefore, no excavation is required in this area.
