LICENSEE EVENT REPORT (LER)

FACILITY NAME (1) Limerick Generating Station, Unit 1										DOCKET NUMBER (2) 0 5 0 0 0 3 5 2										PAGE (3) 1 OF 0 8																													
TITLE (4) 'A' Loop of the Emergency Service Water system was inoperable as a result of an equipment failure and personnel errors.																																																	
EVENT DATE (5)										LER NUMBER (6)										REPORT DATE (7)										OTHER FACILITIES INVOLVED (8)																			
MONTH			DAY			YEAR			YEAR			SEQUENTIAL NUMBER			REVISION NUMBER			MONTH			DAY			YEAR			FACILITY NAMES										DOCKET NUMBER (3)												
																											Limerick, Unit 2										0 5 0 0 0 3 5 3												
1 0			2 5			9 1			9 1			0 2			4			0 1			0 2			0 8			9 3													0 5 0 0 0 1 1									
OPERATING MODE (9) 1										THIS REPORT IS SUBMITTED PURSUANT TO THE REQUIREMENTS OF 10 CFR 5. (Check one or more of the following) (11)

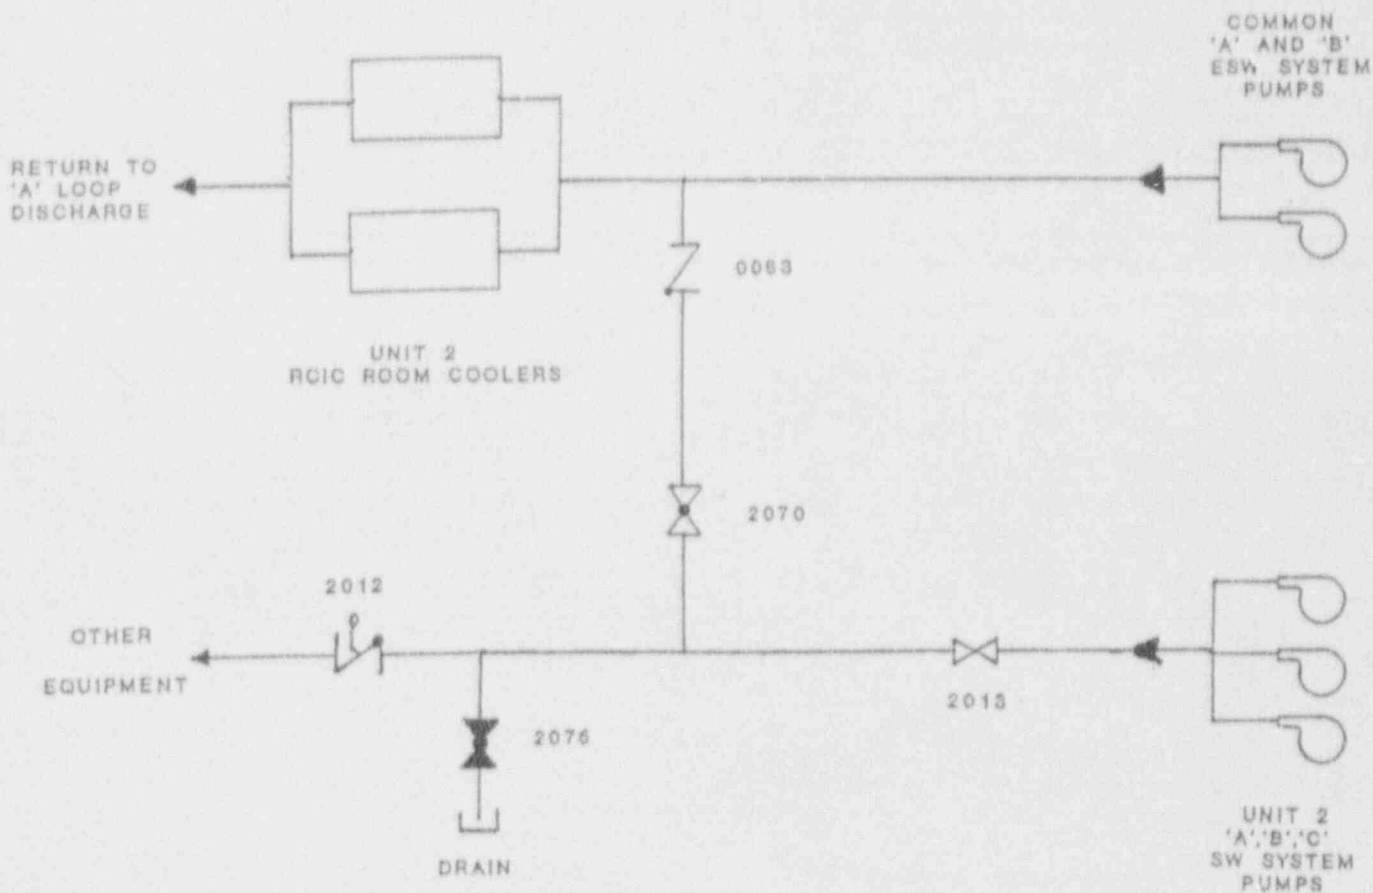
On October 25, 1991, during the afternoon shift, Surveillance Test (ST) procedure ST-6-011-231-0, "A Loop Emergency Service Water Pump, Valve, and Flow Test," was being performed for its normally scheduled quarterly performance by a non-licensed operator. This ST procedure contains an Inservice Inspection (I) step (step 6.4.40) that verifies proper operation of the safety related ESW system check valve, 11-0063. This check valve provides one isolation point between the non-safety related Service Water (SW) system and the ESW system. This check valve ensures ESW system piping integrity under accident conditions and allows the SW system to supply cooling water to the Unit 2 Reactor Core Isolation Cooling (RCIC;EIS:BN) system room coolers (EIS:CLR) during normal operating conditions (See Figure 1).

The purpose of ST procedure step 6.4.40 is to ensure the valve checks flow by verifying that no pressurized flow exists from the ESW system line to the SW system line. Proper operation of the check valve is verified by opening drain valve 11-2075 and observing no pressurized water flow with valve 11-2013 closed. The non-licensed operator properly performed this ST procedure step; however, he observed that pressurized flow did exist from the drain valve. The licensed Operations Floor Supervisor was immediately made aware of this condition by the non-licensed operator as required by the ST procedure. The non-licensed operator was then instructed by the Operations Floor Supervisor to place a note in the ST procedure identifying this discrepancy in accordance with the procedure. A note was placed in the ST procedure stating that, "pressurized flow exists from valve 11-2075 as it did the last time the ST was performed." However, the non-licensed operator was referring to the last time he had performed the ST procedure in May 1991, at which time the check valve was replaced in kind. The non-licensed operator then informed the Main Control Room

The Shift Manager reported the failed ST procedure to the on duty Senior Plant Staff member on October 26, 1991. However, the ST procedure was not signed off by the Senior Plant Staff member at that time because questions arose regarding a separate plant issue which required immediate attention. On October 28, 1991, at 0830 hours, the ST procedure was signed off as unsatisfactory by the Senior Plant Staff member. On October 29, 1991, during routine review of failed ST procedures, a plant Technical Staff member noted that the check valve had failed. The Technical Staff member determined that, since the valve serves as a boundary between the ESW and SW systems, reverse leakage through the valve would render the 'A' Loop of the ESW system inoperable. Based on this determination, the Technical Staff member immediately notified the licensed MCR Shift Supervisor. At 1430 hours, further troubleshooting was performed and the system engineer verified that the leakage through the check valve was above the Inservice Test (IST) program limit of 10 gpm. Following the troubleshooting, operations personnel closed manual valve 11-2070 at 1600 hours and isolated the SW to ESW system interface (See Figure 1). This restored the 'A' Loop of the ESW system and associated equipment to an operable status.

The primary cause of this event resulted from an equipment failure of the 'A' Loop ESW system check valve 11-0063 due to corrosion product buildup resulting from normal SW system piping corrosion.

- o The ESW system check valve, 11-0063, was repaired on November 19, 1991.
- o As a result of raw water corrosion problems at Limerick Generating Station (LGS), a task force was established. The Raw Water Task Force is developing a comprehensive program that is addressing raw water corrosion problems in LGS systems, including the ESW system. The comprehensive program is expected to be fully developed by June, 1993. The Raw Water Task Force has already identified changes to programs and systems to eliminate raw water corrosion problems in LGS systems. The Raw Water Task Force will manage the implementation of these comprehensive changes over the next several years.

- o The LGS check valve program has been used to identify other check valves in similar applications. Valve 11-0036 was identified and is scheduled to be disassembled and inspected for corrosion buildup during the second refueling outage of LGS Unit 2. Additionally, testing has been increased to a monthly frequency on check valve 11-0063 until a solution to the corrosion buildup is determined.
