LICENSEE EVENT REPORT (LER)

FACILITY NAME (1) Susquehanna Steam Electric Station - Unit 2										DOCKET NUMBER (2) 0 5 0 0 0 3 8 8										PAGE (3) 1 OF 0 4									
TITLE (4) ESF Actuation (Lightning Strike).																													
EVENT DATE (5)						LER NUMBER (6)						REPORT DATE (7)						OTHER FACILITIES INVOLVED (8)											
MONTH		DAY		YEAR		YEAR		SEQUENTIAL NUMBER		REVISION NUMBER		MONTH		DAY		YEAR		FACILITY NAMES						DOCKET NUMBER(S)					
																								0 5 0 0 0					
0 5 3 1		8 5		8 5		0 2 0		0 0 0		6 2 7 8 5								0 5 0 0 0											
OPERATING MODE (9) 4						THIS REPORT IS SUBMITTED PURSUANT TO THE REQUIREMENTS OF 10 CFR § (Check one or more of the following) (11)																							
POWER LEVEL (10) 10.0						20.402(b)						20.405(c)						<input checked="" type="checkbox"/> 50.73(a)(2)(iv)						73.71(b)

SUSQUEHANNA STEAM ELECTRIC STATION
LICENSEE EVENT REPORT 85-020-00
ER 100450 FILE 841-23
PLAS- 097

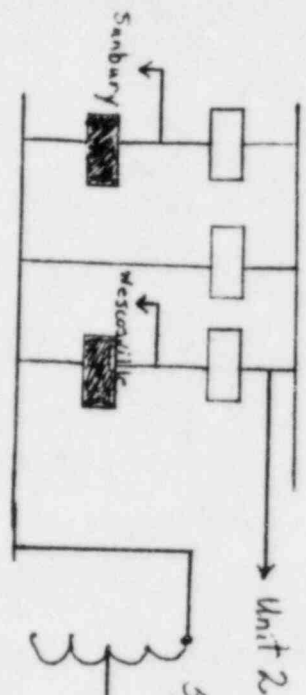
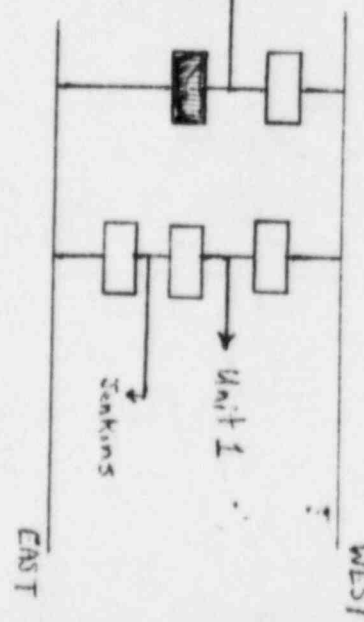
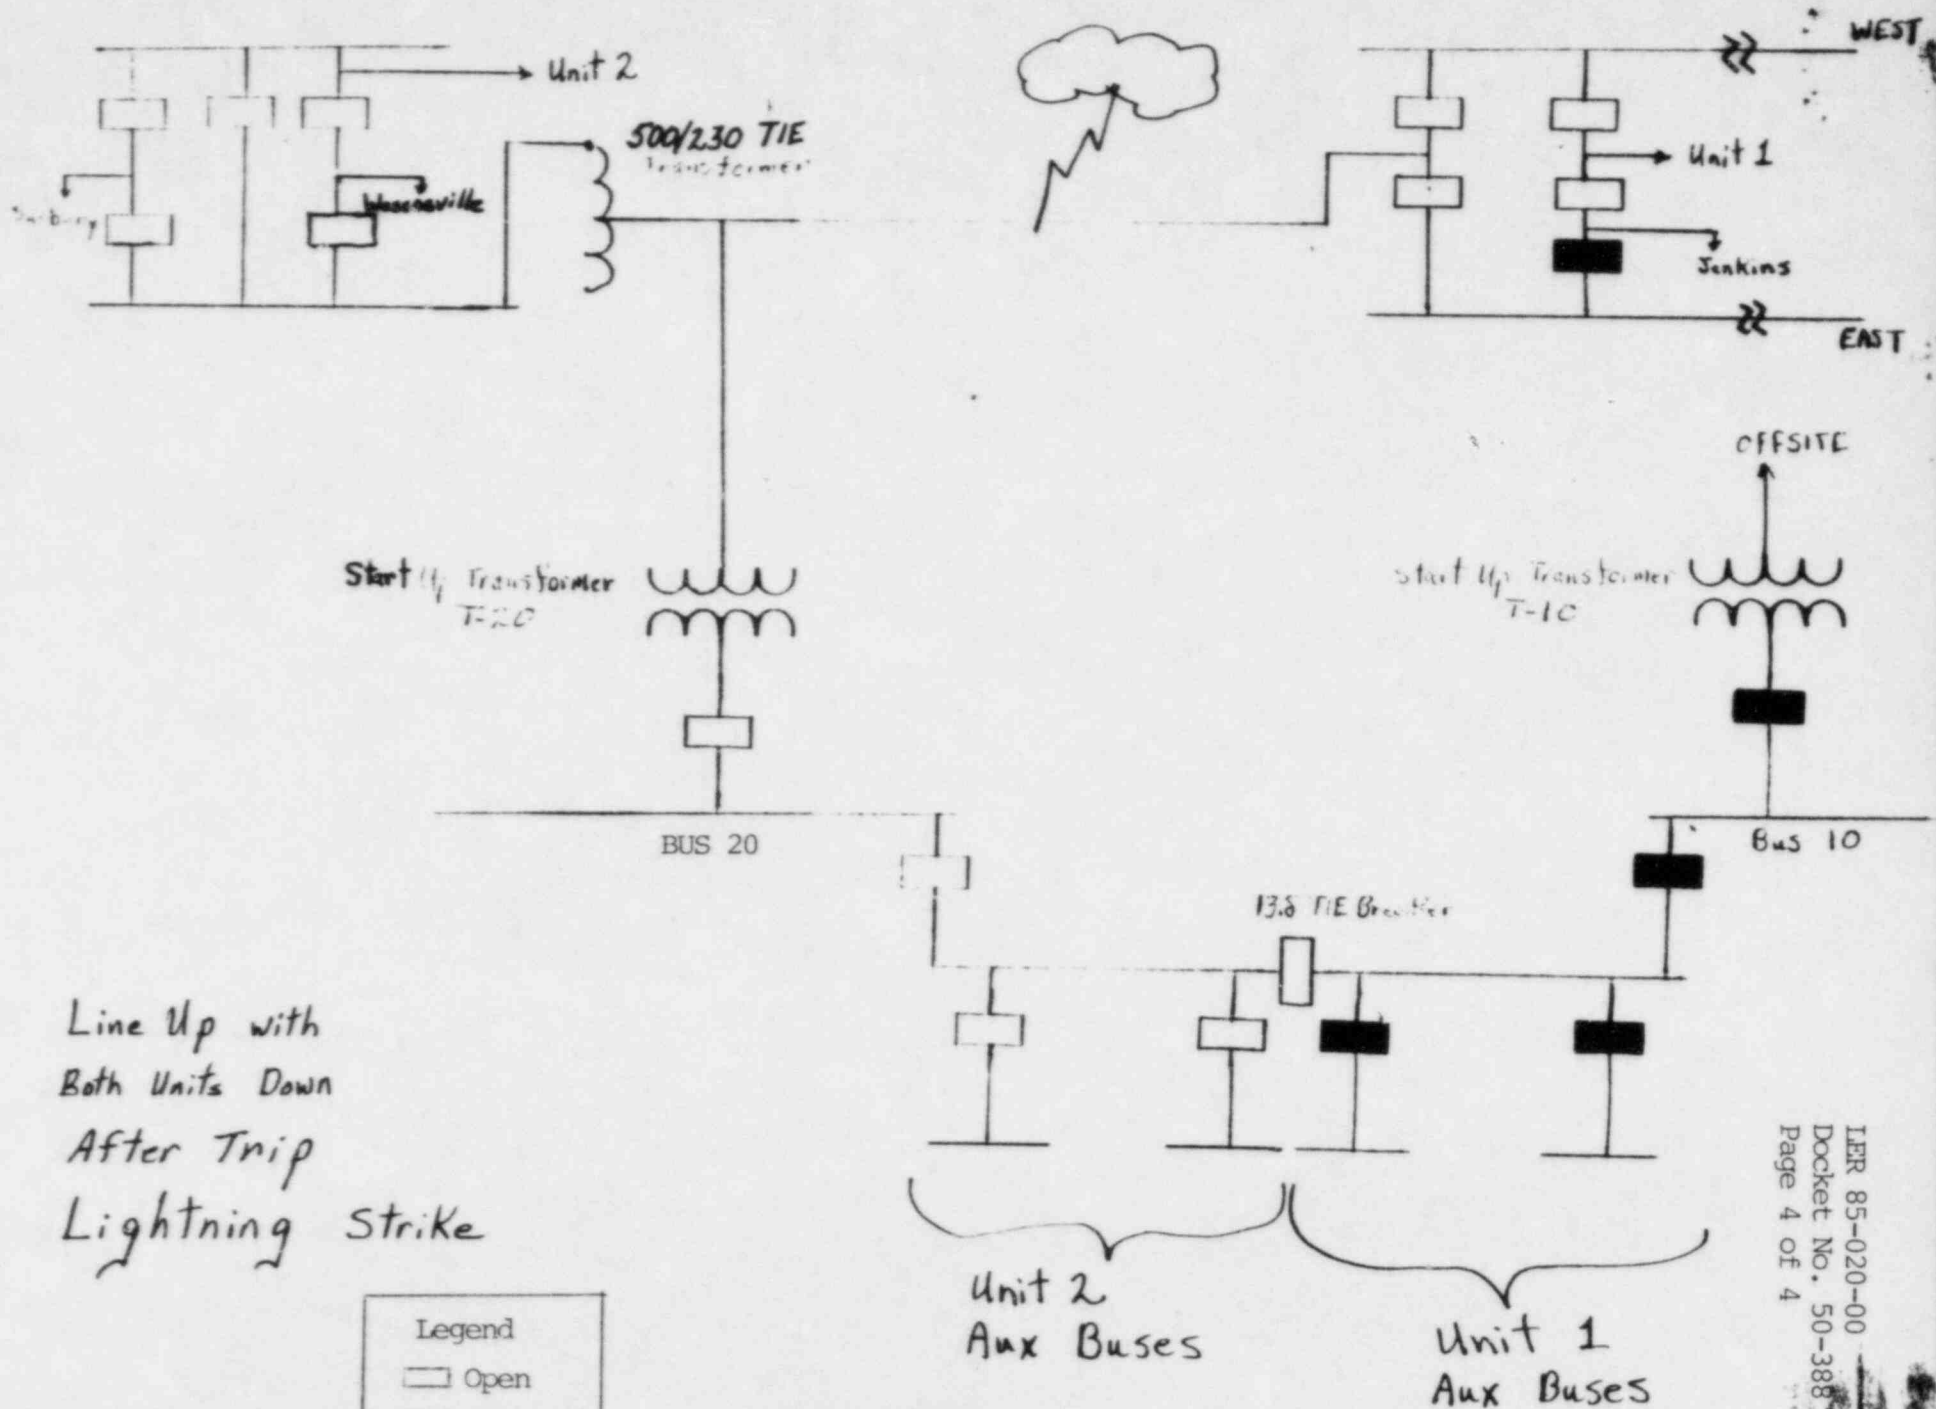
ATTACHMENT 1

On May 31, 1985, Unit 2 was in Cold Shutdown to allow repair of a packing leak on the reactor recirculation pump 'A' discharge bypass valve. Unit 1 remained shutdown for its first refueling outage. (Refer to Attachment 1 for the switch yard line up.) At approximately 2247, lightning struck or struck near the tie line between the 500KV and 230KV switchyard (EIIIS code: FK). (Refer to Attachment 1 for the switchyard lineup prior to the lightning strike and Attachment 2 for the post strike lineup.) As a result, the 500KV switchyard completely de-energized because the yard's North Bus was open since Unit 2 was shut down. The loss of the 500KV switchyard actuated the Double Circuit Outage scheme and, per design, the Unit 2 lock-out relays operated.

The Startup Transformer 20 - Bus 20 breaker (BKR) tripped on undervoltage. Both Unit 2 auxiliary buses were feeding from Bus 20 because Unit 2 was shutdown. With both Units down, the Bus 10 - Bus 20 tie breaker will not auto close. (The tie breaker was closed manually within one minute after Bus 20 tripped.) The loss of power caused the closure of radiation detection contacts for Division II instrumentation for Zone III (Refuel Floor) and subsequent start of the Control Room Emergency Outside Air Supply System (CREOASS) (BH) train 'B' (CREOASS is an Engineered Safety Feature.) Division I ESF logic was fed through Bus 10 and was unaffected throughout this occurrence.

May 31, 1985
 Pre Trip line up
