U.S. NUCLEAR REGULATORY COMMISSION
REGION I

Report No. 030-05985/93-001
Docket No. 030-05985
License No. 37-00276-25
Licensee: Professional Service Industries, Inc.
Pittsburgh Testing Laboratory Division
850 Poplar Street
Pittsburgh, Pennsylvania 15220
Facility Name: Pittsburgh Testing Laboratory Division
Inspection at: Medusa Concrete Company, Route 18, Wampum,
Pennsylvania and the Licensee's Office at
850 Poplar Street, Pittsburgh, Pennsylvania
Inspection Conducted: February 1 and 2, 1993

Inspection Summary: Special, announced inspection conducted on February 1 and 2, 1993
(Report No. 030-05985/93-001).

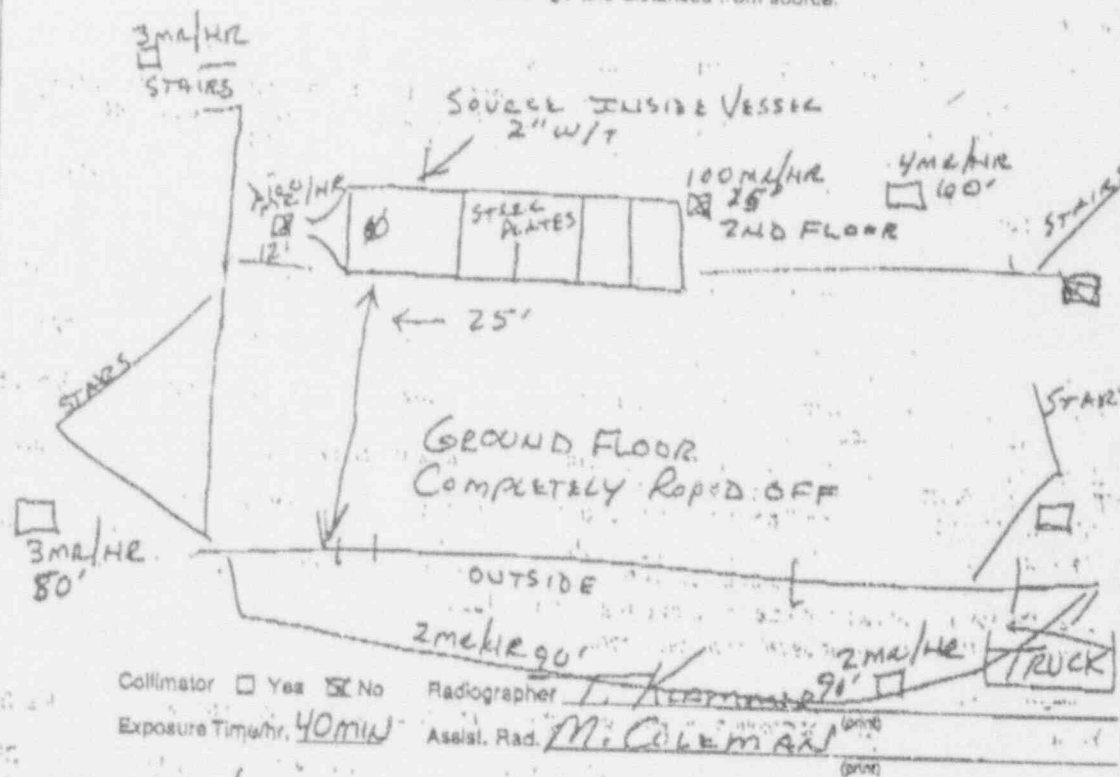
The radiographer indicated that during the exposure, two individuals (employees of the Medusa Cement Company) entered the restricted area from the end of the building away from the vessel (again, see attached diagram). The PSI radiographer and assistant radiographer noticed the individuals as they exited the building on the ground floor near the restricted area boundary. The radiographer reportedly confronted both individuals to determine why they were in

According to the radiographer, the two individuals indicated that they had walked through the area looking for misplaced tools. The two individuals further indicated that the entire time they were in the area was approximately 2 to 2½ minutes. Upon further investigation it was determined that the individuals traversed the catwalk and entered the high radiation area toward the south end of the building where the vessel is located. The Safety Officer for Medusa Cement has indicated the two individuals stepped over the radiographic exposure device (which was posted with a high radiation area sign) to gain access to the high radiation area.

Sketch and Survey of Restricted Area
Show the source as \odot . Show HRA as ☒ and RA as ☐ with locations, radiation readings and distances from source.
