Subject: Service Water Leak Inside Containment
R.E. Ginna Nuclear Power Plant
Docket No. 50-244

SERVICE WATER LEAK INSIDE CONTAINMENT

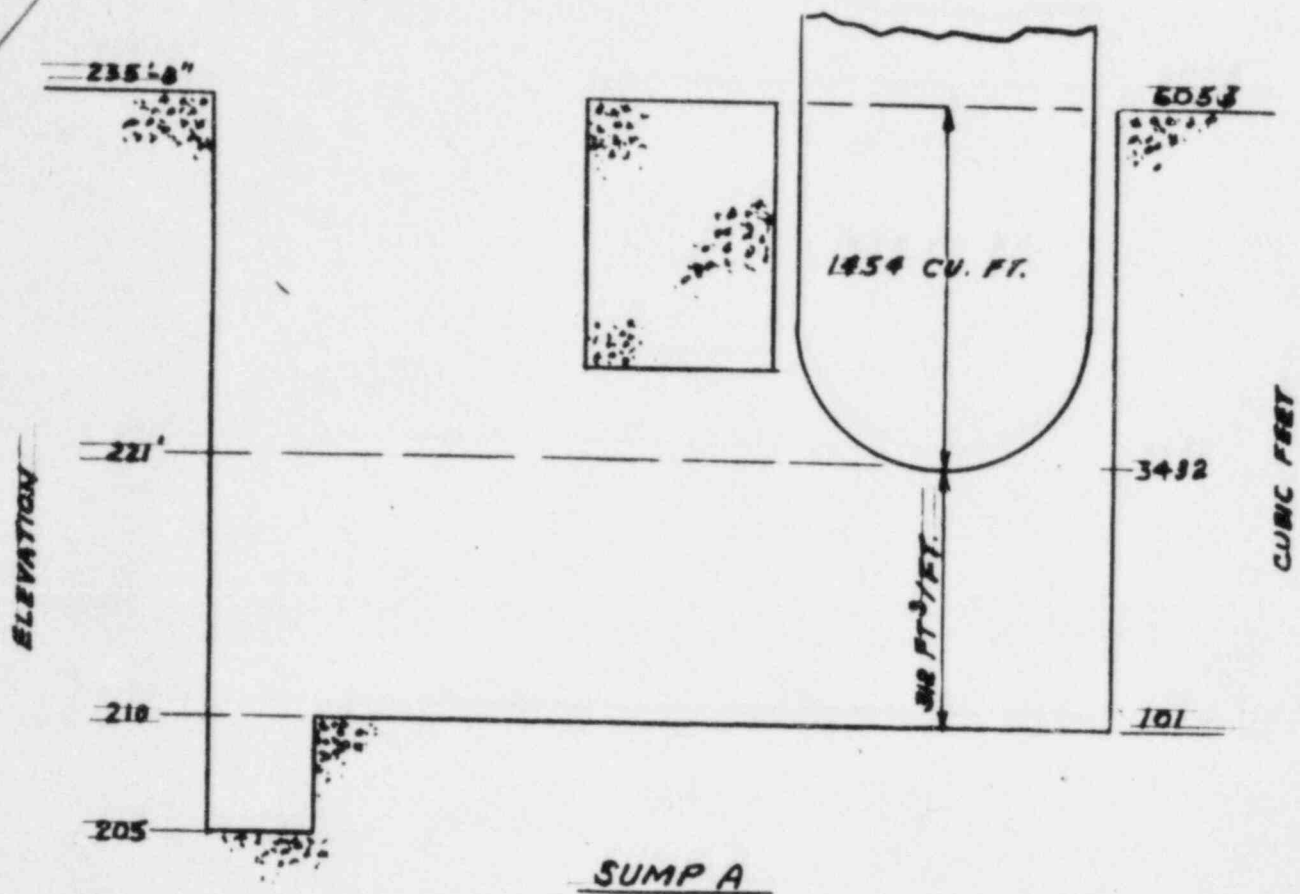
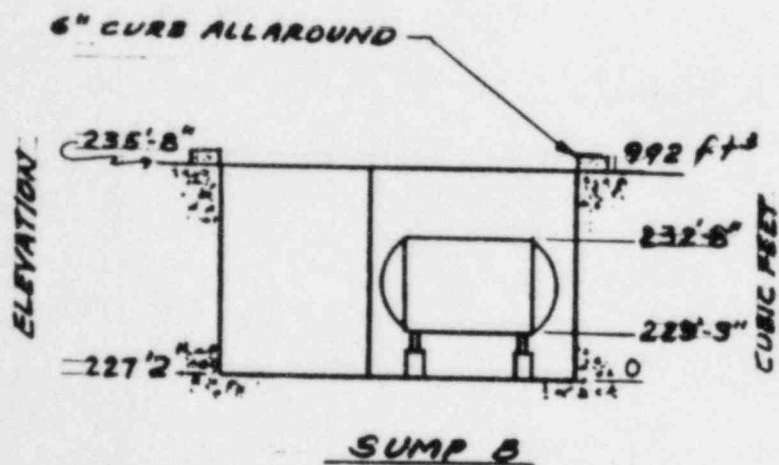
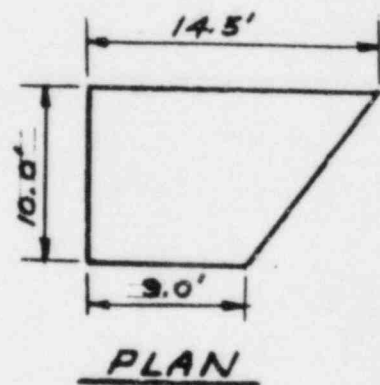
0	ORIGINAL	INITIAL DATE	HJP 9-10-84	Rev 9-19-84	Cpm 9-19-84	RCM 10-2-84
NUMBER	REVISION	DRAWN BY	CHECKED BY	RESP. ENG.	ENG. MANG'R.	
ROCHESTER GAS & ELECTRIC CORP. ROCHESTER, NEW YORK			SUMP "A" AND "B" VOLUMES		SCALE None	
					NO. 03021-582

At 1030 hours on July 1, 1985, while Ginna Station was operating at 100% power and following completion of PT-2.7 "Service Water System" test, the Containment Vessel "A" Sump Pump actuation interval decreased significantly from normal. This sump is located at the bottom of the reactor vessel cavity area and is the lowest elevation of the Containment Vessel. (See attached drawing)
