Subject: Braidwood Station Unit 1
NRC Docket Number: 50-456

Operating Interval Between Eddy Current Inspections for Circumferential
Indications in the Braidwood Unit 1 Steam Generators

REQUEST FOR ADDITIONAL INFORMATION
RELATED TO THE PROPOSED DELETION OF THE
BRAIDWOOD, UNIT 1 MID-CYCLE STEAM GENERATOR TUBE INSPECTION
DOCKET NO. STN 50-456

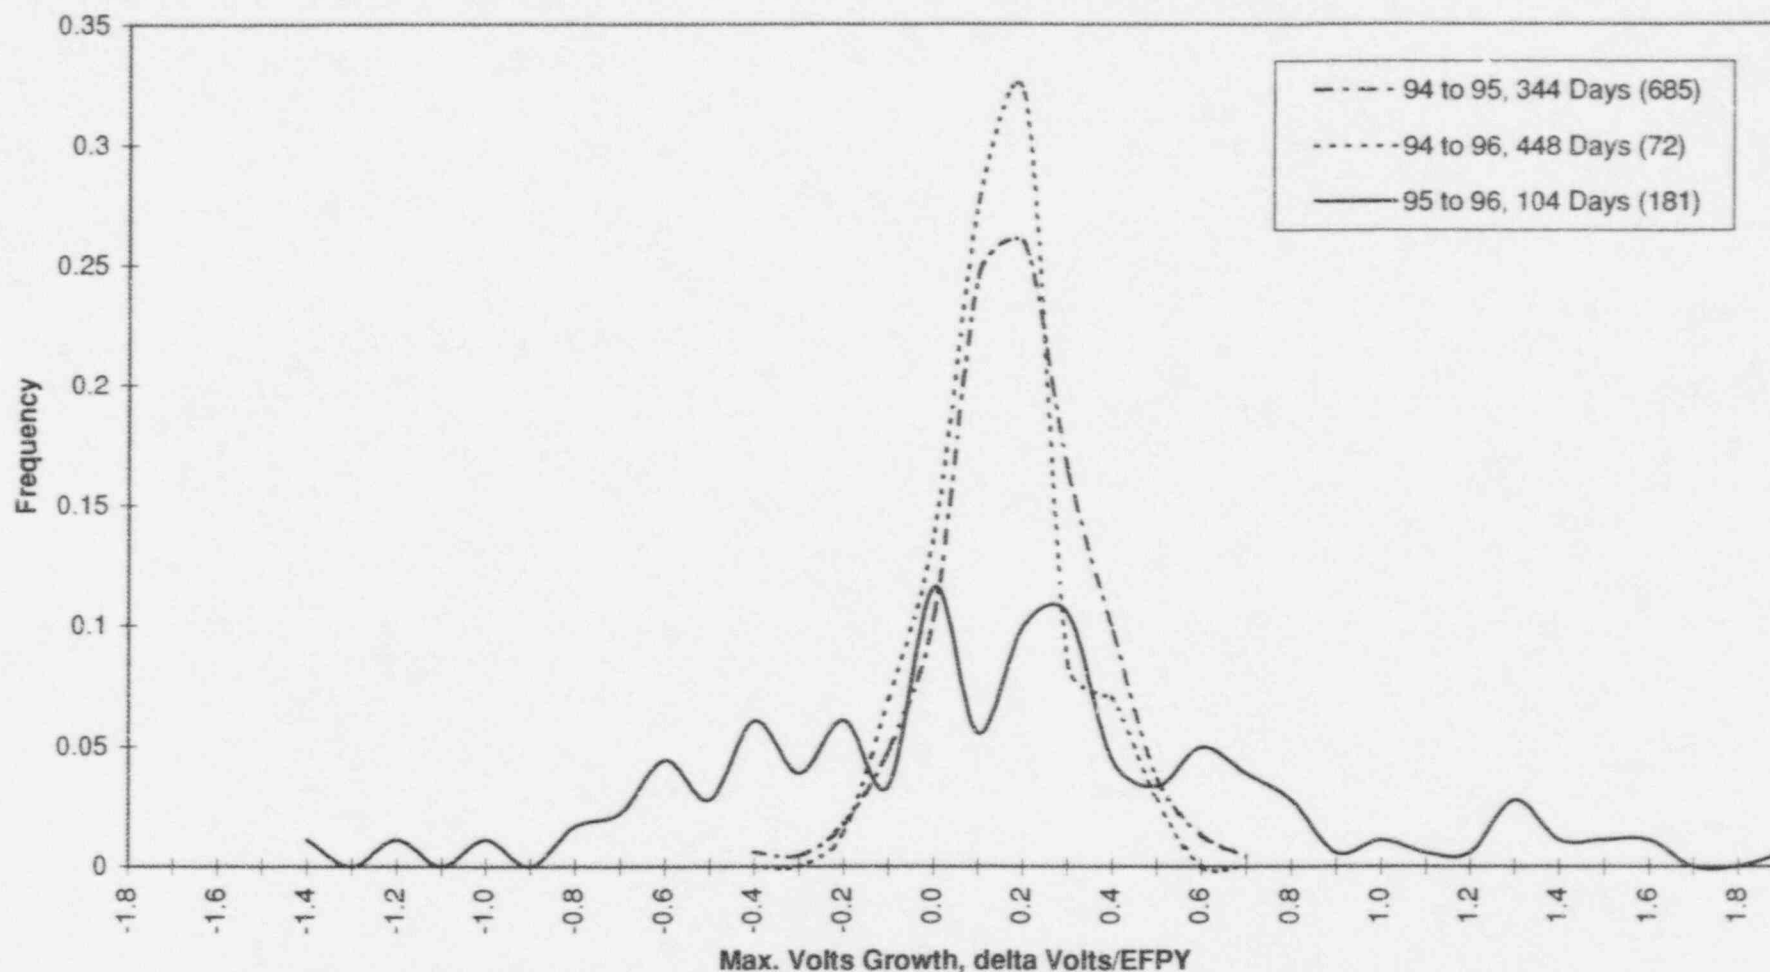
Figure 5a

The distribution of growth rates shown in Figures 5a and 5b provide the following observations: the growth rate distributions for longer intervals, approximately one full cycle of operation (1994 to 1995 and 1994 to 1996), are smooth with relatively short tails and is peaked at the middle. The distribution for the short operating interval, approximately one quarter of an operating cycle (1995 to 1996) is not smooth, has long tails in both directions and is flat. The curves on the figures show that there is a significant difference in the short and long cycle growth rates.

Evaluation of Byron Maximum Voltage Growth for Three Operating Intervals

Conclusion: Significant Difference in the Short Cycle Growth Rate Distribution Compared to the Growth Rate Distributions Obtained from Full Cycle Operation

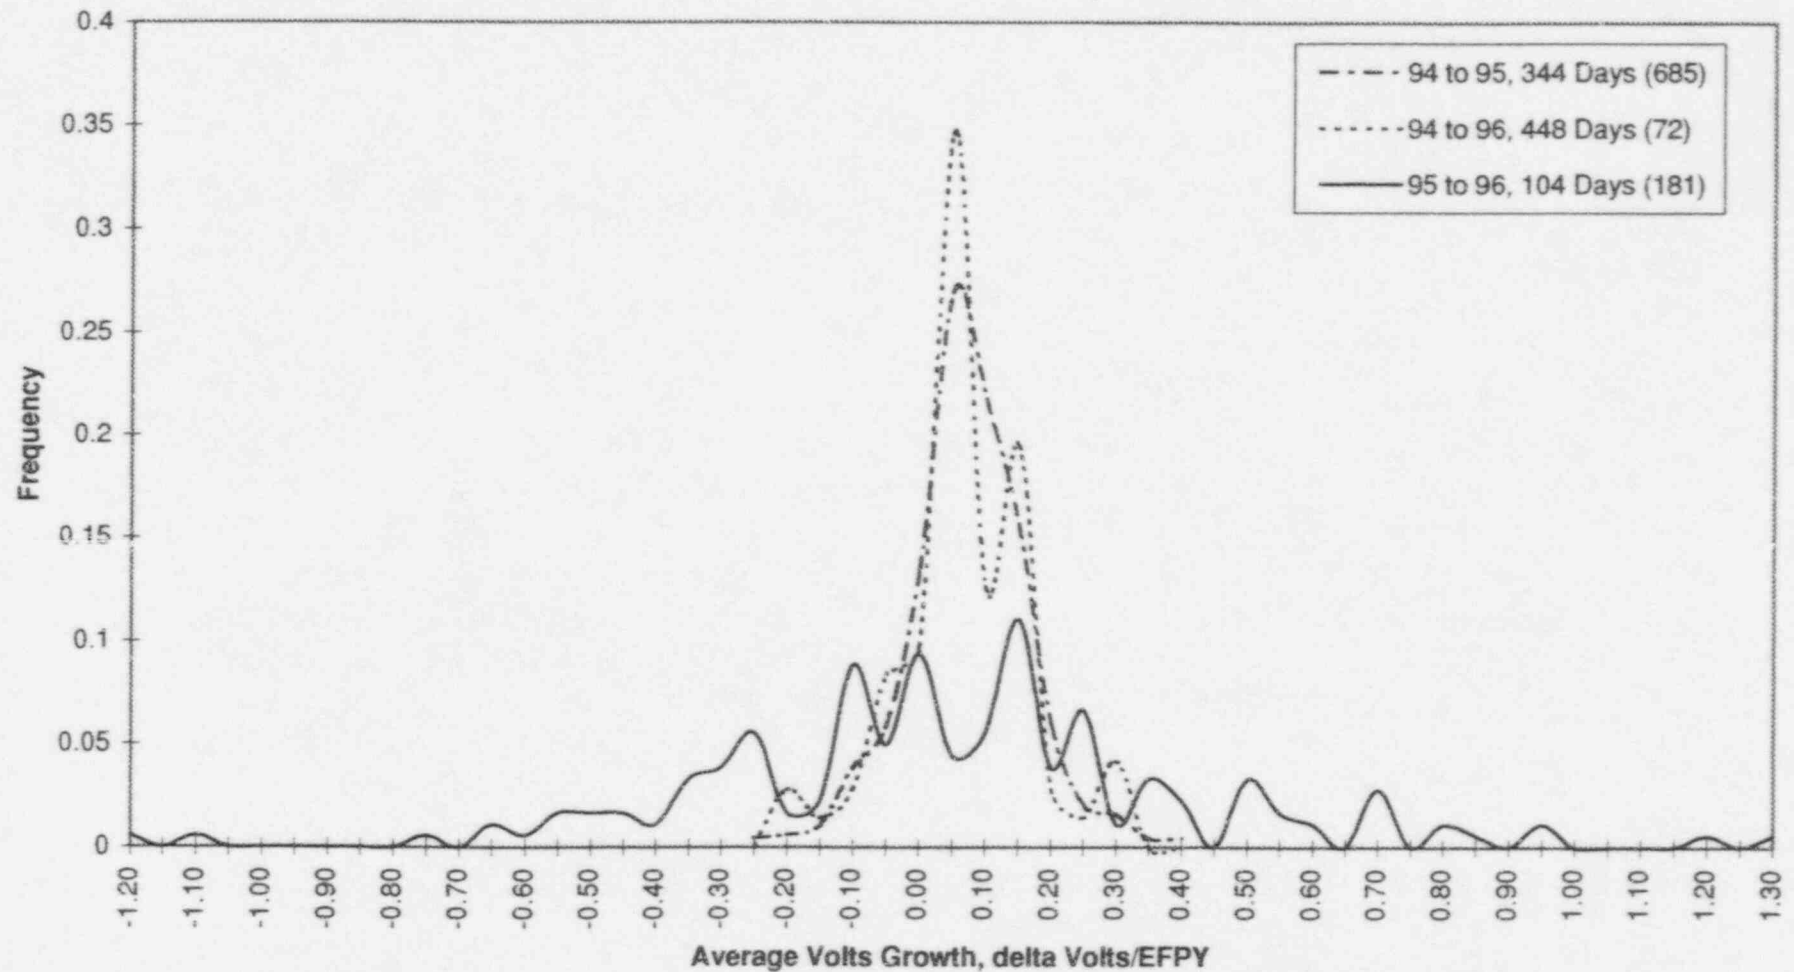
Evaluation of Byron Average Voltage Growth for Three Operating Periods
Figure 5b

Conclusion: Significant Difference in the Short Cycle Growth Rate Distribution Compared to the Growth Rate Distributions Obtained from Full Cycle Operation

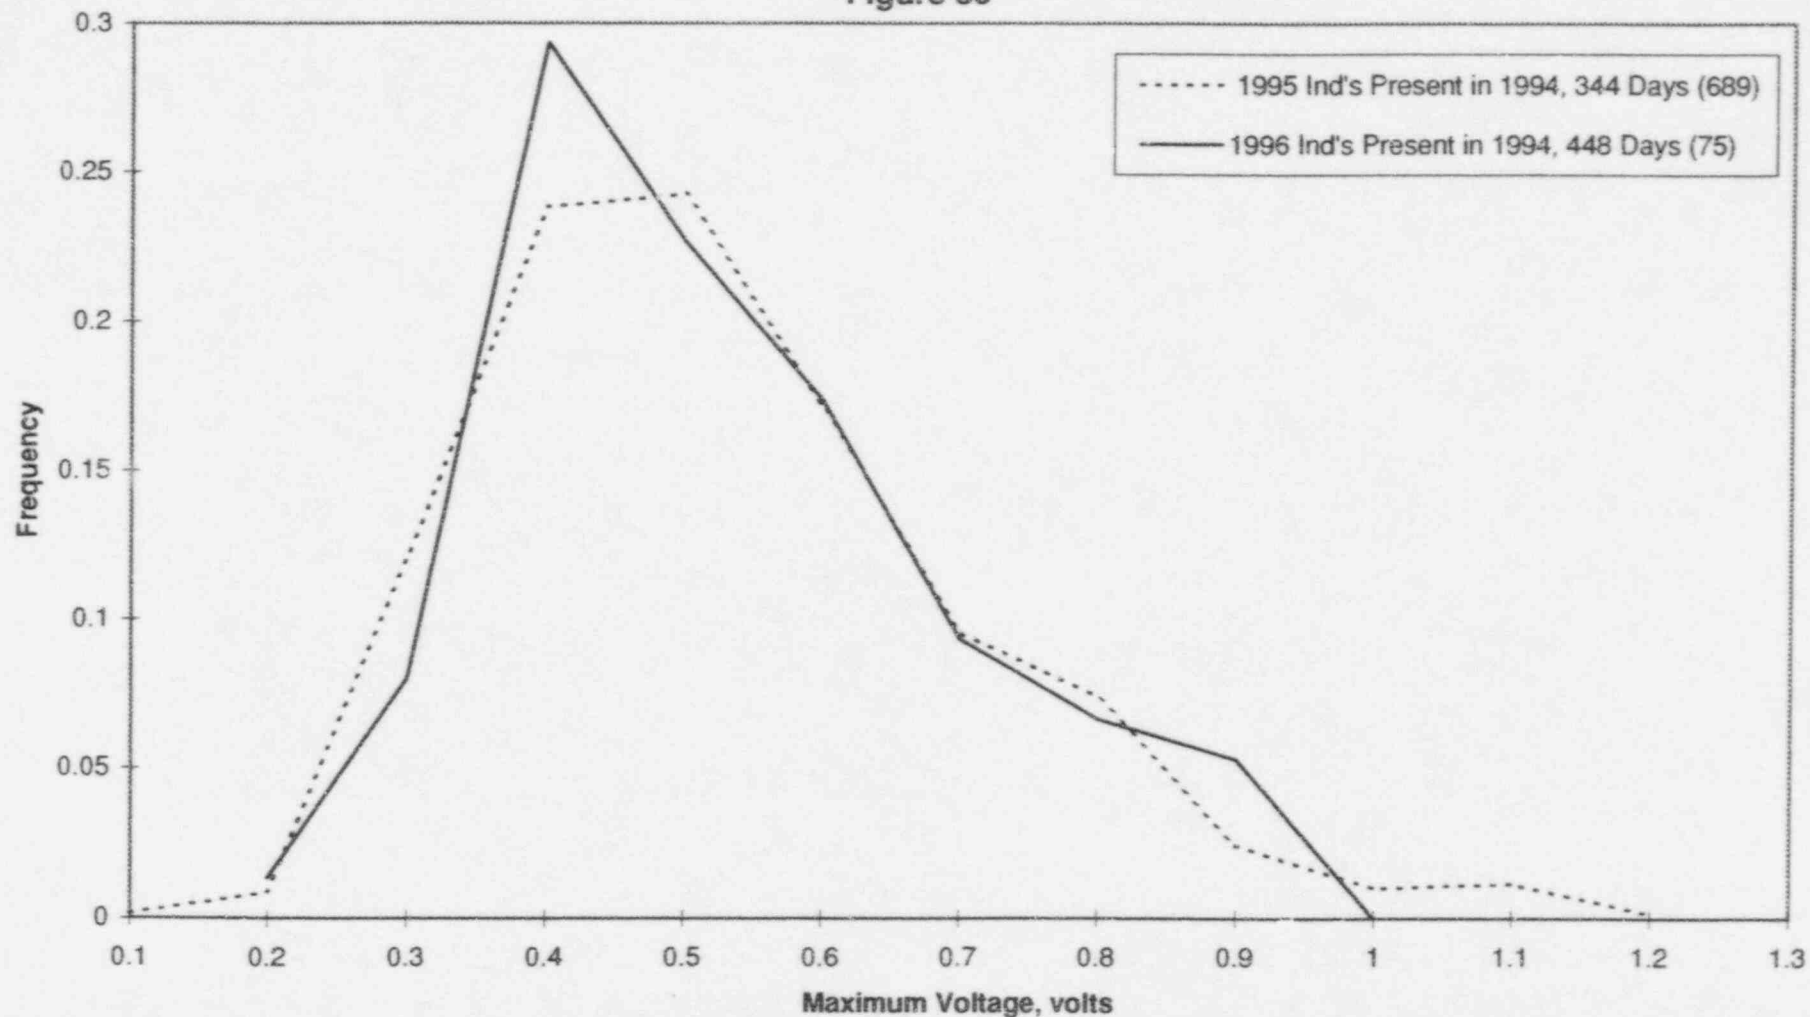
Figure 5c

Because there are some large short interval growth rates, an evaluation of the voltage distribution of 1995 and 1996 indications present in 1994 was performed. If the large short interval growth rates were real it would be expected that the distribution of indications present from 1994 to 1996 would be significantly greater than the distribution of indications present from 1994 to 1995. Figures 5c and 5d show the Frequency of indications versus the maximum and average voltage in volts, respectively. The figures show that there is no significant difference in size of indications present from 1994 to 1995 compared to 1994 to 1996. This indicates that full cycle growth rates are appropriate for a full operating cycle evaluation.

Byron Unit 1 1996 & 1995 Indications In Service Since 1994

Conclusions: No Significant Difference in Size of Indications Present from 1994 - 1995 Compared to 1994 - 1996. This Indicates that Full Cycle Growth Rates are Appropriate for a Full Operating Cycle

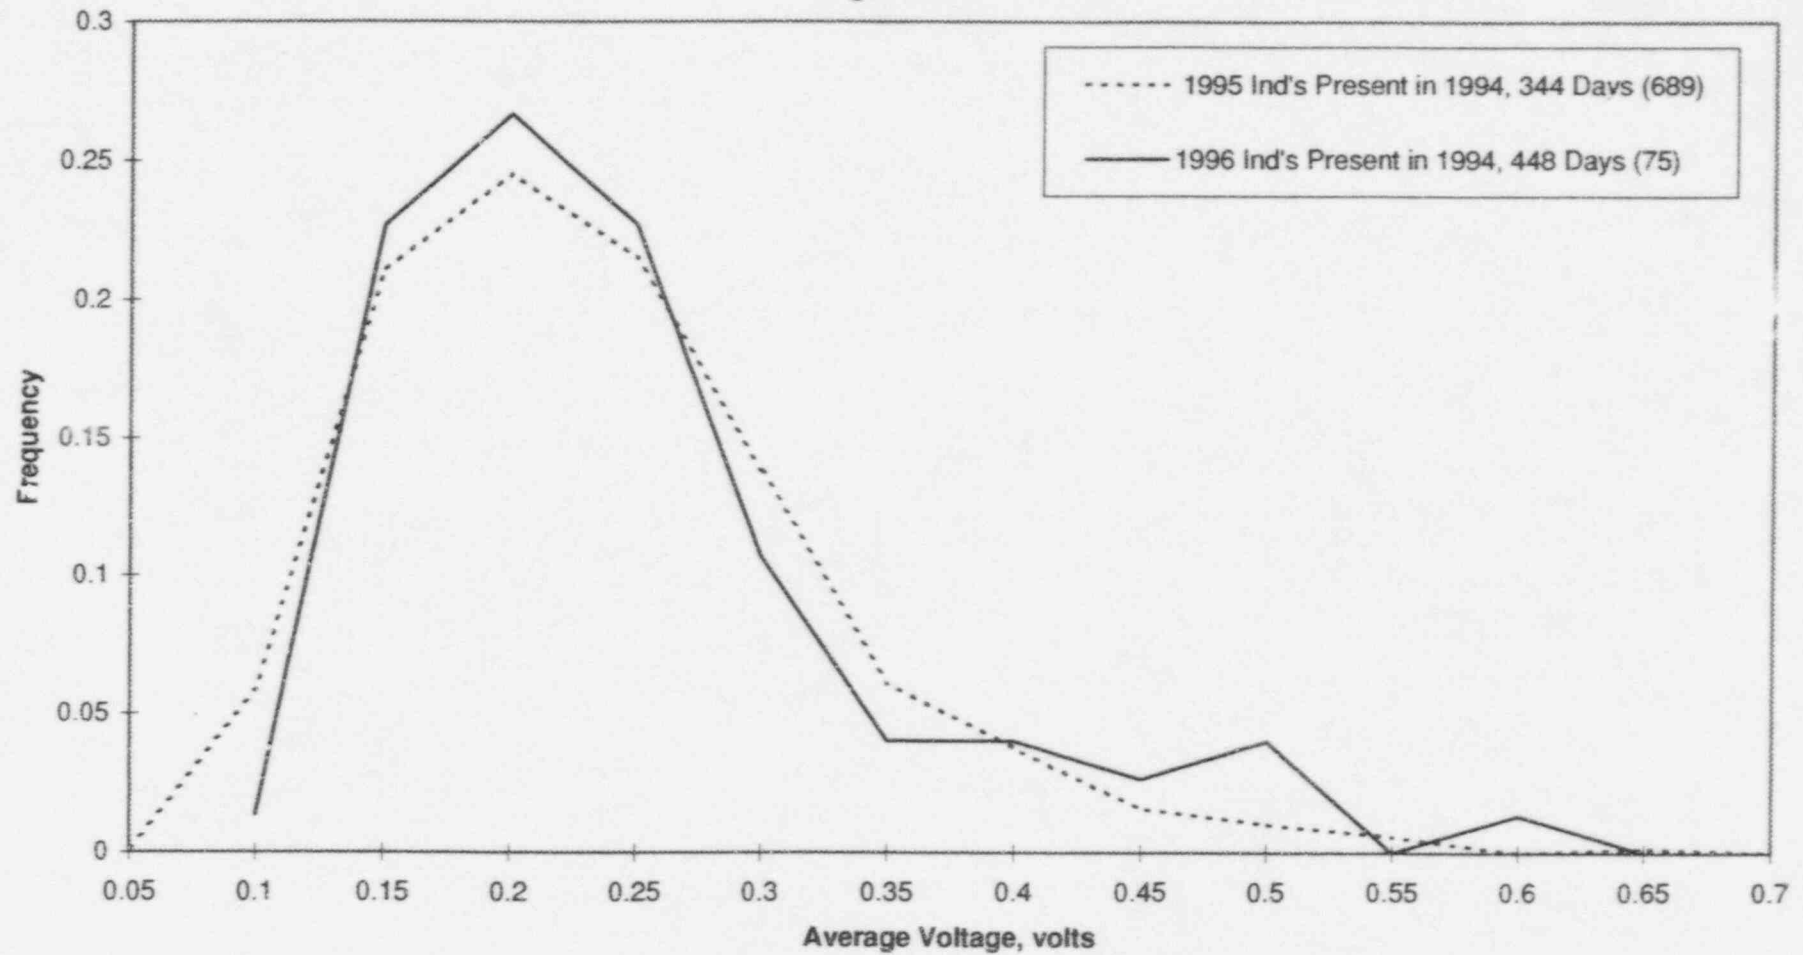
Figure 5d

Byron Unit 1 1996 & 1995 Indications In Service Since 1994

Conclusions: No Significant Difference in Size of Indications Present from 1994 - 1995 Compared to 1994 - 1996. This Indicates that Full Cycle Growth Rates are Appropriate for a Full Operating Cycle
