U. S. NUCLEAR REGULATORY COMMISSION

Report No. 030-17325/92001(DRSS)

Licensee: BBC&M Engineering Inc.  
6190 Enterprise Court  
Dublin, Ohio 43017

Inspection on October 21, 1992 (Report No. 030-17325/92001(DRSS))

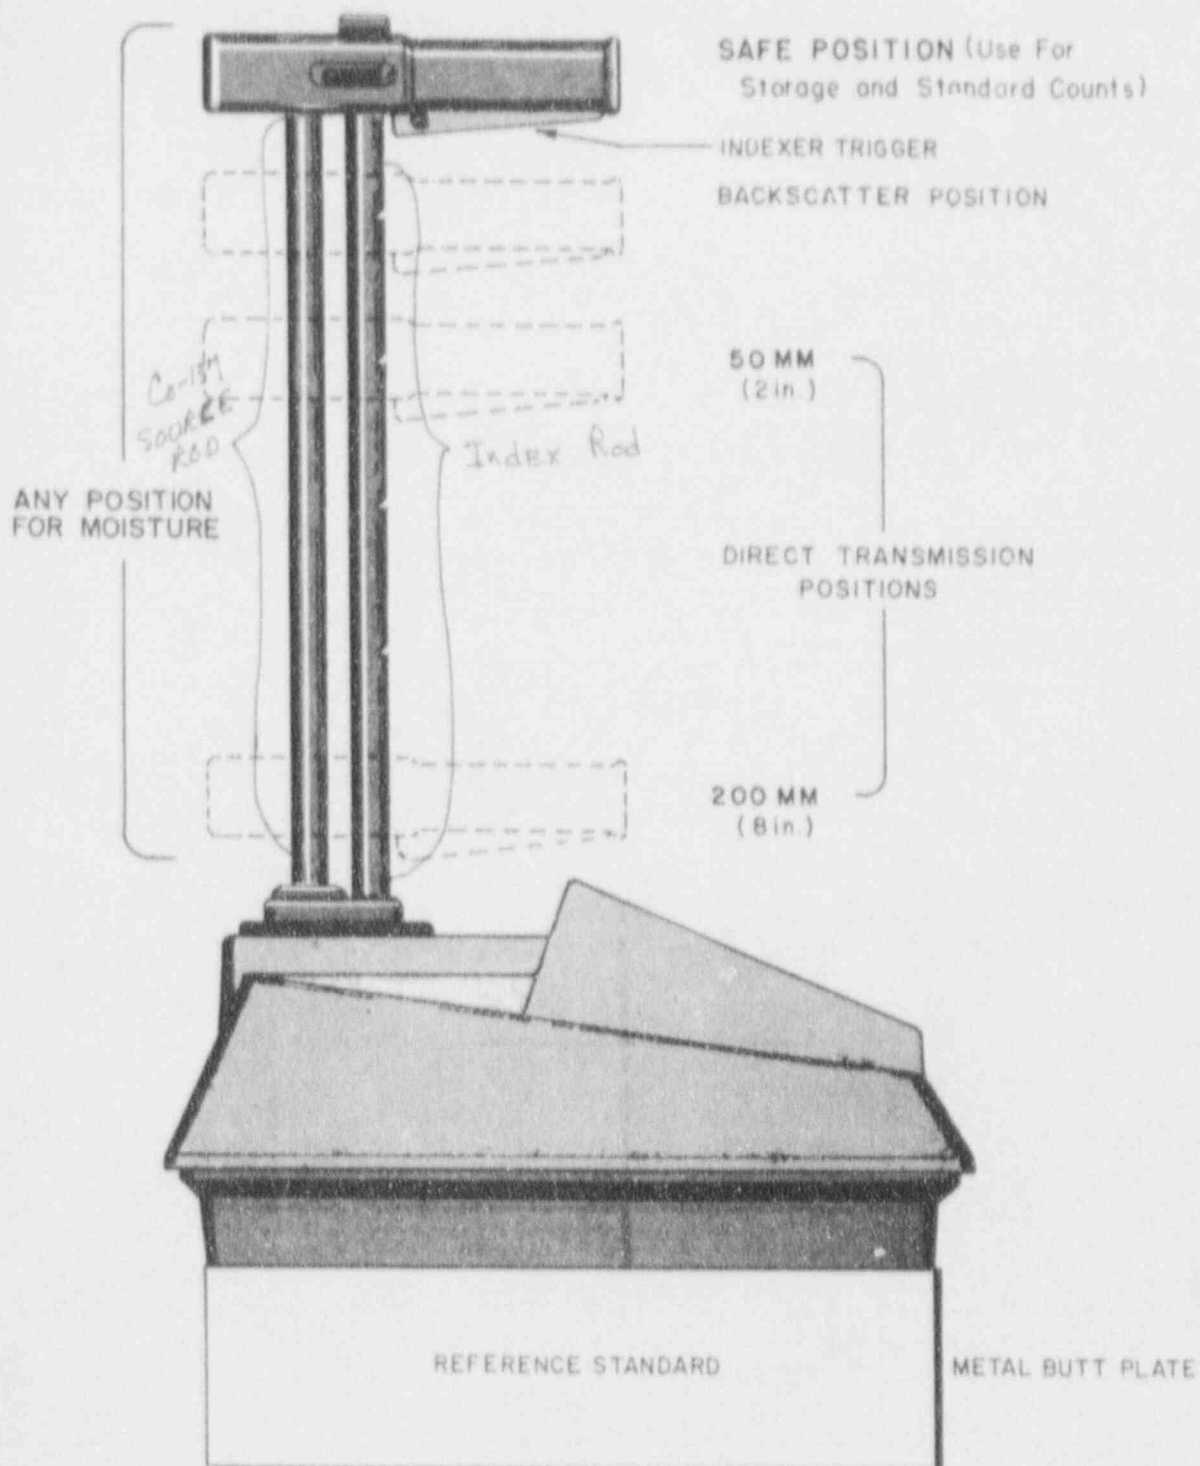
Reference Standard Orientation  
Figure 2-2

Inspection Findings - The inspectors discussed this incident with the involved licensee representatives. The facts as presented in the licensee's letter dated September 11, 1992, remained the same (Attachment 1). The RPO speculated that the dozer may have nicked the device during the course of its operation. It is also possible that dozer operations may have kicked up debris which struck the index rod and caused the damage (Attachment 2). The gauge user stated that he was in visual contact with the device from noon until 1:15 pm, but acknowledged that he wasn't watching it every second during that time. He also indicated that he had placed the device in a safe location above the area where the backfill operations were taking place. The user indicated that the source rod was in the safe position but was not locked. License Condition 19 requires the licensee to conduct its program in accordance with statements, representations and procedures contained in certain referenced letters and applications. Item No. 3 of the referenced letter dated March 19, 1980, entitled "Protection of Gauges at Temporary Job Locations" requires, in part, that the source rod be locked in the safe position when the technician is not attending the gauge with the intention of making a series of tests at a temporary job location. The failure of the gauge user, on September 10, 1992, to lock the source rod in the safe position as required is an apparent violation of License Condition No. 19.

The inspectors reviewed the record of the leak test performed following the incident and found the results to be within regulatory limits. Replacement of the index rod was performed by persons specifically licensed by the Commission to perform such services. Neither the source rod nor the electronics was damaged during this incident.

procedures with them during a September 22, 1992 safety meeting. The RPO has instituted the use of bright orange cones to be placed near the gauging devices in use at jobsites to alert machinery operators in the area.
