NORTHWEST LABORATORIES

Report To: Sonotech, Inc.

Report On: Ultrasonic Couplants/
Crevice Corrosion Testing

Lab No: E 60731-2 ,

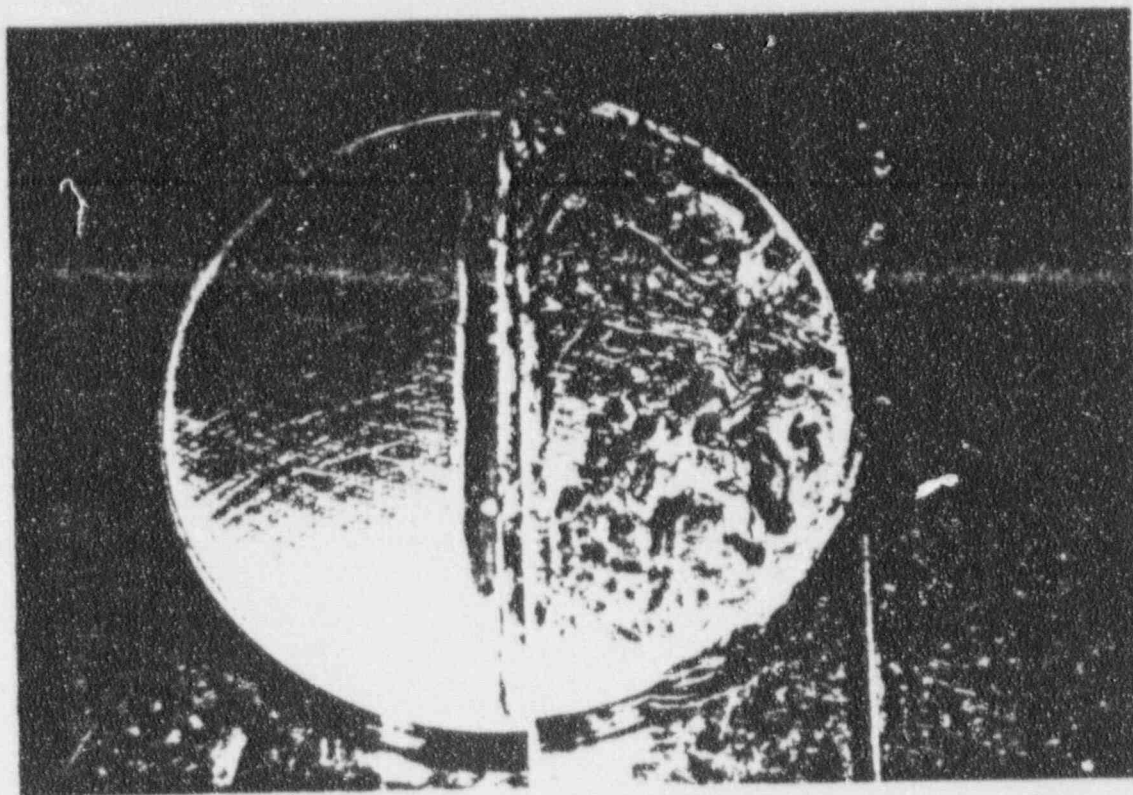
- A. Appearance of steel test surfaces before removal of couplant materials.
 - 1. Sonotrace 30 - Photo #1
Heavy areas of brown discoloration on the steel disc under the glass plate and along the edge of the glass plate.
 - 2. Ultragel II - Photo #2
Very light brown discoloration on the steel disc along the edge of the glass plate, and some brown discoloration along the edge of the disc.
- B. Appearance of steel test surfaces after removal of couplant materials.
 - 1. Sonotrace 30 - Photo #3
Heavy areas of brown discoloration as seen before removal of the corrosion products.
 - 2. Ultragel II - Not photographed.
Visible surface attack on the steel disc along the edge of the glass plate, and some brown discoloration along the edge of the disc.

Photo 1 - Sonotrace 30 sample after seven days exposure. The glass plate is covering the right half of the disc.

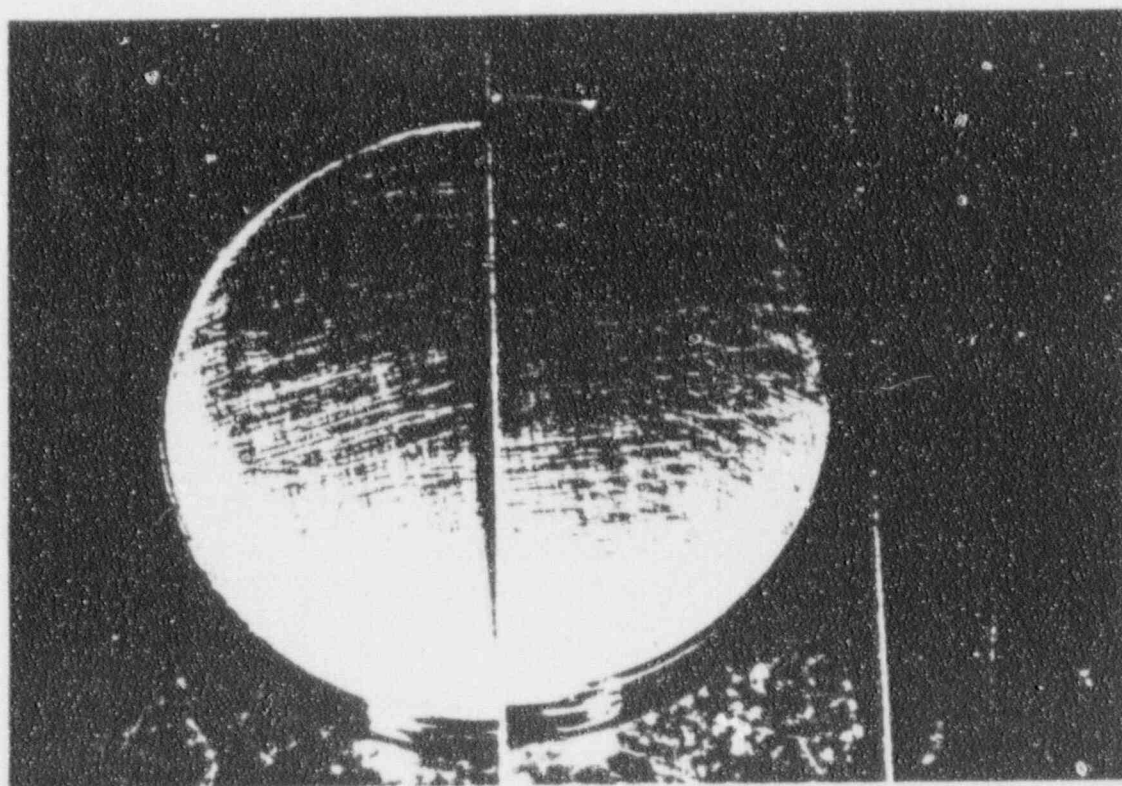
Photo 2 - Ultragel II sample after seven days exposure. The glass plate is covering the right half of the disc.

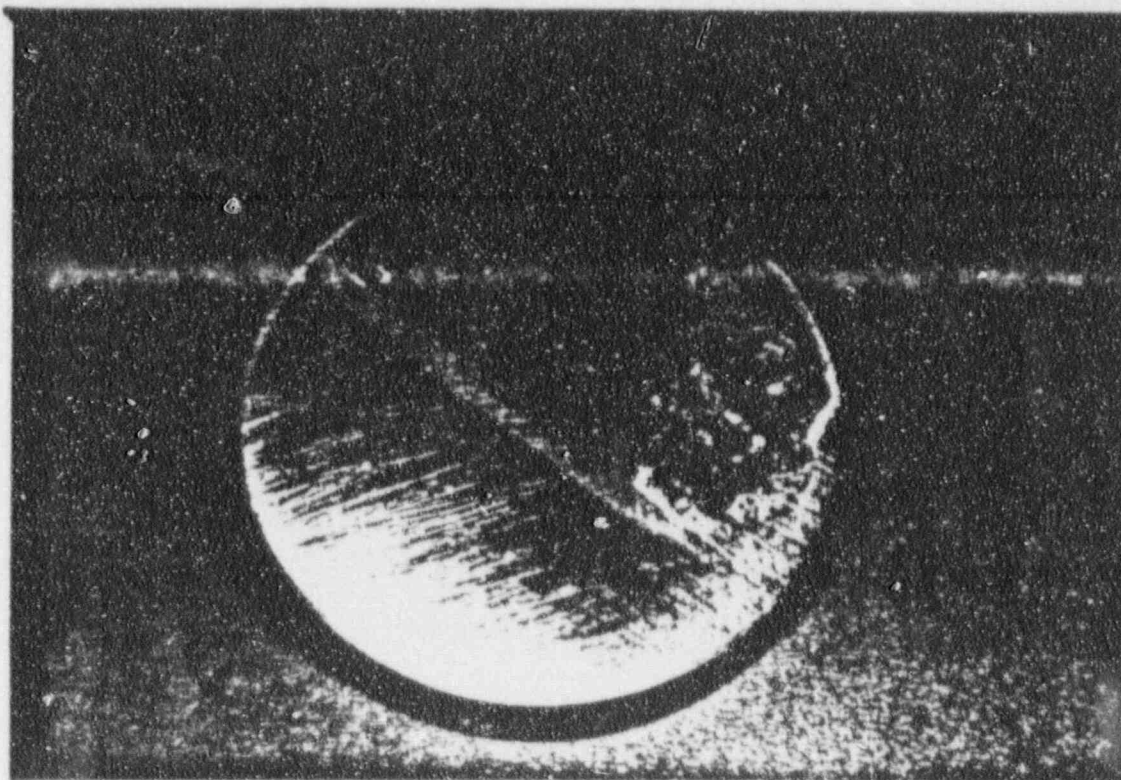
Photo 3 - Sonotrace 30 sample before removal of corrosion products.

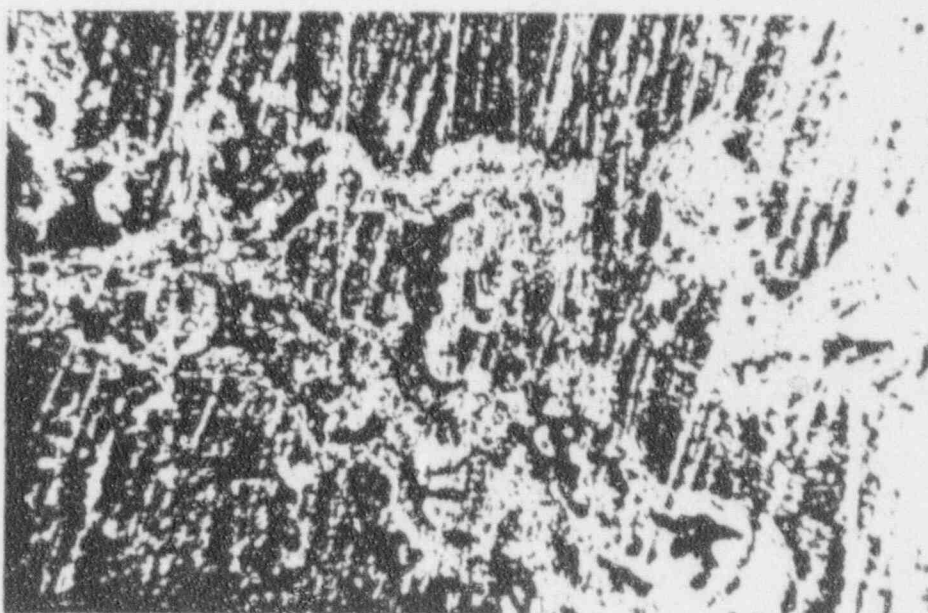
Visible surface attack was observed where there had been brown corrosion products. The edges of the chemically attacked areas were marked by deeper pits. See photos 4 and 5.

Photo 4 - Sonotrace 30 sample - detail of surface after partial removal of corrosion products. Light colored areas are chemically attacked areas and dark areas are remaining corrosion products. Approximately 10X magnification.

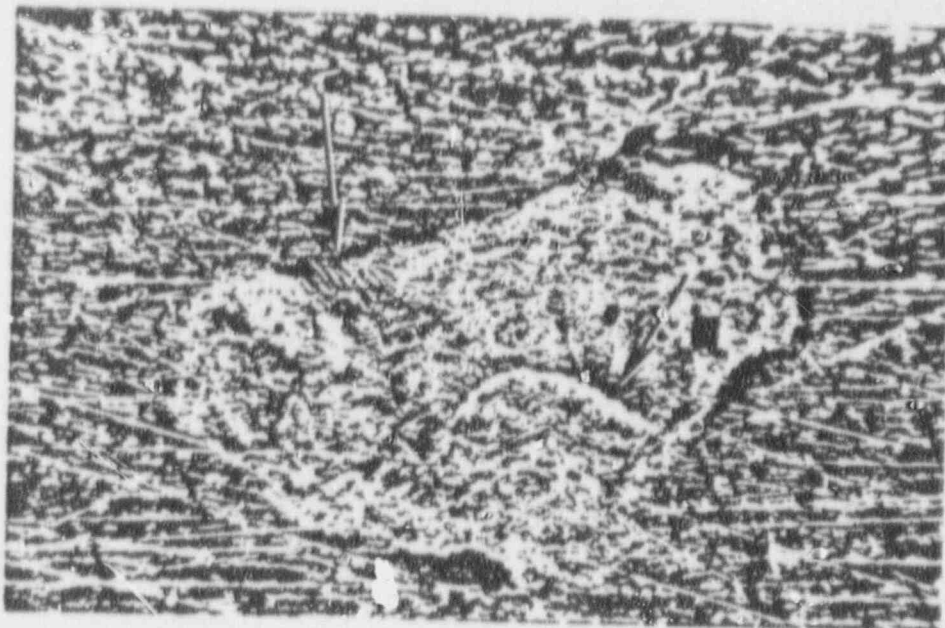
Photo 5 - Sonotrace 30 sample - Detail of chemically attacked area after removal of corrosion products. Arrows indicate some of the pitted areas around the border of the chemically attacked area and extending into it. Approximately 35X magnification.

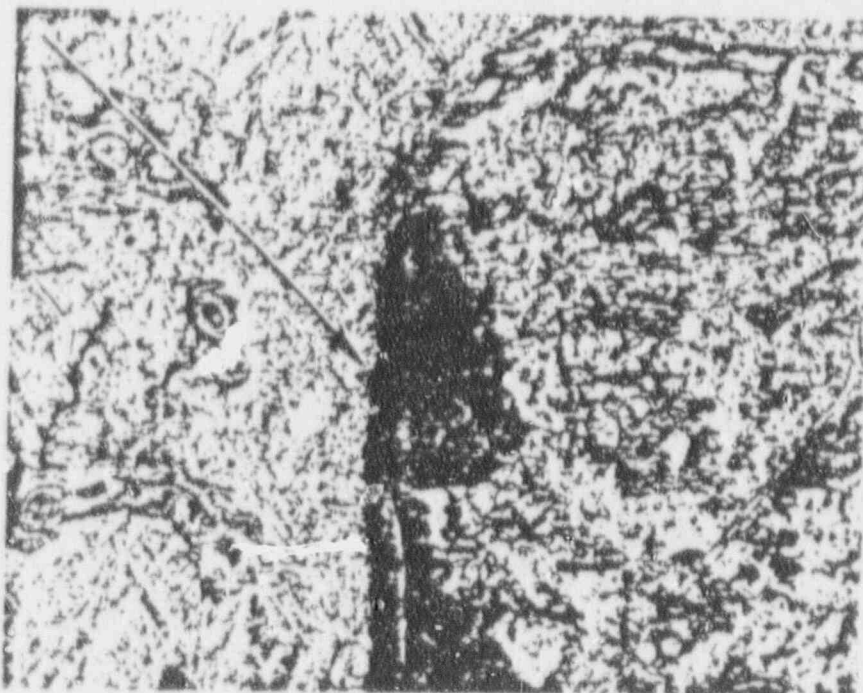
Results: Several pits were found to be greater than one mil in depth and the depth of one pit was measured as 2.4 mils. See photo 6.

Photo 6 - Sonotrace 30 sample - Detail of chemically attacked area. Arrow at dark area indicates pit which was measured as 2.4 mils deep. 100X magnification.

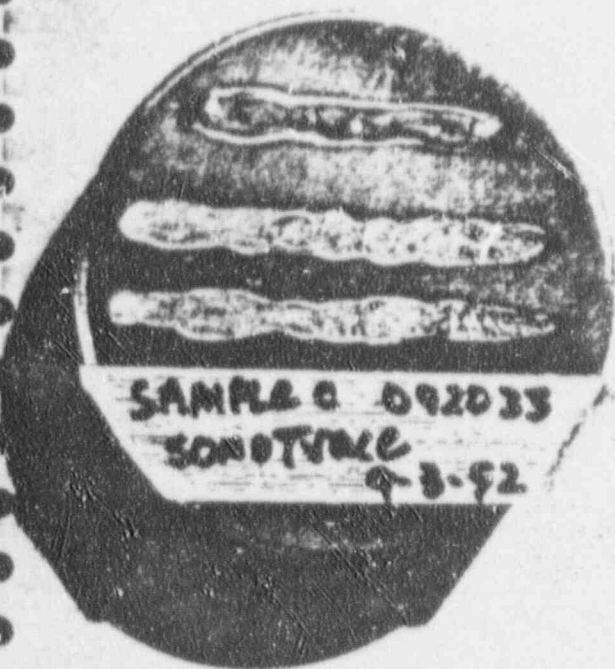
Test 3 - Sonotrace 30 - Photo 3

- a) Top bead - brownish discoloration
- b) Middle bead - light yellow-brown discoloration
- c) Bottom bead - light yellow-brown discoloration

Photo 3 -
Test 3
after 13 days

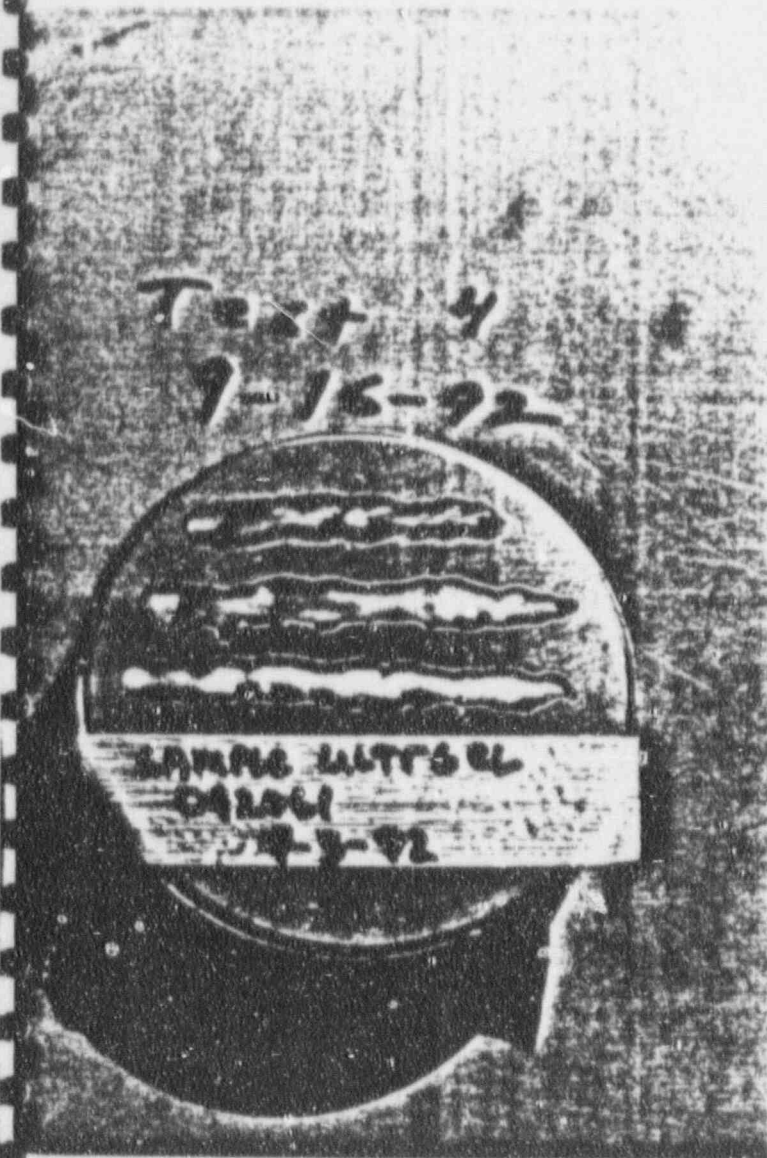
Test 4 - Ultragel II - See Photo 7

- a) Top bead - yellow-brown discoloration
- b) Middle bead - little or no discoloration
- c) Bottom bead - little or no discoloration

Photo 7 -
Test 4
after 13 days

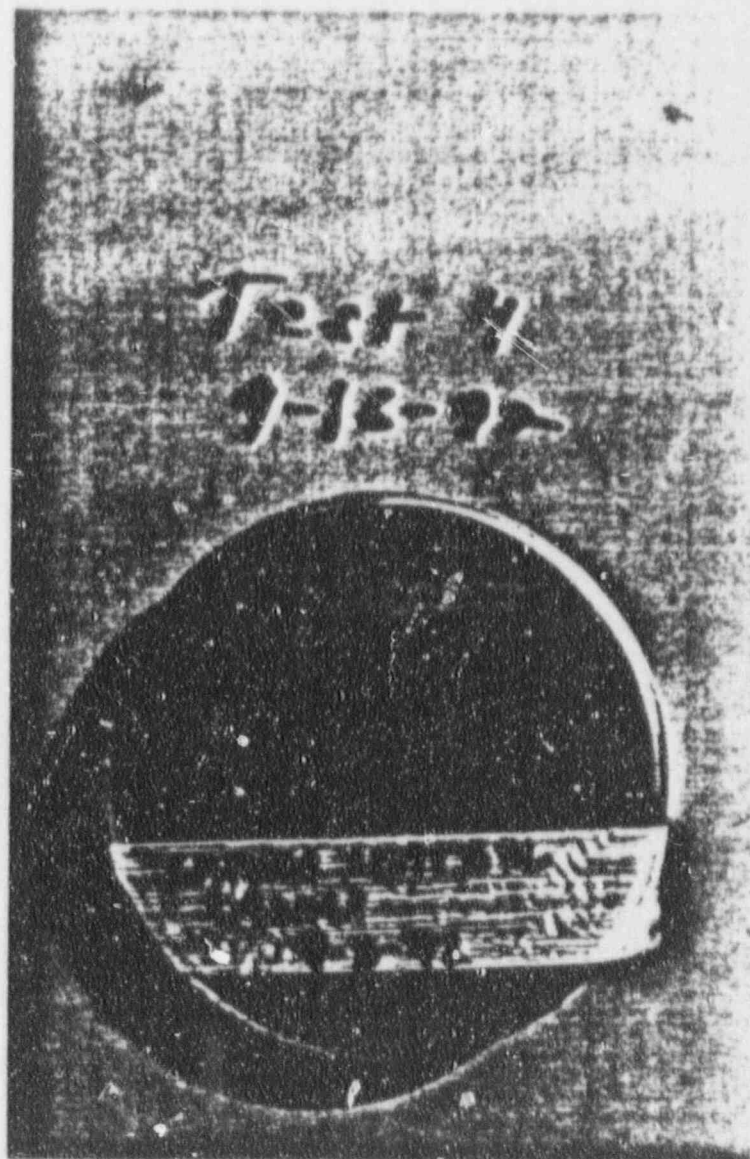
Test 4 - Ultragel II - See Photo 8

- a) Top bead - A very visible surface attack with the deepest attack along the edge.
- b) Middle bead - A slight surface attack
- c) Bottom bead - A slight surface attack

Photo 8 -
Test 4
steel surface
after removal
of couplant

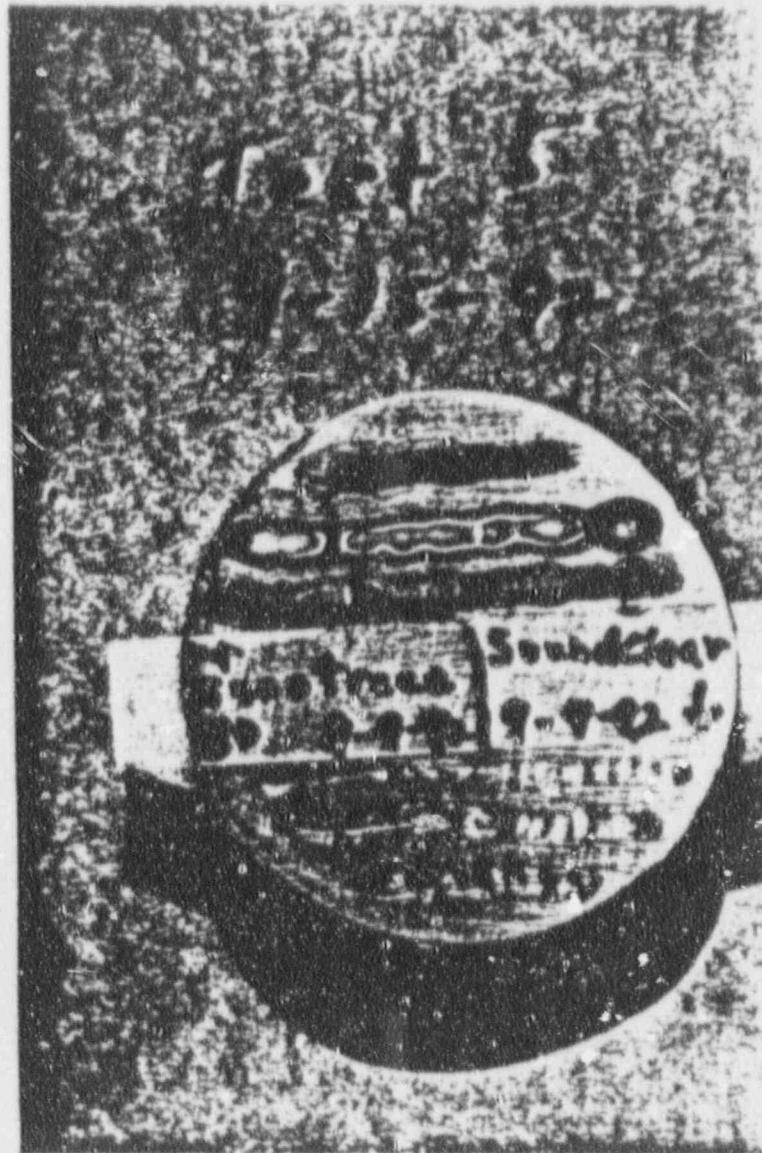
Test 5 - Sonotrace 30 and Soundclear - See Photo 10

- a) Sonotrace 30
Top bead - brownish discoloration
- b) Middle bead - yellow-brown to brown discoloration
- c) Bottom bead - yellow-brown to brown discoloration

- a) Soundclear
No indication of any surface attack.

Photo 10 -
Test 5
after 6
days

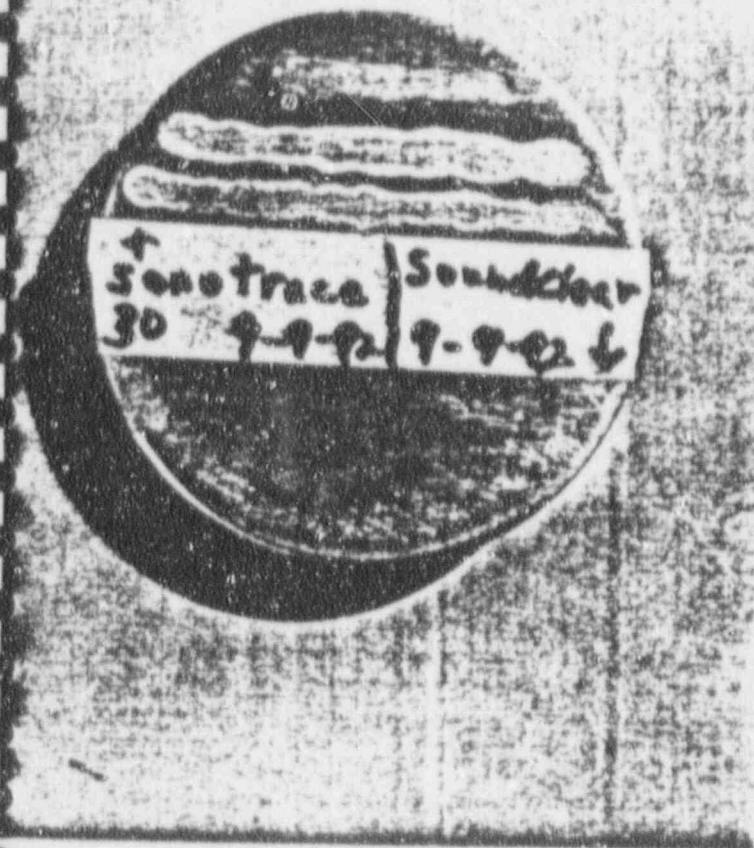
Test 5 - Sonotrace 30 and Soundclear - See Photo 11

Sonotrace 30 -

- a) Top bead - A visible surface attack with the deepest attack along the edge.
- b) Middle bead - A very visible surface attack with the deepest attack along the edge.
- c) Bottom bead - A very visible surface attack with the deepest attack along the edge.

Soundclear - No indication of any surface attack.

Photo 11 -
Test 5
Steel surface
after removal
of couplants

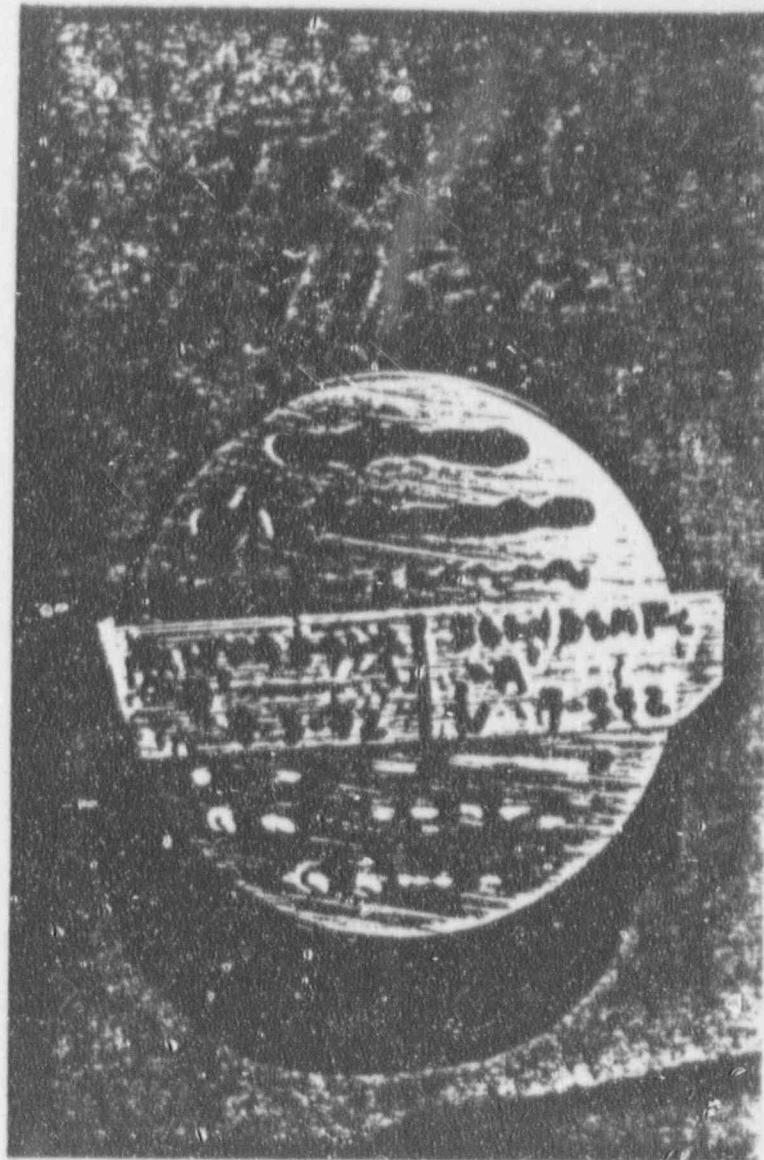
Test 6 - Ultragel II and Soundsafe - See Photo 14

- a) Ultragel II
Top bead - brownish discoloration
- b) Top bead - brownish discoloration
- c) Bottom bead - brownish discoloration
- Soundsafe - No indication of any surface attack

Photo 14 -
Test 6
after 12 days

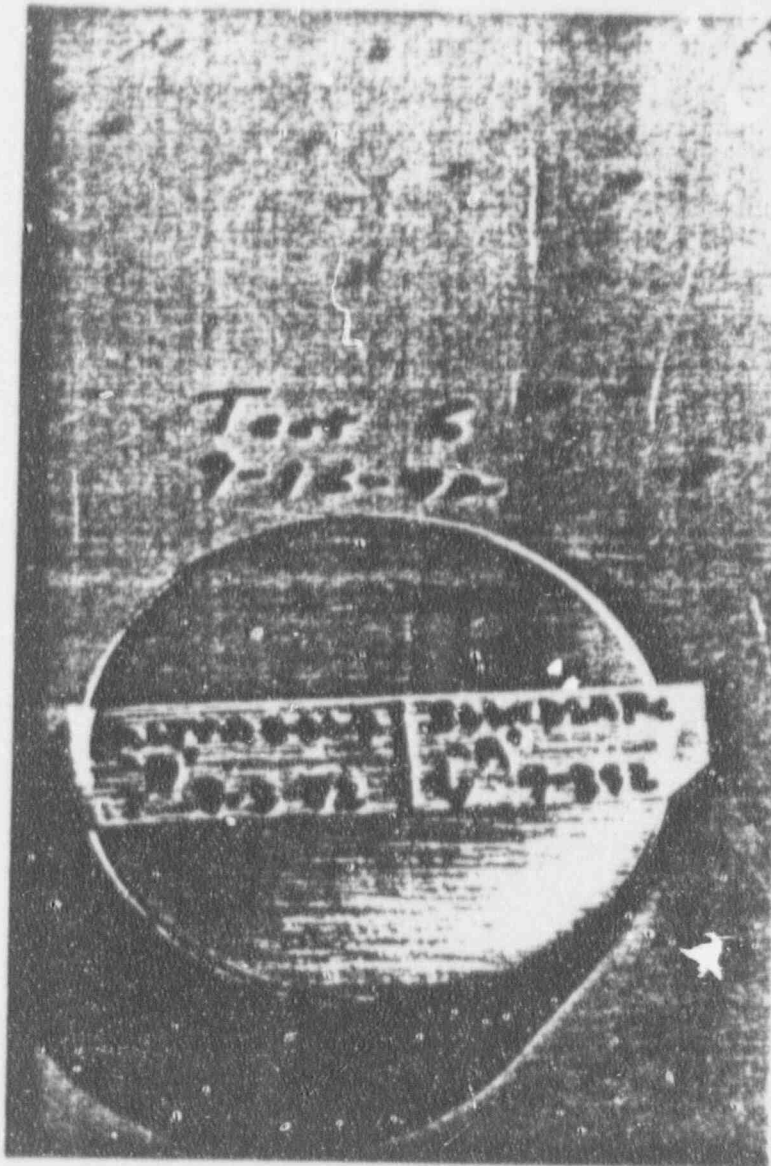
Test 6 - Ultragel II and Soundsafe

Ultragel II -

- a) Top bead - A visible surface attack with some deeper attack along the edge.
- b) Middle bead - a visible surface attack with a small amount of deeper attack along the edge.
- c) Bottom bead - A barely visible surface attack.

Soundsafe - No indication of any surface attack.

Photo 15
Test 6
Steel surface
after removal
of couplants
