ENGINEERING EVALUATION REPORT

HUMAN FACTORS ASPECTS OF BOILING WATER REACTOR
REACTIVITY MANAGEMENT EVENTS DURING POWER OPERATIONS

FEBRUARY 1993

Unit:	Multiple	Report No.:	AEOD/E93-01
Docket No:	Multiple	Date:	February 22, 1993
Licensee:	Multiple	AEOD Contact:	J. Kauffman
NSSS/AE:	Multiple		
Event Dates:	Multiple

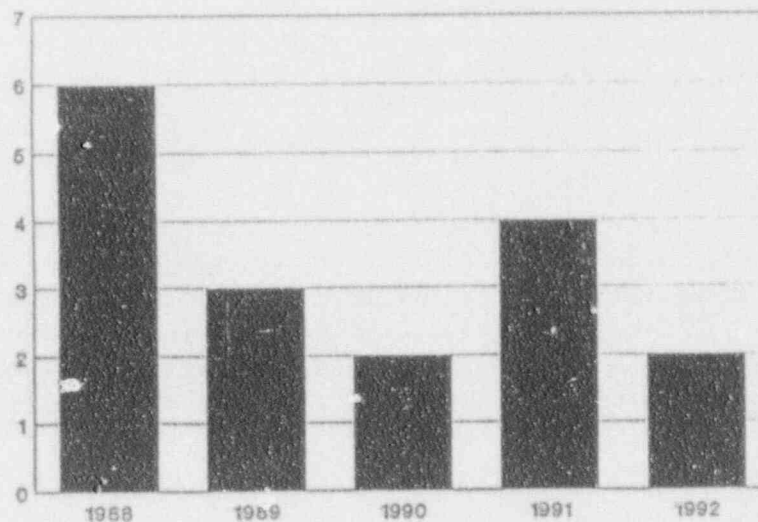
Figure 1 BWR Reactivity Events

From 1988 to 1989 there was a perceptible drop in the number of BWR reactivity events. From 1989 to present there was no discernible trend. No plant was identified as an outlier.

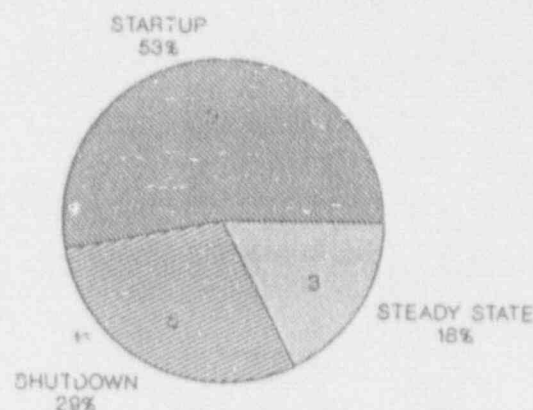
Figure 2 BWR Reactivity Events by Activity

Over half of the reactivity events occurred during startup, and about 30 percent occurred during plant shutdowns. Only 18 percent occurred during steady state operation at high power.

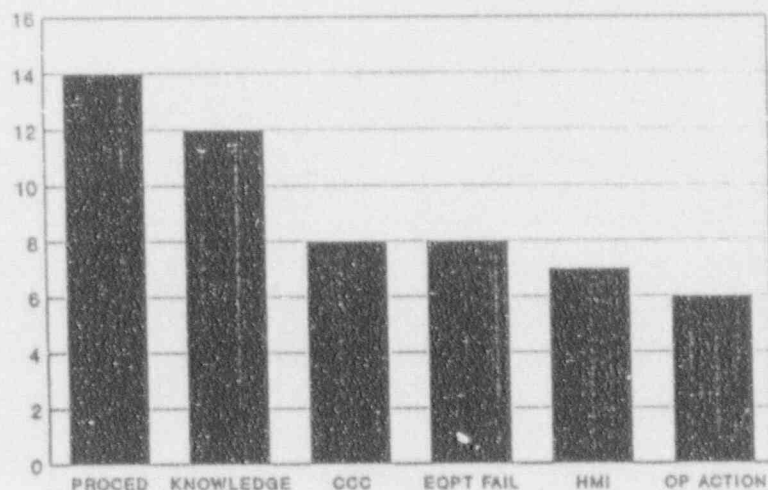
Figure 3 BWR Reactivity Events HF/Equipment Causes
(Some events-multiple causes)

Every event had human factors aspects, while less than half of the events involved equipment failure.

The human performance weaknesses were in: (1) procedures, (2) operator knowledge, (3) command, control and communications, (4) human-machine interface, and (5) impromptu operator actions.

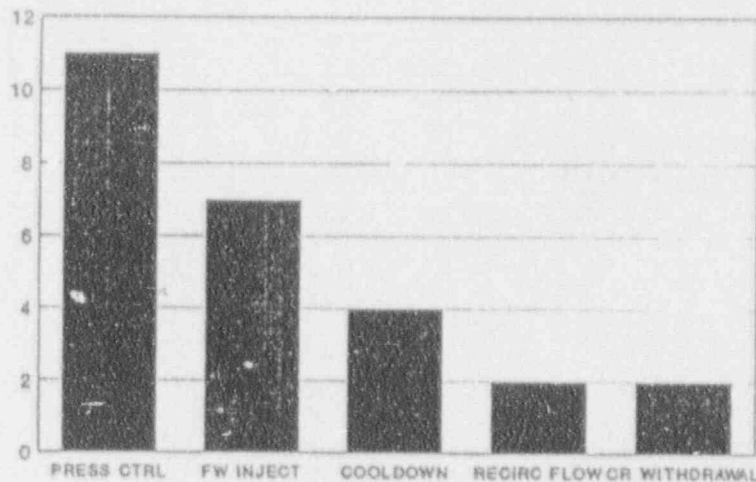
Figure 4 BWR Reactivity Insertion
Physical Causes
(Some events-multiple causes)

The physical causes of reactivity insertion events were: (1) pressure transients, (2) cold FW injection, (3) plant cooldown, (4) recirculation flow increase, and (5) control rod withdrawal.
