U.S. NUCLEAR REGULATORY COMMISSION
REGION I

Report No. 93-02

Facility: Vermont Yankee Nuclear Power Station
Vernon, Vermont

Inspection Period: January 3 - February 5, 1993

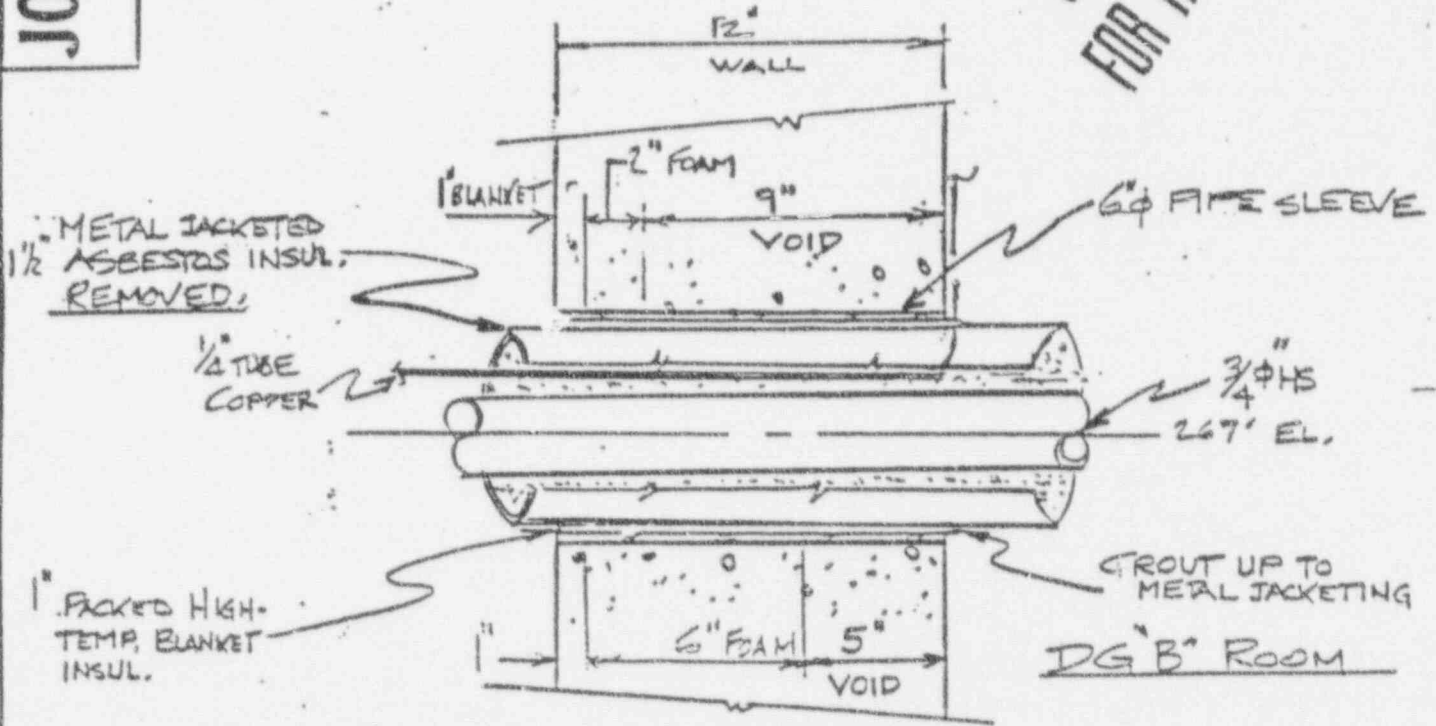
SECTION "A-A"
ELEVATION

LINE No. 3/4 HS
DESIGN TEMP 320°
OPERATING TEMP. 292°
PIPE MAT. C.S.
