THE INTERIM EQUIPMENT AND PROCEDURES AT
BROWNS FERRY TO DETECT WATER IN THE SCRAM DISCHARGE VOLUME

OFFICE FOR ANALYSIS AND EVALUATION OF

September 1980

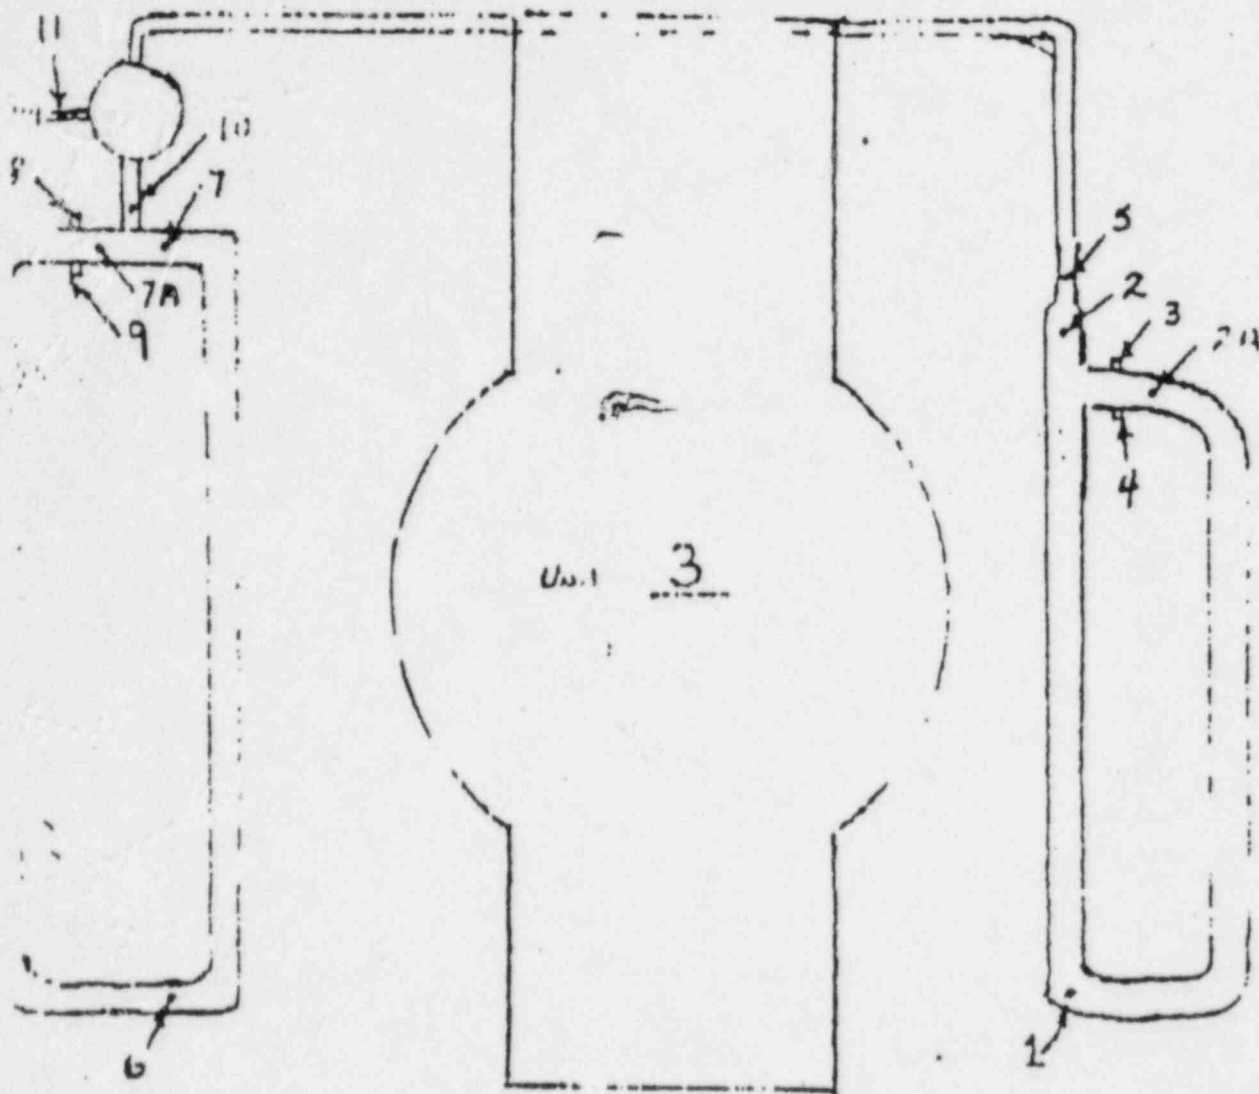
Figure 1 Unit-3 Transducer Location

Unit 3 has eleven transducers located as shown in Figure 1. Units 1 and 2 each have four transducers located as shown in Figures 2 and 3. Unit 3 was instrumented to a greater extent to attempt to find the cause of the June 28, 1980, partial scram event. Since completing the testing of SDV drainage, long-term monitoring has been limited to use of transducers #2 and #7 on Unit 3; transducers #12 and #13 on Unit 2; and transducers #14 and #15 on Unit 1. In the case of failure of these transducers, a backup transducer is available on each header. The transducers are bonded to the headers with a high temperature adhesive.

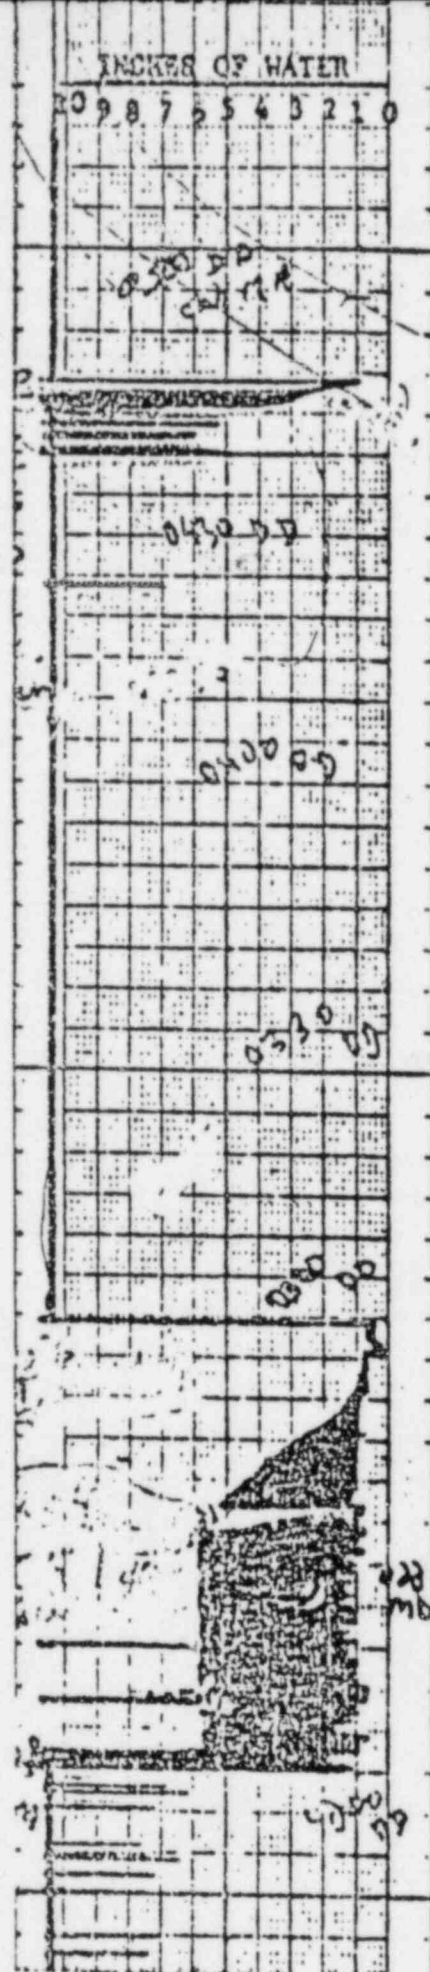
UNIT 2 SCRAM
7/26/80

5 Performing Surveillance
Instructions, Turbulent Water
in Headers at 0440
