SUBJECT: OPERATING REACTORS EVENTS BRIEFING
FEBRUARY 10, 1993 - BRIEFING 93-05

OPERATING REACTORS EVENTS BRIEFING 93-05

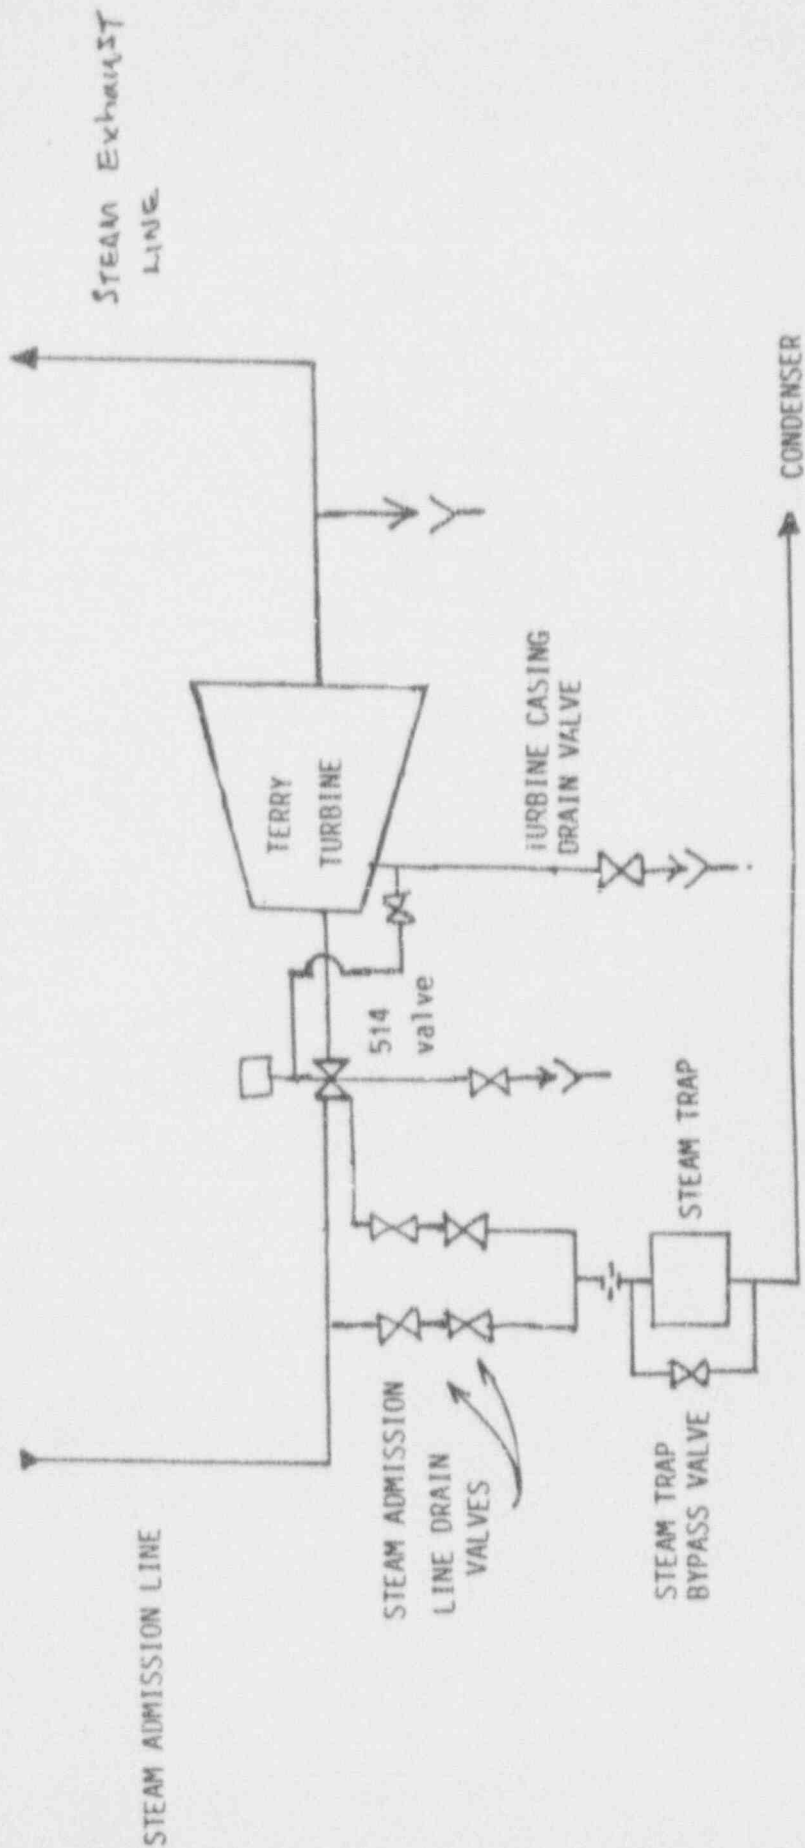
TURBINE STEAM SUPPLY AND EXHAUST SYSTEM
TURBINE DRIVEN AUXILIARY FEEDWATER PUMP

SOUTH TEXAS PROJECT, UNITS 1 & 2 TURBINE DRIVEN AUXILIARY FEEDWATER PUMPS (TDAFP) TRIPPED SEVERAL TIMES ON OVERSPEED FROM THE END OF DECEMBER 1992 THROUGH JANUARY 1993.

- INADEQUATE PREVENTIVE AND CORRECTIVE MAINTENANCE PRACTICES, INADEQUATE ROOT CAUSE ANALYSIS, INADEQUATE MANAGEMENT OF DESIGN AND CONFIGURATION CONTROL.
- PRESENCE OF FOREIGN MATERIAL IN THE UNIT 1 TDAFP TURBINE EXHAUST STACK DRAIN LINE.

- ON FEBRUARY 1, 1993, TDAFP WAS DECLARED INOPERABLE FOLLOWING A TRIP ON OVERSPEED THAT OCCURRED DURING AN OPERABILITY SURVEILLANCE TEST. IT APPEARS THAT THE ROOT CAUSE OF THE OVERSPEED TRIP WAS:

- MISADJUSTMENT OF GOVERNOR VALVE CAUSED THE VALVE TO BE SLIGHTLY OPEN.
 - COORDINATION BETWEEN THE OPENING TIME OF THE TRIP/THROTTLE VALVE AND THE GOVERNOR VALVE CAUSED A MARGINAL SITUATION FOR AN OVERSPEED.

- A POSSIBILITY OF EXCESSIVE CONDENSATE UPSTREAM OF THE TRIP/THROTTLE VALVE.
 - EXCESSIVE LEAKAGE PAST THE TRIP/THROTTLE VALVE FURTHER REDUCED THE MARGIN BETWEEN THE TURBINE START AND AN OVERSPEED TRIP.

- THE MOST PROBABLE ROOT CAUSE OF THIS OVERSPEED TRIP HAS BEEN INVESTIGATED. IT WAS CAUSED BY A WATER SLUG INTO THE TURBINE DUE TO A CONDENSATE BUILD-UP UPSTREAM OF THE TRIP/THROTTLE (514) VALVE. THE BUILD-UP WAS CAUSED BY CLOSING OF THE STEAM LINE DRAIN STEAM TRAP BYPASS VALVE IN COMBINATION WITH AN INOPERABLE STEAM TRAP. BUT SEVERAL CAUSES APPEAR TO BE SIMILAR TO THOSE ON THE UNIT 1 TDAFP.

- THE LICENSEE HAS DETERMINED THAT:
 - THE TRIP AND THROTTLE VALVE WAS LEAKING AT ABOUT ONE HALF THE RATE OF THE STP1 TDAFP VALVE. (ABOUT 20 GALLONS PER HOUR).

- THE TRIP AND THROTTLE VALVE FOR BOTH UNITS HAVE BEEN REMOVED, LEAK TESTED AND REFURBISHED BY THE VENDOR.
