## LICENSEE EVENT REPORT (LER)

FACILITY NAME (1)  
Fort St. Vrain, Unit No. 1DOCKET NUMBER (2)  
0 5 0 0 0 2 6 1 7  
PAGE (3)  
1 OF 0 1 7TITLE (4)  
Loop I Automatic Shutdown Initiated By Plant Protective SystemEVENT DATE (5)  
MONTH DAY YEAR  
0 6 0 3 8 5  
LER NUMBER (6)  
YEAR SEQUENTIAL NUMBER REVISION NUMBER  
8 5 - 0 0 9 - 0 0 0  
REPORT DATE (7)  
MONTH DAY YEAR  
0 7 0 3 8 5  
OTHER FACILITIES INVOLVED (8)  
FACILITY NAMES  
N/A  
DOCKET NUMBER(S)  
0 5 0 0 0THIS REPORT IS SUBMITTED PURSUANT TO THE REQUIREMENTS OF 10 CFR §: (Check one or more of the following) (11)  
OPERATING MODE (9)  
N  
POWER LEVEL (10)  
0 1 0 0

An automatic Loop 1 shutdown was initiated by the plant protective system (PPS) at approximately 1247 hours on June 3, 1985. Since Loop 2 was already in the shutdown state at the time of the Loop 1 shutdown, a short term Loss Of Forced Circulation (LOFC) occurred. The reactor was shut down and depressurized, with decay heat being removed by "B" helium circulator and Loop 1 steam generator operating on condensate. The core temperature rise during the LOFC was small since the reactor had been shut down for an extended period for maintenance, and did not appro

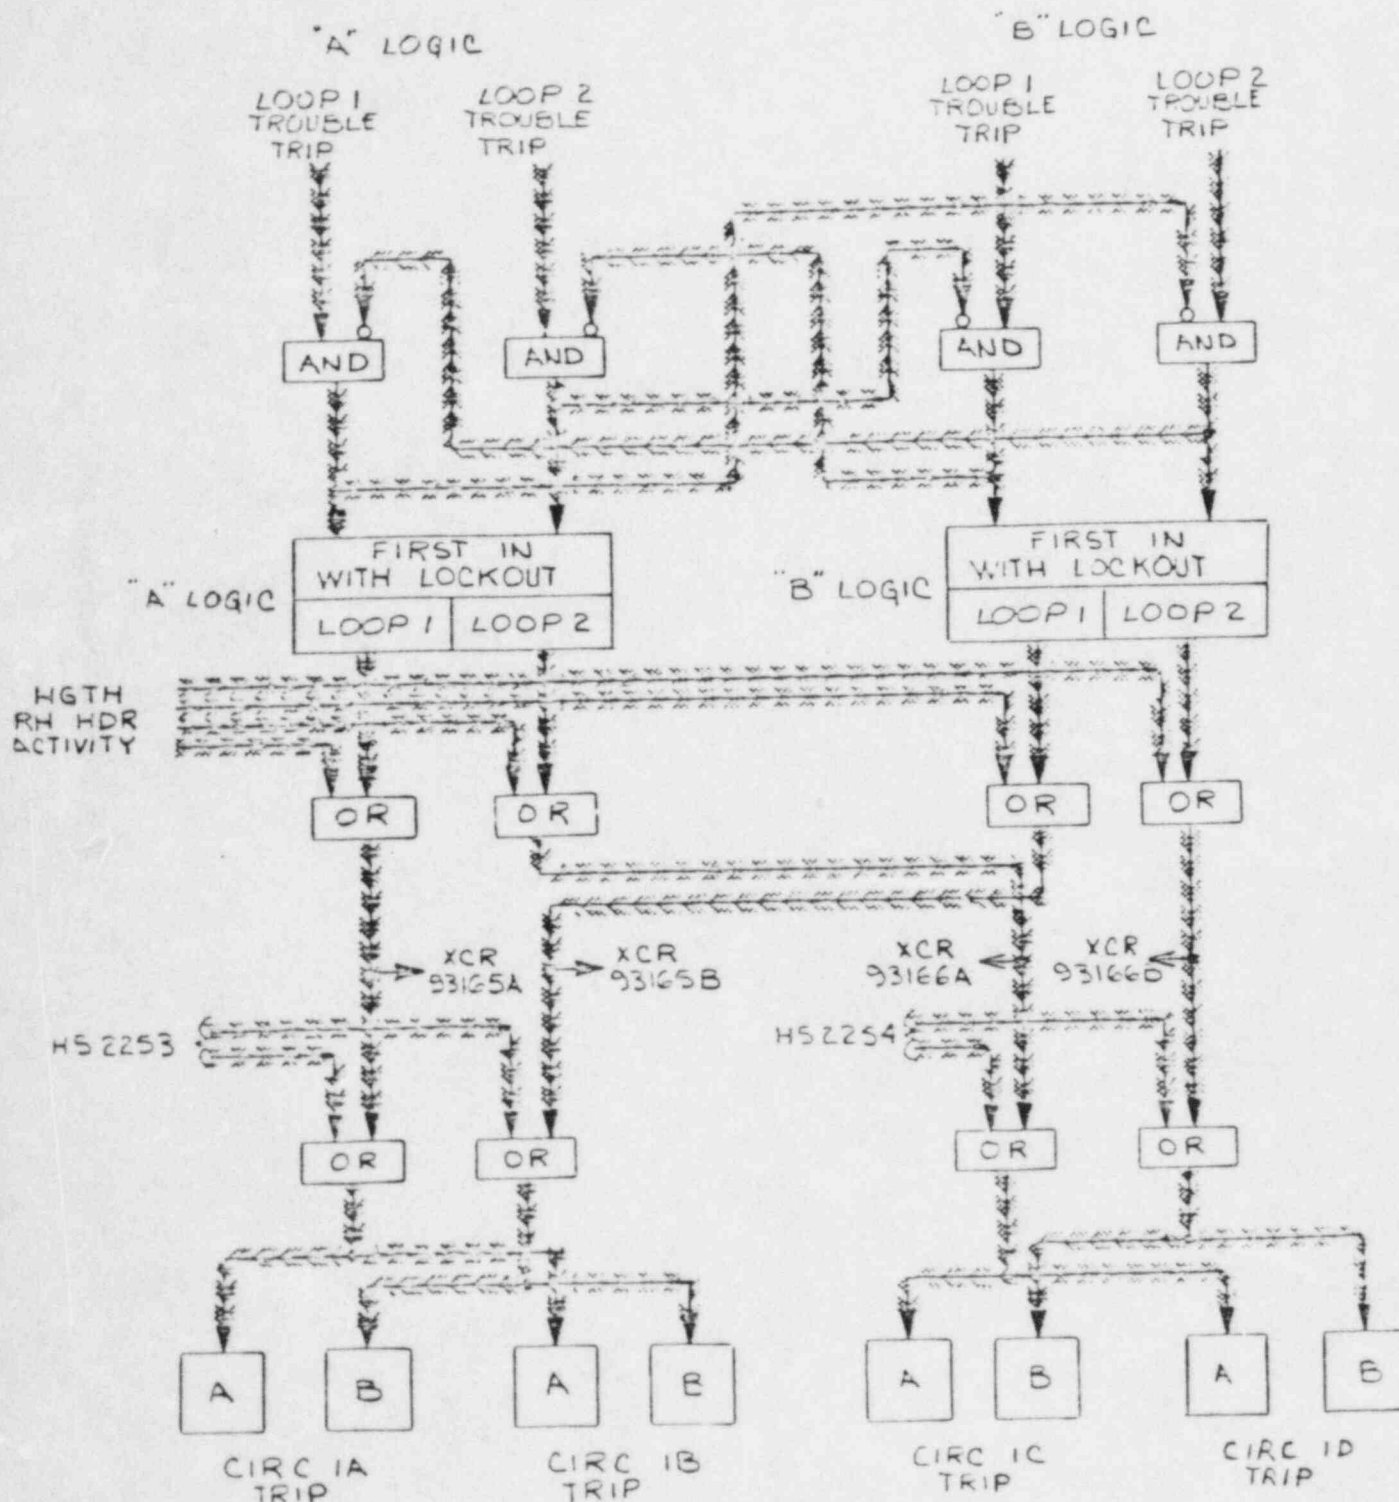
FIGURE 3

Further testing however, showed that two intermodular connections between the two-loop trouble (TLT) logic modules TLT-1A and TLT-1B were shorted. Since these connections are responsible for maintaining the first-in-with-lockout function, this short is the probable cause of the Loop 1 shutdown not being inhibited. This connection was repaired and further testing was conducted in attempts to duplicate the June 3, 1985 event. The event could not be duplicated.

The probable cause of the Loop 1 shutdown not being inhibited was a short in two intermodular connections between TLT logic modules A and B (Figure 3), which cleared the lockout signal from Loop 2.

The blown DC power supply fuse has been replaced and the intermodular connections have been repaired.
