Northern States Power Company

MONTICELLO NUCLEAR GENERATING PLANT
Docket No. 50-263 License No. DPR-22

LER 96-009

Failure to Perform the Required Actions within One Hour
Following the Discovery of Water in a Fire Hydrant Barrel

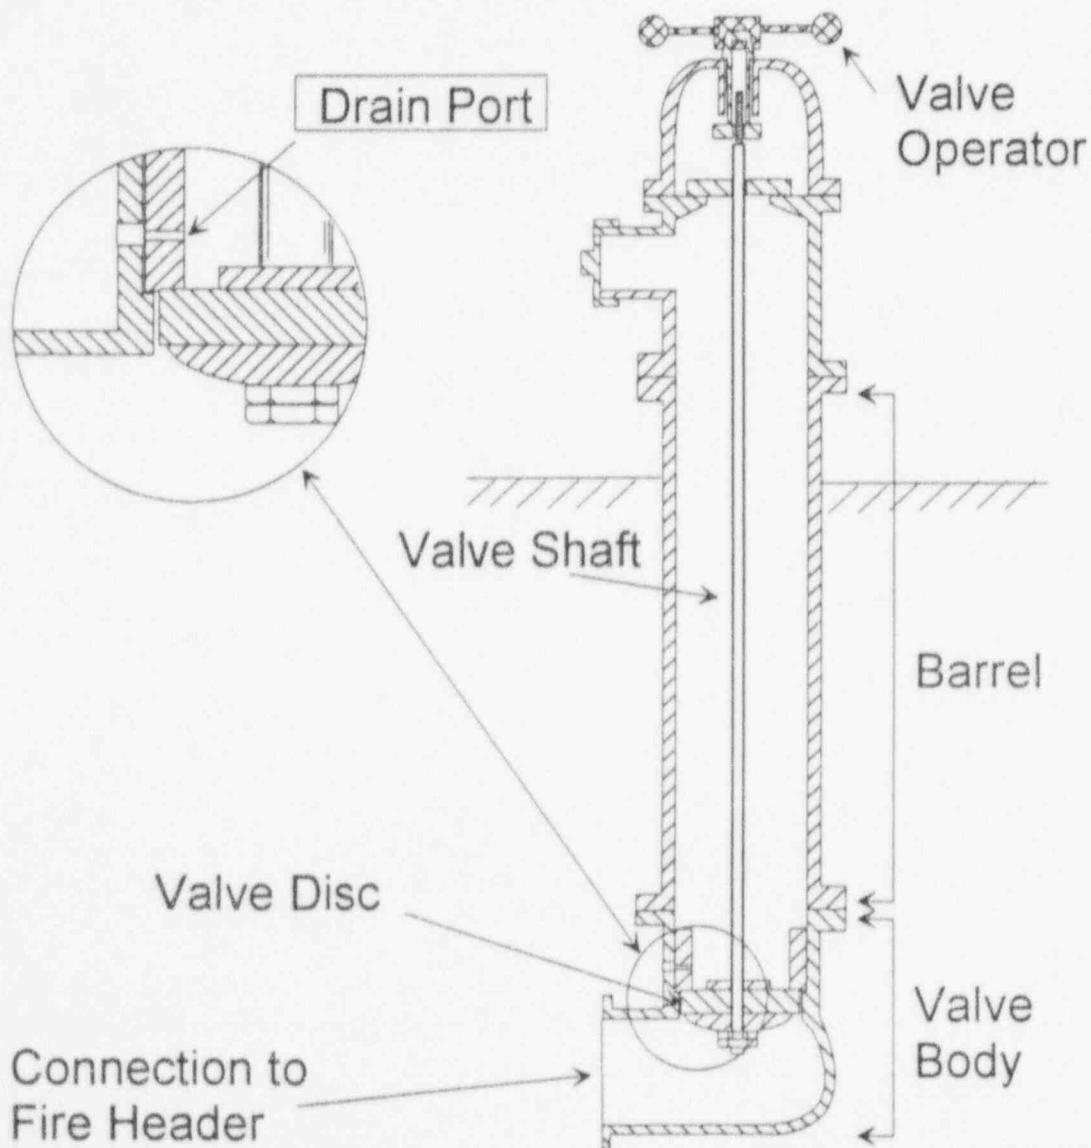
YARD FIRE HYDRANT

The fire hydrant barrel provides a hydraulic connection from the fire main to the hydrant itself and also passes the mechanical operator for the valve (see attached figure). The barrel is normally dry. To use the hydrant, the valve operator opens the valve supplying water to the barrel and the hydrant. This fills the barrel with water and it remains full of water during use. After use, the valve is closed, and the water drains through a drain port to the ground surrounding the barrel. If the water does not drain, the ability of the fire hydrant to perform its function is unaffected, provided the water is not allowed to freeze.

The cause of the failure of the water to drain from the hydrant barrel was drain hole plugging in the valve body, located below the ground. Carbon steel corrosion byproduct debris was obstructing drainage.

The hydrant was excavated and the drain port was cleaned. The hydrant was declared operable on October 6, 1996.

The water was pumped out of the fire hydrant barrel and the drain port was repaired under work orders 9602567 and 9602627.

The preventive maintenance program for the yard fire hydrants will be reviewed for changes to minimize drain port plugging.
