LICENSEE EVENT REPORT (LER)

FACILITY NAME (1)
Trojan Nuclear Plant

TITLE (4)
Penetration Failed Containment Local Leak Rate Test

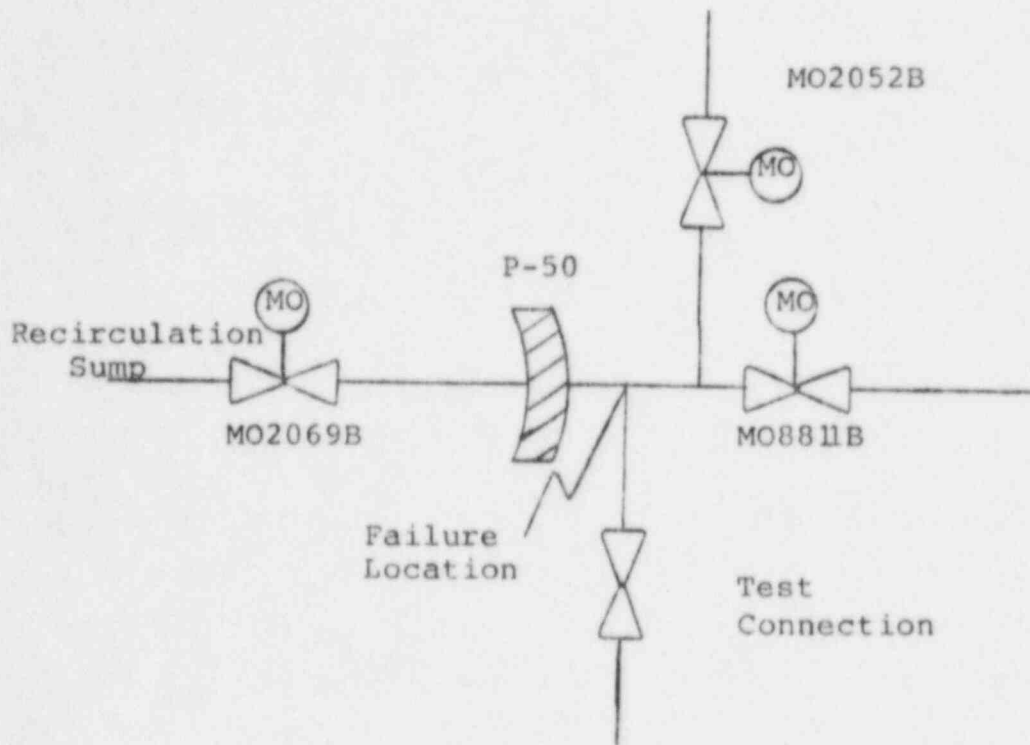
Figure 1

On June 1, 1985, the plant was in a maintenance and refueling outage with the core unloaded and scheduled outage work in progress. Containment integrity was not required to be established. Local leak rate testing was being performed on penetration P-50, the 'B' train recirculation sump suction line, in accordance with Periodic Engineering Test (PET) 5-2, "Containment Local Leak Rate Testing". During the test a 1/2-inch circumferential crack was discovered in a 3/4-inch Schedule 40 test connection pipe. The test connection (see Figure 1) is located between MO8811B and penetration P-50. The recirculation sump suction line is not in use during normal operation. During pressurization of the penetration piping to determine leakage across MO8811B, a large air leak was audibly apparent. Upon investigation, the 1/2-inch circumferential crack was discovered near the weld-base metal interface on the test connection pipe where it is welded into a socket on the 18-inch recirculation pipe. The crack had initiated on the outside diameter of the pipe.

A laboratory analysis of the failure determined that the pipe exhibited fatigue failure. The pipe failed after approximately 3800-4000 cycles.

The crack, which initiated on the outside diameter of the pipe, was in a location where the total stress from using a pipe wrench to install and remove the cap and test fittings would be the greatest. It is believed a number of cycles occurred each time the cap or test fittings were installed or removed and these accumulated cycles could have partially contributed to the failure. It is not presumed these actions, however, account for the entire 4000 cycles. Since this line is not normally in use, the cause of the majority of the cycles is unknown. For this reason, the pipe will be examined during the next refueling outage. The test connection pipe has not been modified or replaced since original plant construction.

Immediate corrective action was taken to replace the failed pipe. In addition, all similar Schedule 40 test connections have been examined using the dye penetrant method to determine if similar failures exist. No similar failures were found through these examinations or through other local leak rate tests performed. This failure appears to be an isolated case.

Additional corrective action will be taken to evaluate the method used for installing and removing the cap and test fittings on the test connection in question. If appropriate, training will be conducted and/or new tooling devised to prevent excessive force from being applied to the test connection piping. In addition, the subject pipe will be examined by the dye penetrant method during the 1986 refueling outage.
