U. S. Nuclear Regulatory Commission  
Attn: Document Control Desk  
Washington, D.C. 20555Subject: Peach Bottom Atomic Power Station, Unit 2  
Core Spray In-Vessel Piping

A/R SUBJECT: UNIT 2 MOD P00335 - CORE SPRAY DOWNCOMER REPAIRS

MOD DESCRIPTION: REPAIR OF CORE SPRAY DOWNCOMER CRACKS

Mod/Change Description: UNIT 2 CORE SPRAY DOWNCOMER  
REPAIR

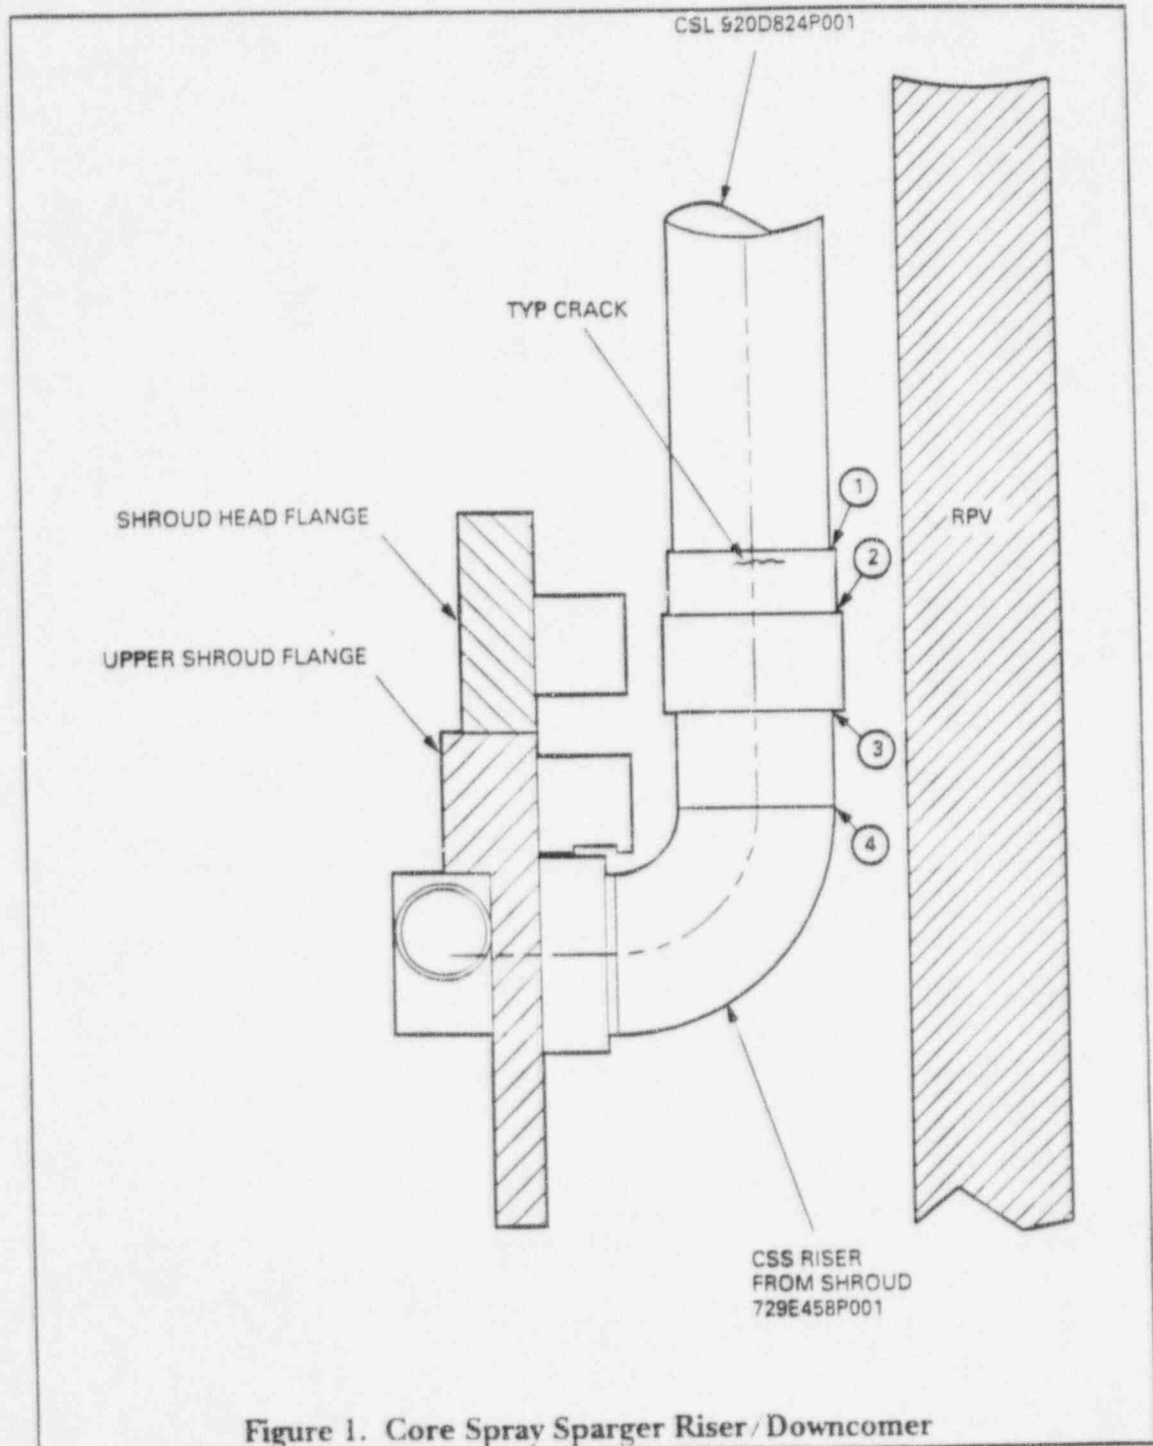
FIGURE 1

During Peach Bottom Unit 3 1993 and 1995 refueling outages (3R09 & 3R10) inspections performed in response to USNRC IE Bulletin No. 80-13, identified crack indications on all four core spray line downcomers, Reference 1. The crack indications were located in the vertical section (downcomer) of the core spray line outside the shroud but inside the Reactor Pressure Vessel (RPV) where the downcomer pipe is connected to a welded sleeve. The indications ran circumferentially in the Heat Affected Zone (HAZ) of the pipe sleeve where the sleeve is welded to the downcomer line. The location of the indications are shown in Figure 1. Repairs were affected on all four core spray line downcomers for Unit 3.

accidents are evaluated in the UFSAR. The existing core spray downcomer and repair clamps do not function to mitigate the consequences of any UFSAR event except the design basis LOCA event. No UFSAR dose calculation will be impacted by this change. For the design basis LOCA event discussed in the UFSAR, the core spray line and downcomer provide the flow path inside the RPV for the ECCS flow to the core spray spargers. Maintaining this flow path is required to ensure that core reflooding capability is maintained following the design basis LOCA. This repair design, through its restraint of the joint, ensures the integrity of the core spray downcomers, with 360 degree through-wall cracks in locations from the HAZ below weld 1 through weld 4 of Figure 1, under DBA conditions.

The design of the modification assumes the postulated cracks at location from the HAZ below weld 1 through weld 4 of Figure 1 will grow to 360 degree through wall. The installation of the downcomer repairs will limit the separation between downcomer and riser to 0.062 inch for the "B" loop downcomers and 0.041 inch for the "A" loop downcomers. This maximum separation results from the temporary cooling of the CS riser relative to the newly installed U-bolt. It is conservatively assumed that the U-bolt is still at 550 degrees F when the CSS riser is cooled to 310 degrees F, average temperature, by the injected water from the torus (240 degree F water temperature difference). After a few minutes of post LOCA core spray system injection, the riser pipe and U-bolt temperatures will reach an equilibrium. However, due to anticipated displacement of a loose spool piece of pipe in the multiple crack situation, the total width of the cracks may remain at to 0.062 inch for the "B" loop and 0.041 inch for the "A" loop.

The function of the modification is to ensure the structural integrity of the Core Spray (CS) downcomer even if cracking were to develop around the full circumference anywhere from the HAZ below weld 1 through weld 4. The proposed change adds two long clamps (similar to the clamp used for the 172.5 degree core spray line in Unit 3) to the 7.5 and 172.5 degree azimuth downcomers (Loop B) and two shorter clamps designed for the 187.5 and 352.5 degree azimuth downcomers (Loop A). The design concepts are illustrated in Figure 2. The upper clamp bears on the top of the sleeve that attaches the core spray downcomer to the core spray sparger inlet pipe. The lower clamp is centered over the inlet pipe to elbow weld joint. Separation of the clamp pairs is used to properly adjust the clamps to ensure that each of the clamps are positioned correctly over the weld areas. The primary difference between the two designs is the means by which the upper and lower clamps are separated: the long clamp design separates the pair through the use of an adjustable tie rod and the short clamp's separation is fixed. The short clamp is
