**LICENSEE EVENT REPORT (LER)**

FACILITY NAME (1) Fort St. Vrain, Unit No. 1										DOCKET NUMBER (2) 0 5 0 0 0 2 6 7										PAGE (3) 1 OF 1 2									
TITLE (4) Failure Of Diesel Generator To Close-In During Loss Of Outside Electrical Power Test SR 5.6.1b-SA																													
EVENT DATE (5)			LER NUMBER (6)					REPORT DATE (7)			OTHER FACILITIES INVOLVED (8)																		
MONTH	DAY	YEAR	YEAR		SEQUENTIAL NUMBER		REVISION NUMBER	MONTH	DAY	YEAR	FACILITY NAMES N/A										DOCKET NUMBER(S) 0 5 0 0 0								
1	2	1	8	8	4	0	1	4	0	1	0	5	1	4	8	5	0 5 0 0 0												
OPERATING MODE (9)		THIS REPORT IS SUBMITTED PURSUANT TO THE REQUIREMENTS OF 10 CFR 8: (Check one or more of the following) (11)																											
N		20.402(b)					20.408(a)					88.73a)(2)(w)					73.71b)												
POWER LEVEL (10)		0 0 0					20.408(a)(1)(i)					88.73a)(2)(w)					73.71(a)

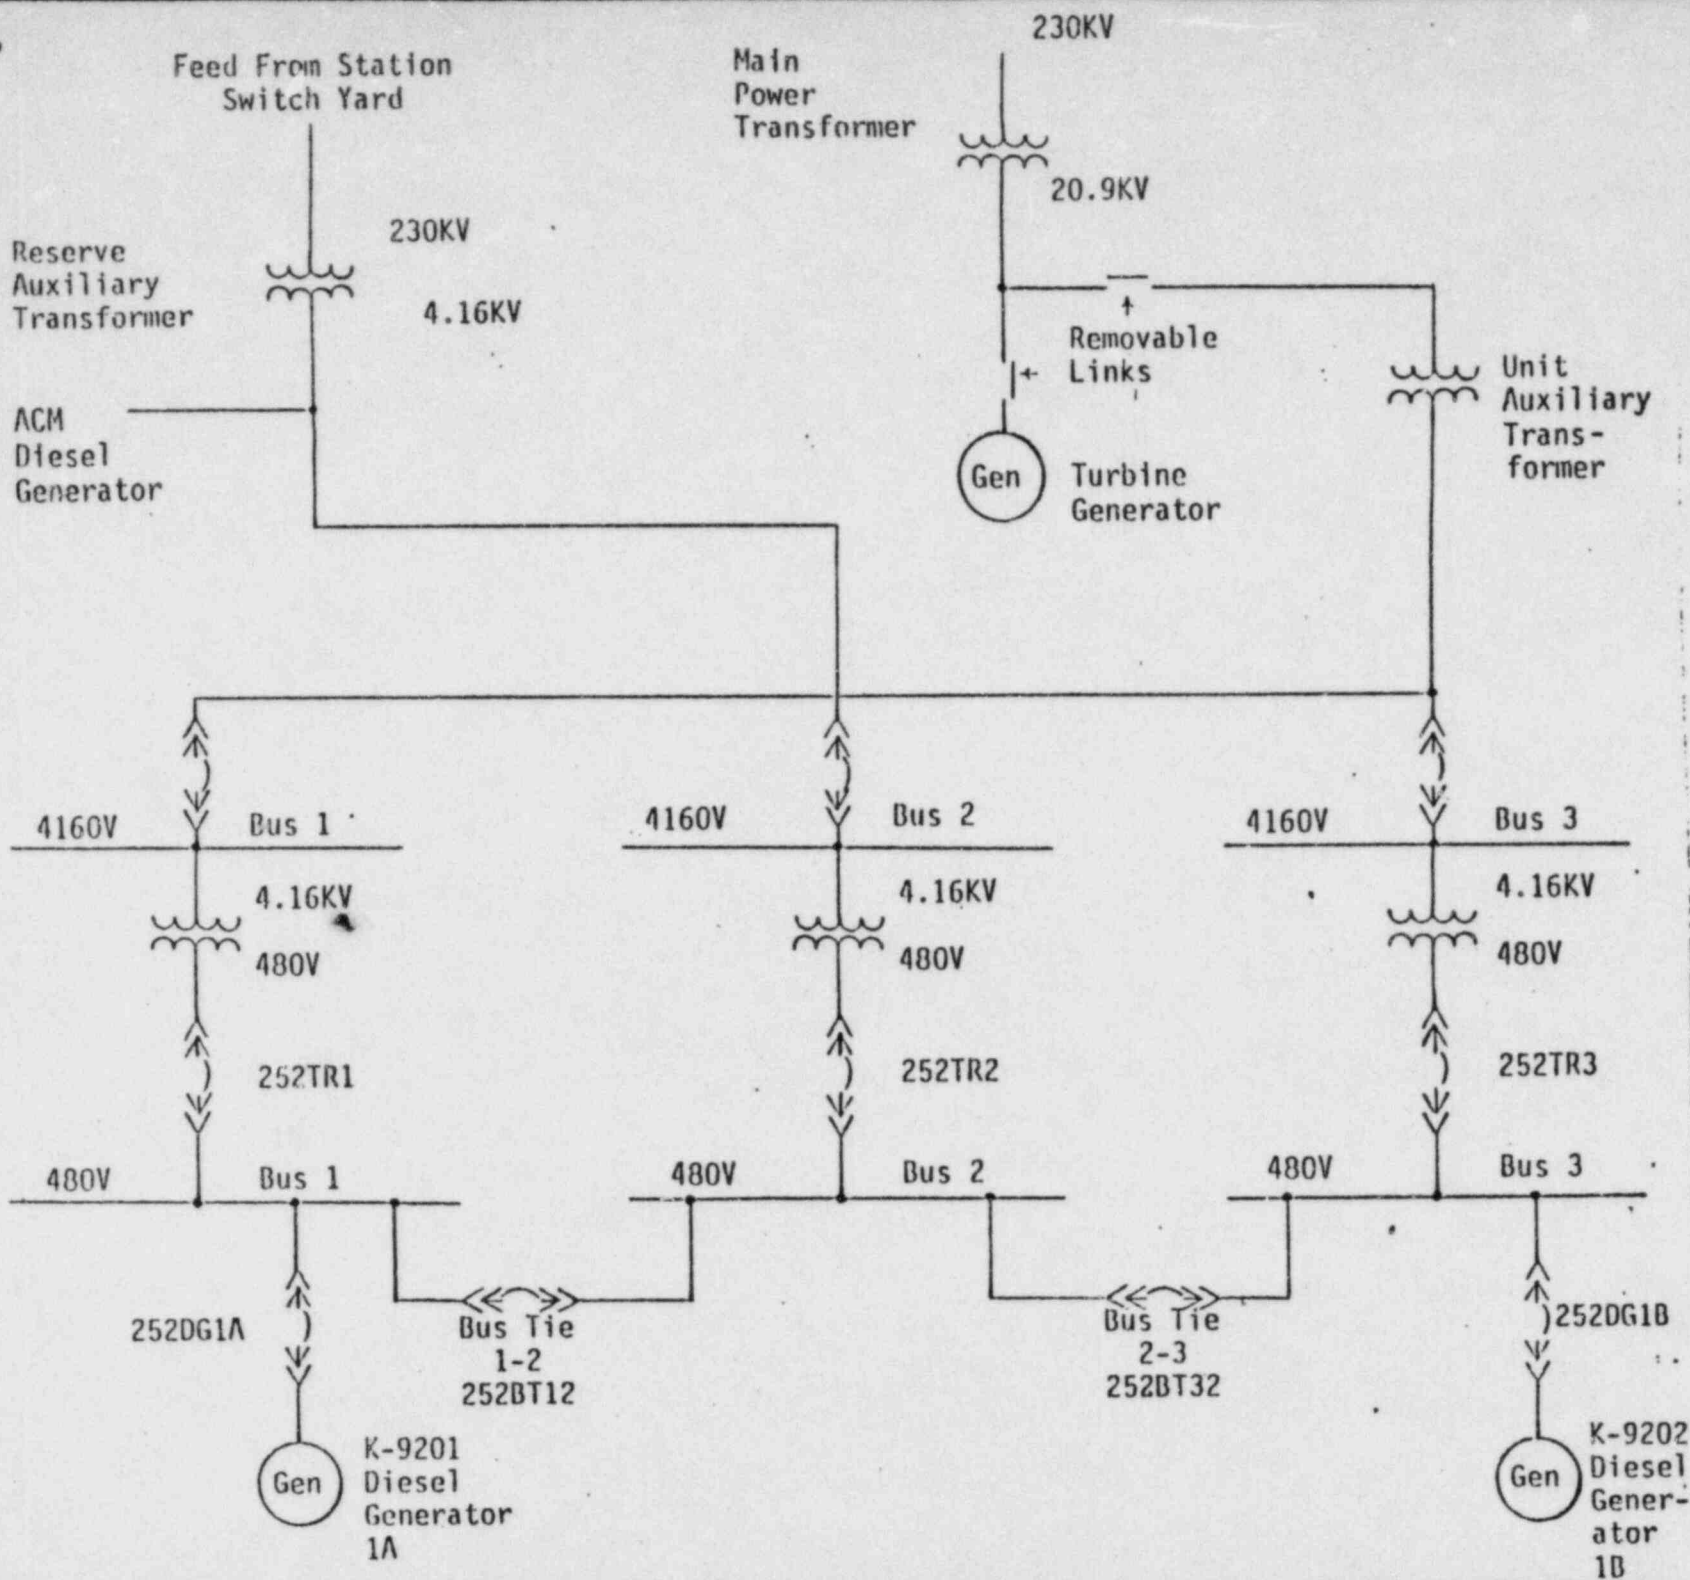
FIGURE 1

In the event that the plant should experience a total loss of power resulting from the simultaneous loss of all outside 230KV power and the tripping of the turbine generator, the two standby diesel generators (1A, K9201 and 1B, K9202) will automatically start (see Figure 1). The first normally functioning unit will be automatically selected to pick up the programmed load of essential equipment on its 480V bus (480V Bus 1 for Generator 1A and 480V Bus 3 for Generator 1B), and also the essential load on 480V Bus 2 (load sequence "A"). The second functioning unit will then be automatically tied to its 480V bus and pick up the programmed load of essential equipment for that bus (load sequence "B").

In the "Loss of Outside Power and Turbine Trip" surveillance ran on December 18, 1984, neither generator set closed onto its respective 480V bus, and power was manually restored to the 480V busses via the 4160V breakers (see Figure 1). Some difficulty was encountered restoring power to the 480V busses from the 4160V busses due to a previously identified problem with the undervoltage relay system logic preventing the 4160V breakers from closing onto a de-energized 480V bus. The problem was immediately recognized, and the fuses for the undervoltage logic power supply were pulled, allowing power to be restored to 480V busses. There is currently a Change Notice prepared to allow a manual over-ride of this logic from a handswitch to be placed at the synchroscope in the Control Room. During the test, personnel entering the diesel generator room found that both Engine 1A and 1B on generator set 1A (1) had shutdown and declutched, and that Engine 1C on generator set 1B (2) had shutdown and declutched.

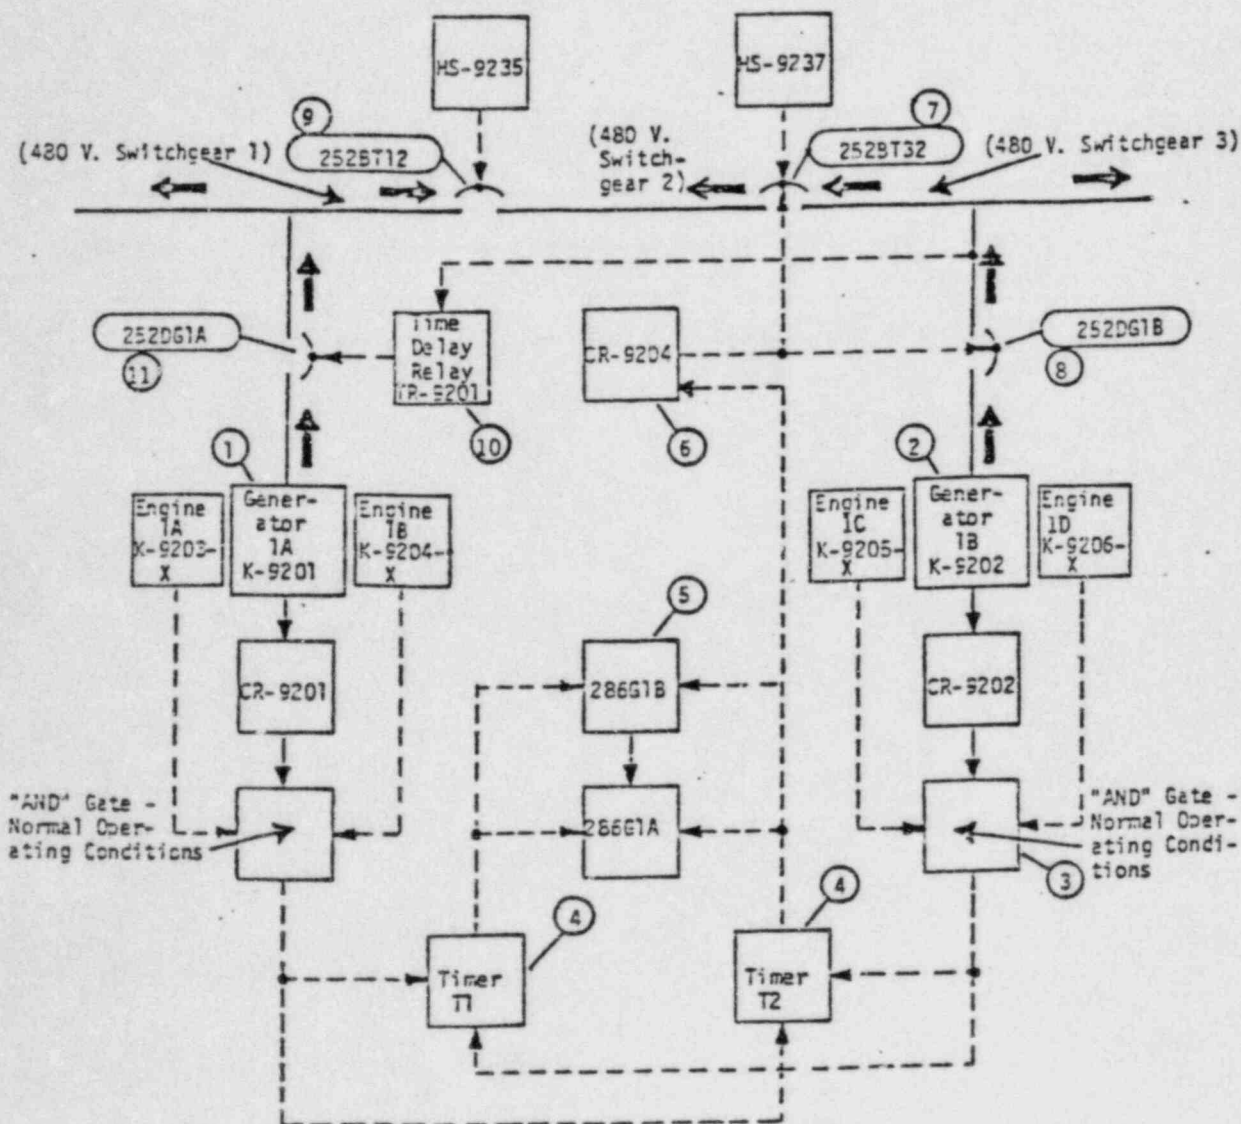
FIGURE 2

During performance of SR 5.6.1b-SA, one section of the test procedure requires that the failure of an engine to start on a generator set be simulated in order to test the proper operation of the lock-out relay logic associated with the other standby generator set. Referring to Figure 2, the test performed on December 18, 1984, simulated the failure of an engine on standby generator set 1A (1) to start. This would have then forced standby generator set 1B (2) to appear to reach normal operating conditions first, completing the logic (3) to start program sequence timers T1 and T2 (4). The "AND" gate of the logic is completed by a match on the intake manifold  $\Delta P$ 's for both engines on a generator set. On December 18, 1984, all four engines started normally, and it is believed that for set 1B, this logic should have been successfully completed to start timers T1 and T2 (4). The identical logic for generator set 1A had been intentionally disabled by lifting the wire for the "AND" gate on set 1A, thereby creating a simulated engine failure condition.

It has been subsequently determined that timer T1 was malfunctioning and that the timer's motor would not turn. Redundant timer T2 has been tested and found to operate properly and should have operated as designed; a control signal should have successfully passed through contact 286G1A (closed due to lifting the wire on 1A set), immediately followed by energizing lock out relay 286G1B (5) and control relay CR-9204 (6), closing the Bus 3-2 Tie Breaker 252BT32 (7) and generator 1B-Bus 3 breaker 252DG1B (8).

The 480V bus tie breakers, 252BT12 (9) and 252BT32 (7) would have opened automatically during load shedding (if not already opened at the time the loss of outside power occurred). The closure of generator set 1B-480V Bus 3 breaker 252DG1B (8) energizes contacts creating a permissive for generator set 1A indicating that set 1A was being selected as the second generator set and could pick up the programmed loads on 480V Bus 1. The permissive energizes TR-9201 (10), closing generator 1A-480V Bus 1 breaker 252DG1A (11) onto 480V Bus 1.

The failure of the generator set 1A 480V Bus 1 breaker (252DG1A) to close indicates that a permissive generated by CR-9204, (4) on Figure 2, was not received. However, the loss of Instrument Bus 1A could have been a factor in preventing 252DG1A (11) to close if Inverter/Static Transfer Switch 1A had tripped on low output voltage very early in the test. That trip would have removed the 120V AC instrument power supply required to power the logic for generator set 1A to be automatically selected as the second operating set and automatically tie onto 480V Bus 1.

Redundant timer  $T_1$  was removed from service, its motor rebuilt, and subsequently restored to service.
