UNITED STATES
NUCLEAR REGULATORY COMMISSION
REGION III
799 ROOSEVELT ROAD
GLEN ELLYN, ILLINOIS 60137

Docket No. 50-454

Rupture Disk on OA Boiling Acid Evaporator

Rupture Disk Failure

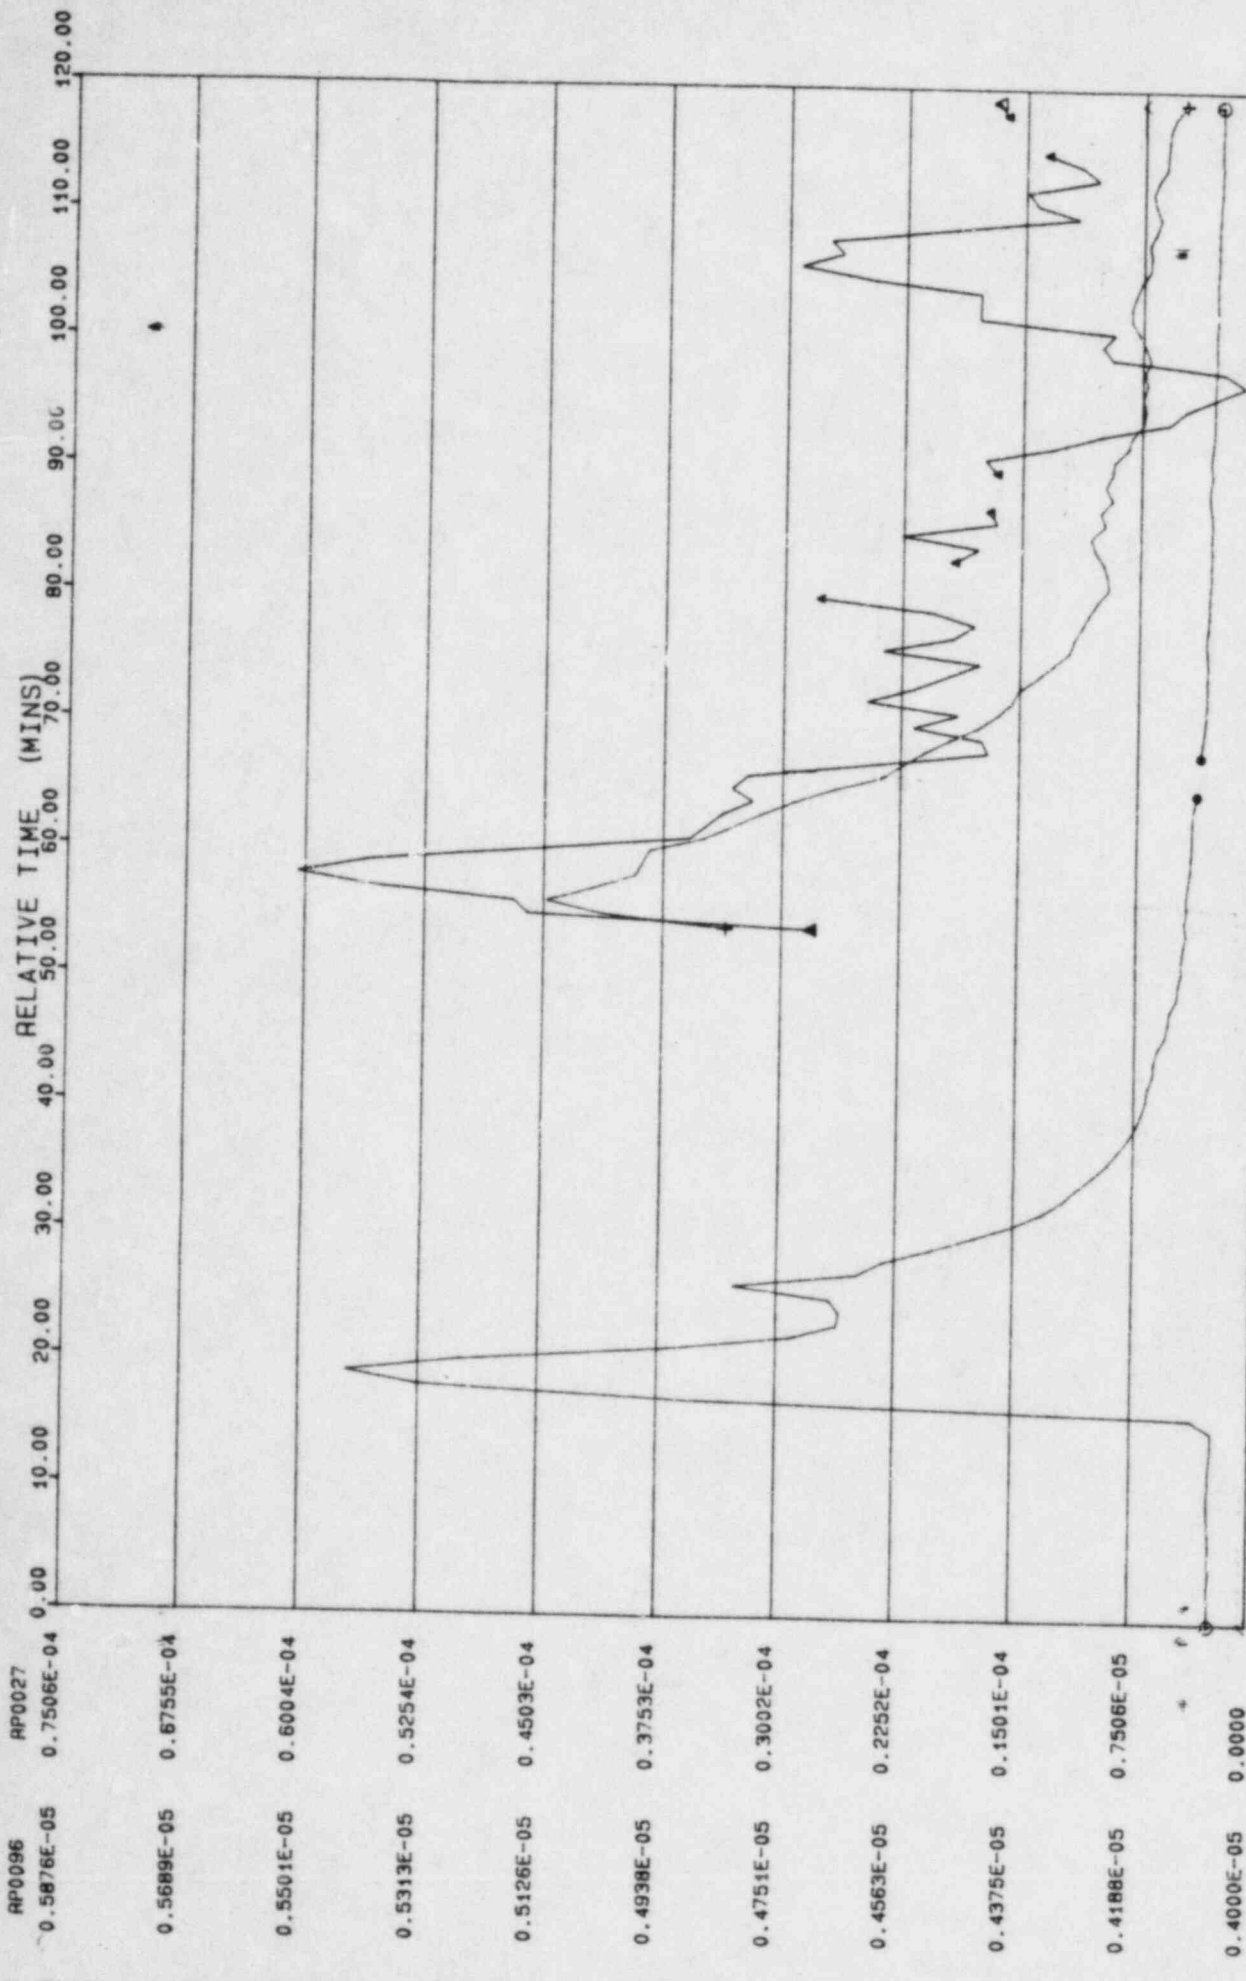
BYRON UNIT 1

During the AB Evaporator event of 4-10-85, the Aux. Bldg. Exhaust OB process radiation monitor (gas channel) went into high radiation alarm at 1314 and remained in high alarm until 1332. The alert alarm cleared at 1338, and detector readings decreased below alarm setpoints.

During this period of time, the Unit-1 and Unit-2 Aux. Bldg. Vent Stack Monitors (1RE-PRO28B and 2RE-PRO28B) were checked for noticeable increases; no increasing activity readings were noted. At 1359 an Aux. Bldg. Exhaust and Supply Fan was turned on to provide a flowpath for the radioactive gas on the 346' elevation of the Aux. Bldg. At this time, no significant increases attributable to the radioactive gas from the 346' elevation were noted on the gas channels of either the Unit-1 or Unit-2 Auxiliary Bldg. Vent Stack Monitors. It was initially thought that all radioactivity was filtered and diluted to a point that ~~small~~ resulted in no detectable activity at the Aux. Bldg. Vent Stack monitors. After the event, a further review of data from the gas channels of the Aux. Bldg. Vent Stack monitors showed that a slight increase had taken place on both 1RE-PRO28B (U-1 ventstack gas channel) and 2RE-PRO28B (U-2 vent stack gas channel) between the times of 1350 and 1410. No alarms were received on either vent stack monitor during the event.

POINT ID	DESCRIPTION	UNITS	SYMBOL
RP0027	AUX BLDG EXH CB - GAS	UCI/ML	⊙
RP0096	AUX BLDG 1 VENT STACK GAS LO	UCI/ML	Δ
RP0099	AUX BLDG 1 VENT WRM GAS LO	UCI/ML	+
RP0020	AUX BLDG 1 WRM GAS LO	UCI/ML	×
