**RADIOLOGIC AND ENGINEERING ASSESSMENT**

DOE ID NO.: GJ-10775-RS  
ADDRESS: 522-1/2 MORNING GLORY LANE

JUNE 1985

URANIUM MILL TAILINGS REMEDIAL ACTION PROJECT OFFICE

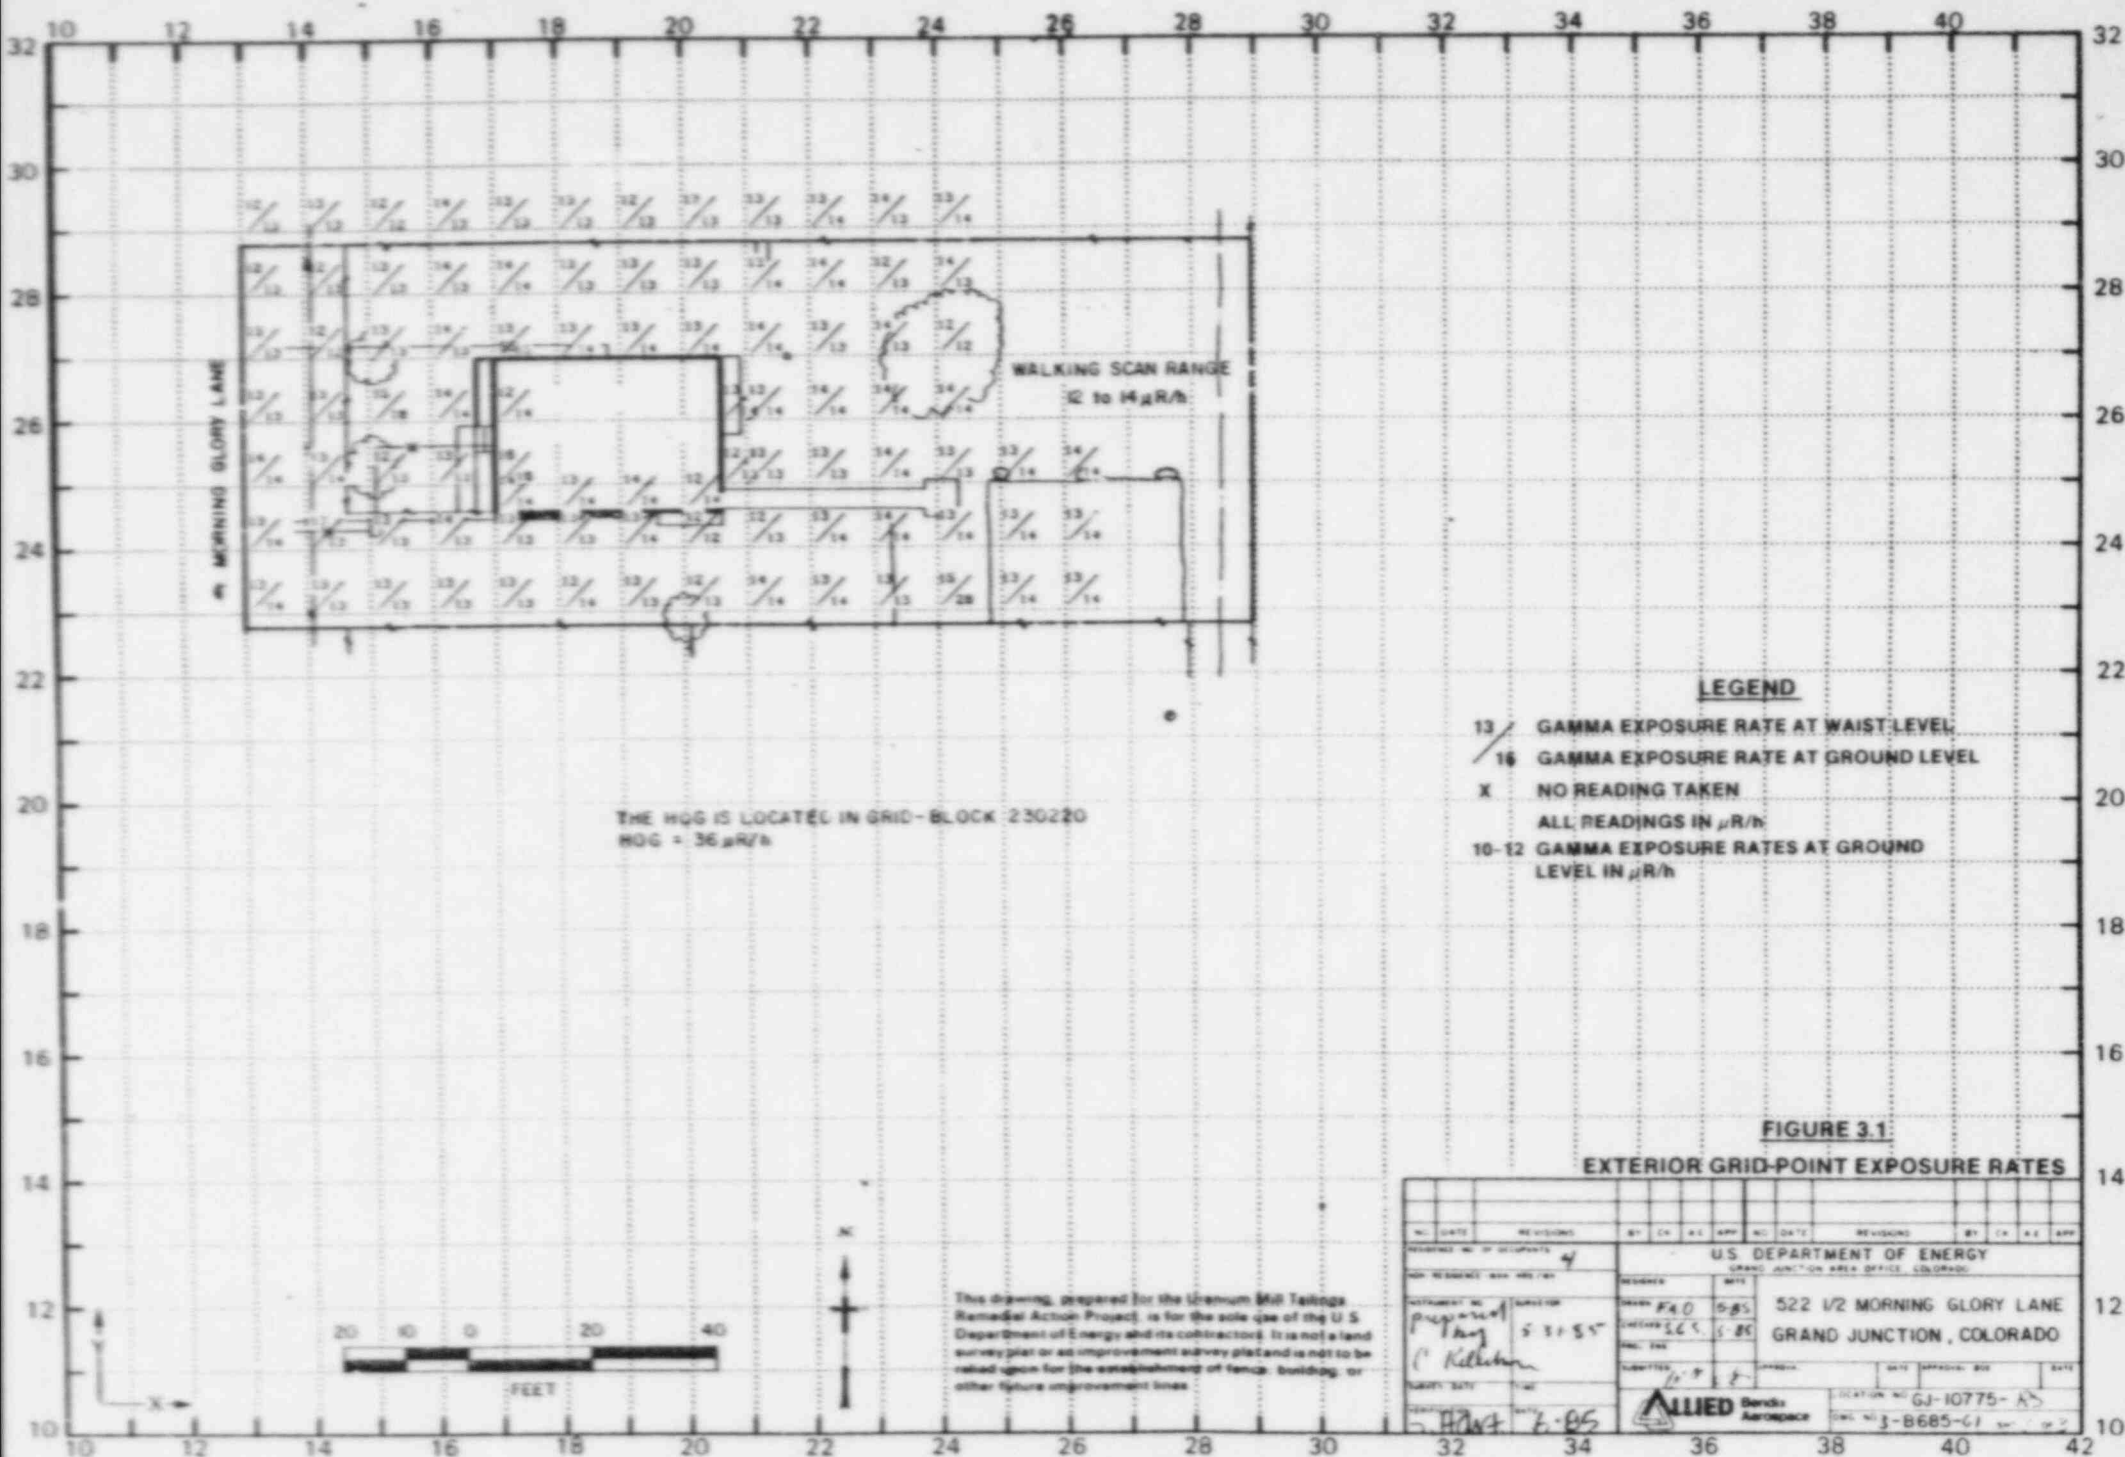
ESTIMATED EXTENT OF CONTAMINATION

Appendix Figure 3.3 shows identified areas and estimated depths of contamination on this property, based on assessments of all measurements taken. As noted in this figure, areas recommended for remedial action that contain identified residual radioactive materials are:

- (AREA A) The 4-inch-thick contaminated concrete sidewalk west of the primary structure is underlain with tailings material. The total depth of contamination is 12 inches (approximately 39 sf).
- (AREA B) The lawn adjacent to Area A is contaminated to a depth of 6 inches (approximately 13 sf).
- (AREA C) The flower bed adjacent to Area A is contaminated to an estimated depth of 6 inches, based on data collected in Area B (approximately 10 sf).
- (AREA D) A small area of the gravel driveway is contaminated to a depth of 9 inches (approximately 18 sf).
- (AREA E) The dirt along the south property line is contaminated to an estimated depth of 9 inches, based on data collected in Area D. The contamination extends under a pickup truck bed, used as a trash receptacle (approximately 75 sf).

NOTE: Area E was surveyed for possible spillover onto the adjacent property and no spillover was found. A discussion of this survey is presented in paragraph 4, page 2, of the May 29, 1985 team leader notes (contained in the Appendix of this REA).

We do not recommend decontamination and restoration of this property. It is recommended that no remedial action be performed and that a brief Property Completion Report be prepared for use in the DOE certification process.

The recommendation that no remedial action be performed on this property is made because the levels of radioactivity on this property fall below the EPA Standards (40 CFR 192):

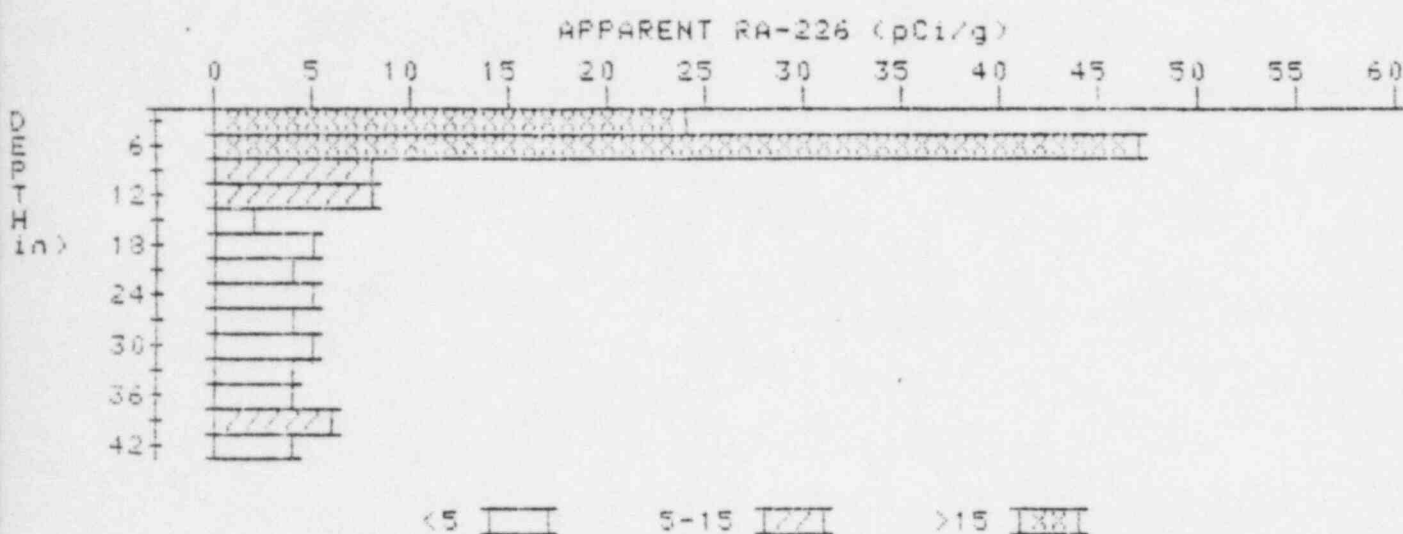
Depth (in)	Apparent Radium-226 (pCi/g) Undeconvolved	Apparent Radium-226 (pCi/g) Deconvolved
3	23.7	23.7
6	25.8	47.3
9	15.8	7.6
12	10.4	7.6
15	6.6	1.6
18	5.6	4.9
21	5.0	4.5
24	4.7	4.7
27	4.4	3.7
30	4.5	4.7
33	4.5	4.3
36	4.6	4.4
39	4.8	6.0
42	4.3	4.3

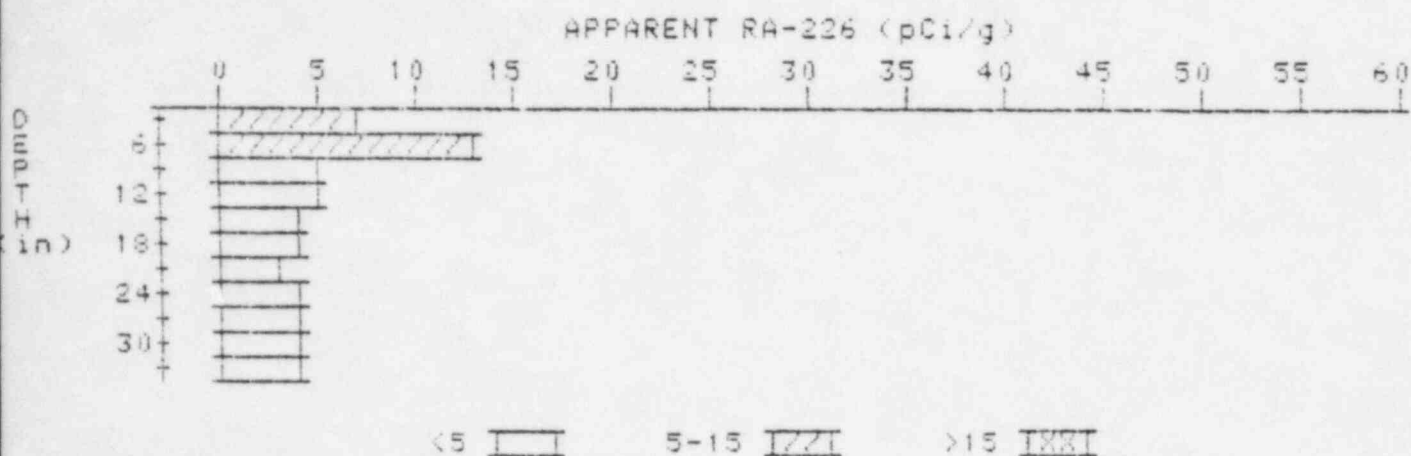
8

Depth (in)	Apparent Radium-226 (pCi/g) Undeconvolved	Apparent Radium-226 (pCi/g) Deconvolved
3	6.9	6.9
6	7.9	12.7
9	6.2	5.0
12	5.2	4.7
15	4.5	3.6
18	4.3	4.5
21	4.0	3.3
24	4.1	4.5
27	4.0	3.6
30	4.1	4.1
33	4.2	4.2
