LICENSEE EVENT REPORT (LER)

FACILITY NAME (1) Duane Arnold Energy Center										DOCKET NUMBER (2) 0 5 0 0 0 3 3 1 1					PAGE (3) 1 OF 0 5								
TITLE (4) Indication of Weld Defects in Recirculation Piping																							
EVENT DATE (5)			LER NUMBER (6)				REPORT DATE (7)			OTHER FACILITIES INVOLVED (8)													
MONTH	DAY	YEAR	YEAR	SEQUENTIAL NUMBER	REVISION NUMBER	MONTH	DAY	YEAR	FACILITY NAMES None				DOCKET NUMBER(S) 0 5 0 0 0										
0	3	1	0	8	5	8	5	0	1	0	0	1	0	5	2	0	8	5	0	5	0	0	0
OPERATING MODE (9) N		THIS REPORT IS SUBMITTED PURSUANT TO THE REQUIREMENTS OF 10 CFR 8: (Check one or more of the following) (11)																					
POWER LEVEL (10) 0 0 0		20.402(b)				20.405(e)				50.73(a)(2)(iv)				73.71(b)

REACTOR RECIRCULATION SYSTEM
LOOP A - DUANE ARNOLD ENERGY CENTER

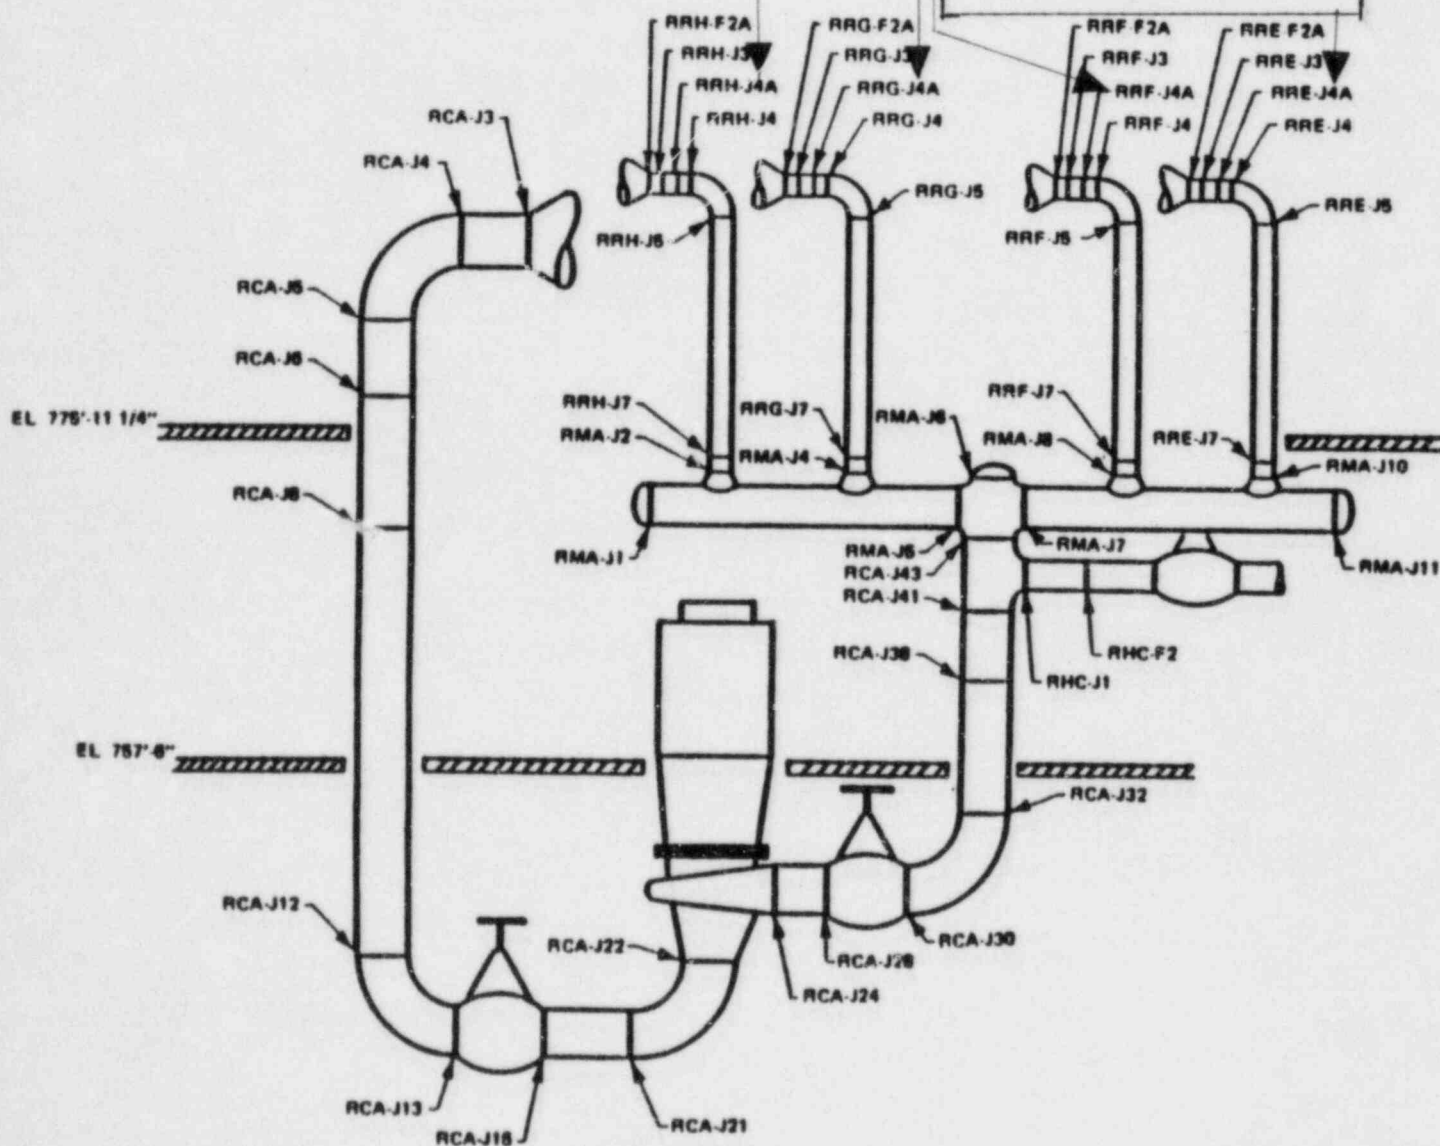
With the exception of a previously undetected lamination in the lower portion of the 'D' riser piping (assumed to be an original manufacturing defect) the defects detected in this inspection are believed to be predominately the result of Intergranular Stress Corrosion Cracking (IGSCC). It is anticipated that the treatment of remaining primary piping welds with IHSI will prevent similar development of IGSCC in other areas of the primary system. With regard to the eleven (11) welds which currently are being repaired with the weld overlay process, all work is being done to optimize long-term quality of the repair. The long-term/permanent repair plans for the affected recirculation piping welds will be extensively analyzed during Cycle 8 of DAEC operation.

Two linear circumferential indications
74% and 70.6% through wall approximately
8" and 3" long respectively.

Linear indication maximum
depth 82.5% through wall
approximately 2" long.

Linear circumferential indication
67.9% through wall 2-1/8 inches long

Linear circumferential
indication with maximum
throughwall depth 57%
3-1/8" long.

A series of repair options were evaluated including immediate full replacement of affected piping, partial replacement, and weld overlay repair of all welds. The use of weld overlays on all eleven affected welds was chosen as it permits greatest flexibility in project planning times, permits greater material acquisition lead time, and is most efficient with regard to current personnel exposure and operation considerations.
