RADIOLOGIC AND ENGINEERING ASSESSMENT

DOE ID NO.: GJ-08611-MR
ADDRESS: 204 COUNTRY CLUB PARK ROAD

JUNE 1985

BENDIX FIELD ENGINEERING CORPORATION
P.O. Box 1569
Grand Junction, Colorado 81502

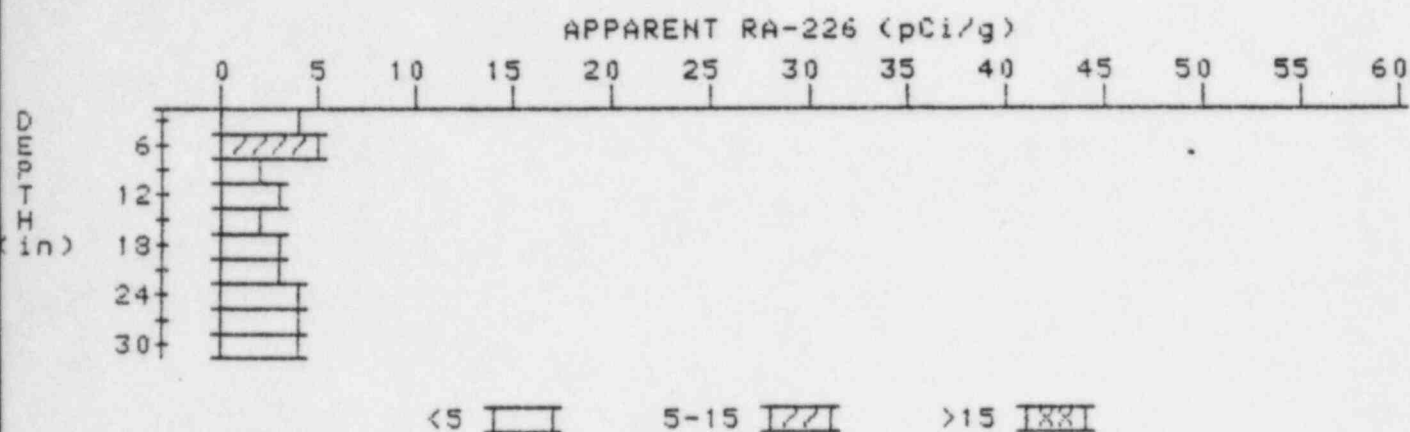
HOLE NUMBER: 1

Depth (in)	Apparent Radium-226 (pCi/g) Undeconvolved	Apparent Radium-226 (pCi/g) Deconvolved
3	7.2	7.2
6	5.5	5.3
9	3.9	1.9
12	3.4	3.2
15	3.0	2.1
18	3.1	3.1
21	3.2	3.0
24	3.4	3.6
27	3.5	3.5
30	3.6	3.6

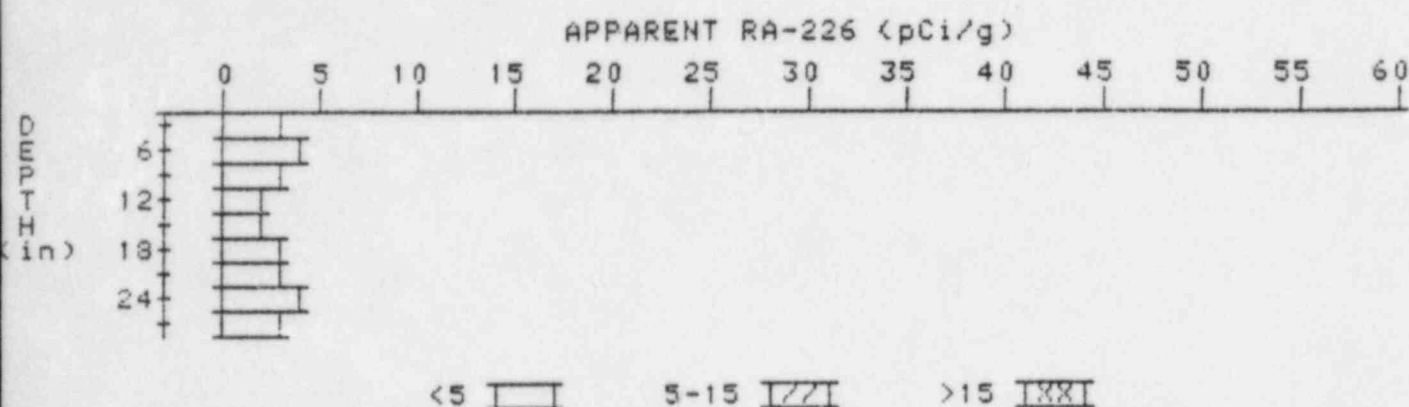
HOLE NUMBER: 12

Depth (in)	Apparent Radium-226 (pCi/g) Undeconvolved	Apparent Radium-226 (pCi/g) Deconvolved
3	5.9	5.9
6	4.6	4.1
9	3.6	2.9
12	3.0	2.3
15	2.8	2.1
18	3.0	3.2
21	3.1	2.9
24	3.3	3.7
27	3.3	3.3

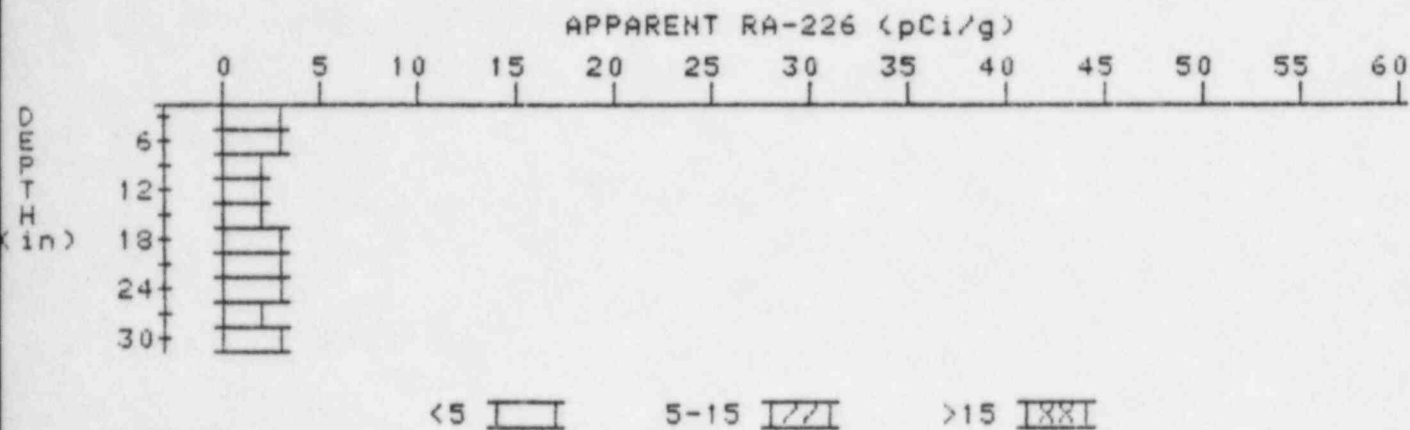
PROPERTY NUMBER: GJ-08611-MR
HOLE NUMBER: 21
LOCATION: 270170

Depth (in)	Apparent Radium-226 (pCi/g) Undeconvolved	Apparent Radium-226 (pCi/g) Deconvolved
3	2.5	2.5
6	2.5	2.7
9	2.4	2.4
12	2.3	2.1
15	2.3	1.8
18	2.6	2.6
21	2.9	3.4
24	2.9	3.1
27	2.8	2.4
30	2.9	2.9
