RADIOLOGIC AND ENGINEERING ASSESSMENT

DOE ID NO.: GJ-10751-RS
ADDRESS: 444 HILL AVENUE

JUNE 1985

BENDIX FIELD ENGINEERING CORPORATION
P.O. Box 1569
Grand Junction, Colorado 81502

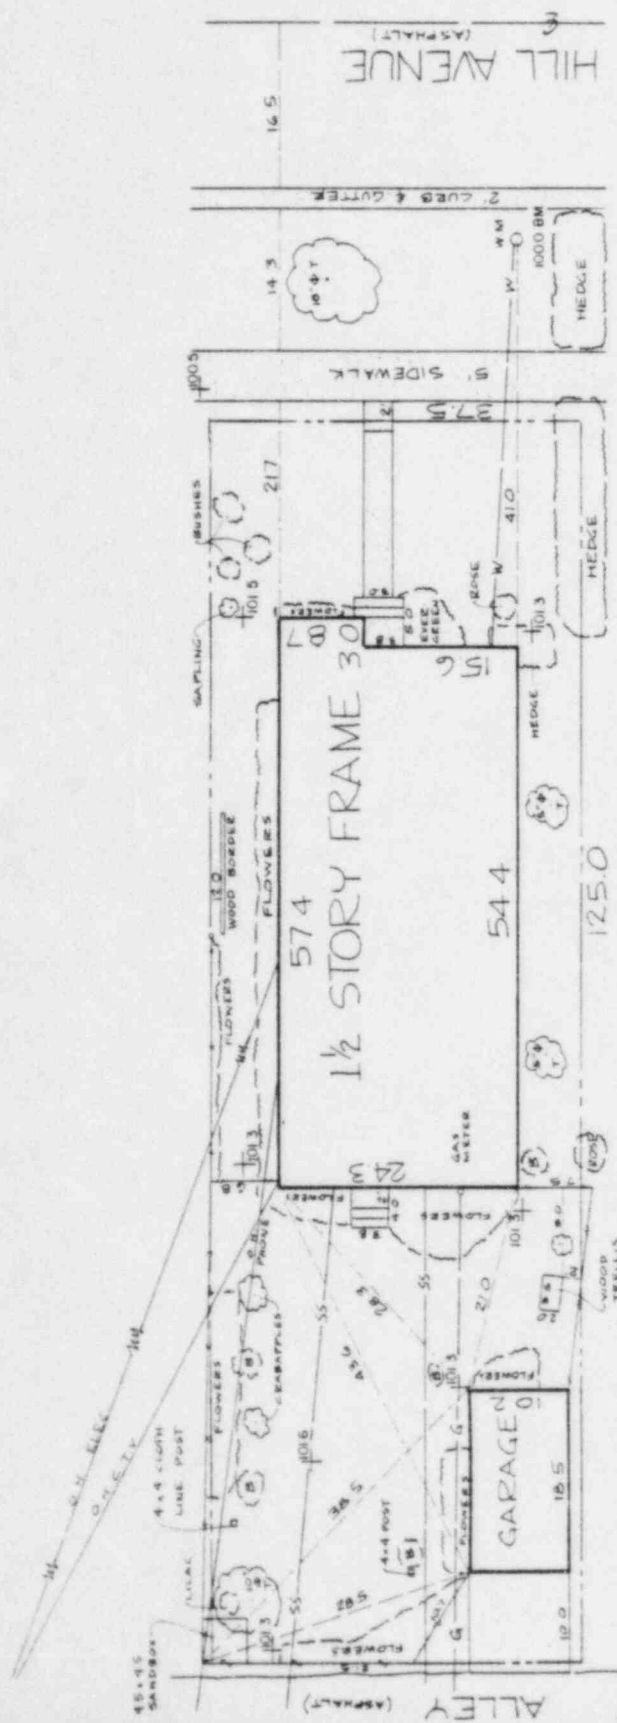
FIGURE 2.2 SITE PLAN

The front and rear yards are well landscaped. Structures, utilities, landscaping, and other special features of this property are included in Appendix Figure 2.2.

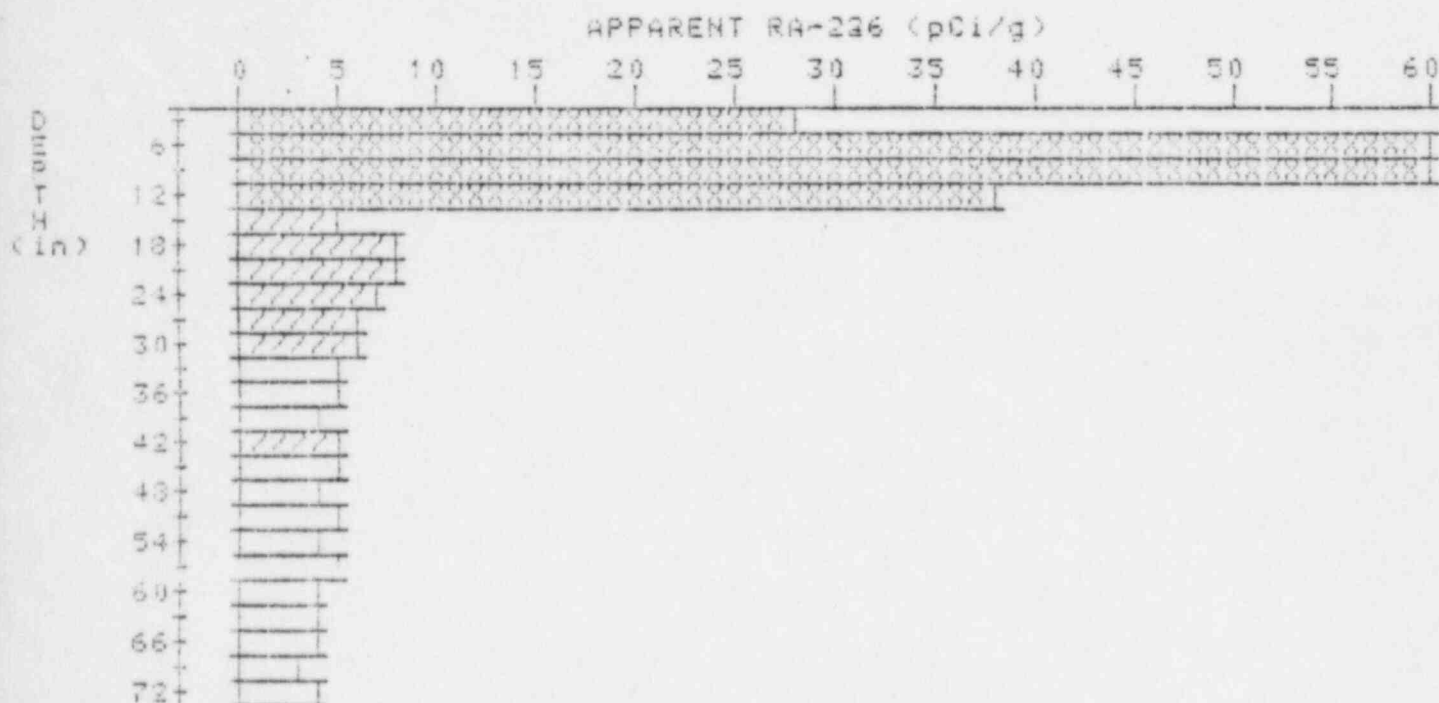
APPARENT RADIUM-226 CONCENTRATION 11 DECONVOLUTION GRAPH

Loc #	Grid Location	Depth (in.)	Meas. Type	In Situ Ra-226 (pCi/g)		Chem Ra-226 (pCi/g)	Comments
				Tot. Ct	Spectr.		
11	270247	00-05	SS			3.2	
		05-12	SS			95.2	
		03	TC	28.4		*	DC = 15 inches Based on deconvolution graph
		06	TC	47.5		*	
		09	TC	55.6		*	
		12	TC	38.5		*	
		15	TC	21.8		*	
		18	TC	14.3		*	
		21	TC	10.6		*	
		24	TC	8.5		*	
		27	TC	7.1		*	
		30	TC	6.2		*	
		33	TC	5.5		*	
		36	TC	5.1		*	
		39	TC	4.8		*	
		42	TC	4.8		*	
		45	TC	4.6		*	
		48	TC	4.4		*	
		51	TC	4.4		*	
		54	TC	4.2		*	
		57	TC	4.3		*	
		60	TC	4.2		*	
		63	TC	4.1		*	
		66	TC	4.1		*	
		69	TC	3.9		*	
		72	TC	4.0		*	
12	274265	00	DS	11.3		*	
13	275265	00	DS	3.8		*	South of walk DC = >12 inches
		06	DS	5.9		*	
		12	DS	4.1		*	
14	276242	00	DS	1.1		*	South of walk
		06	DS	1.4		*	
		12	DS	1.0		*	
		00-06	SS			1.7
