RADIOLOGIC AND ENGINEERING ASSESSMENT

DOE ID NO.: GJ-10759-RS
ADDRESS: 545 HILL AVENUE

JUNE 1985

BENDIX FIELD ENGINEERING CORPORATION
P.O. Box 1569
Grand Junction, Colorado 81502

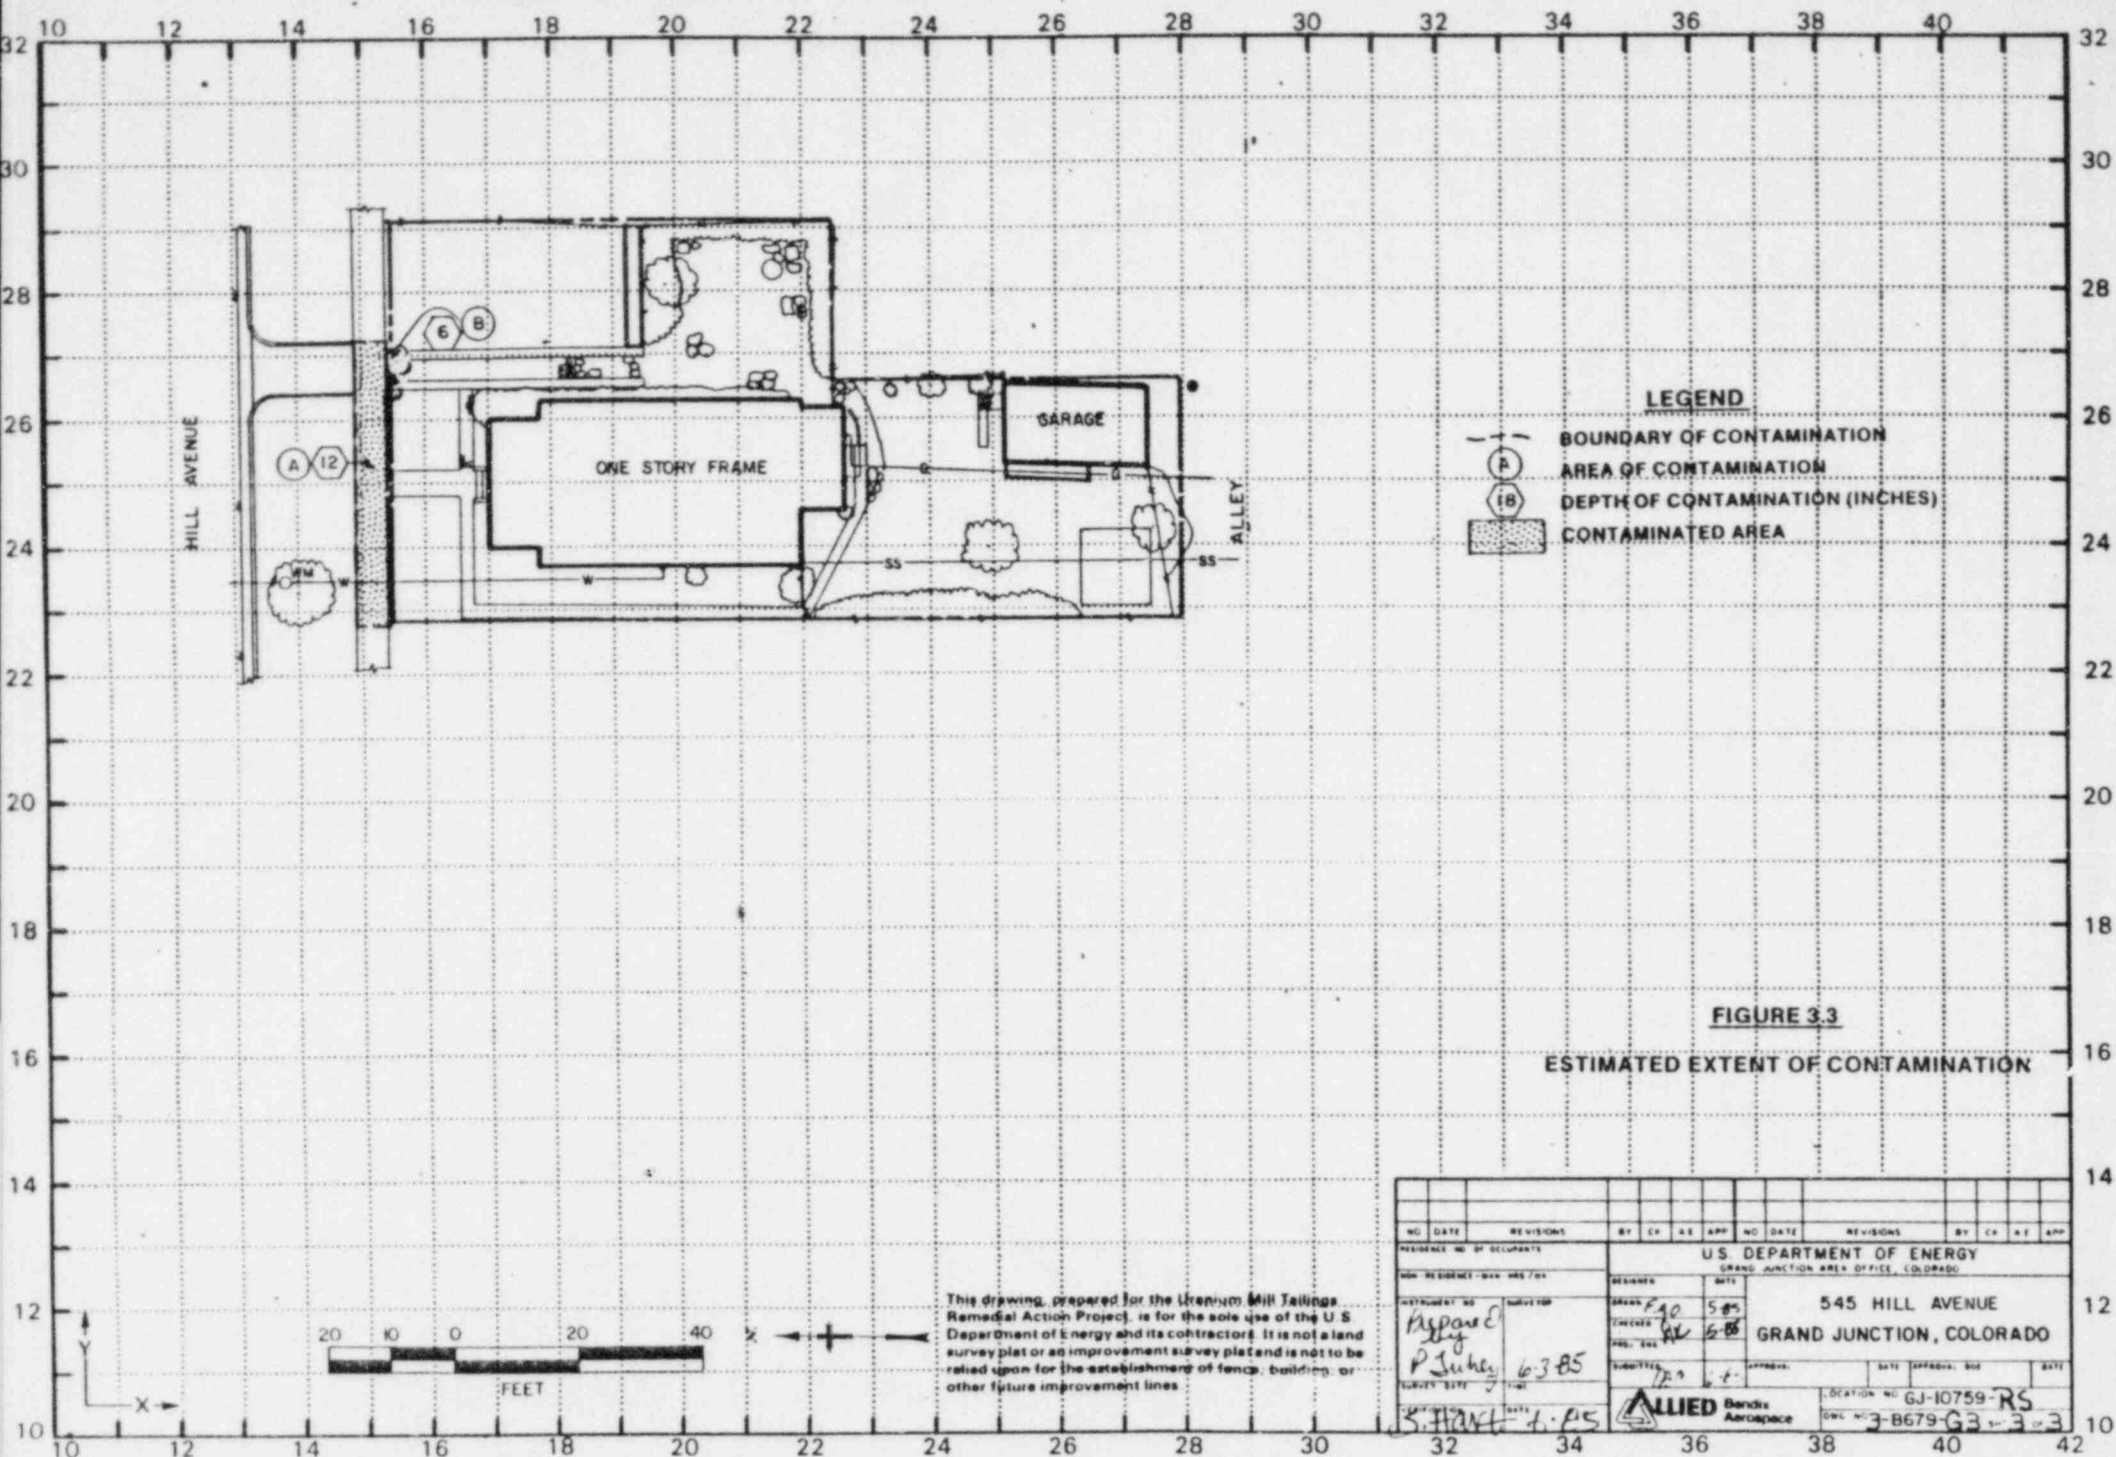
Appendix Figure 3.3 shows the identified areas and estimated depths of contamination on this property, based on assessments of all measurements taken. As noted in this figure, the areas recommended for remedial action that contain identified residual radioactive materials are:

(AREA A) A deposit under the 5-inch-thick uncontaminated concrete city sidewalk extends to a depth of 7 inches. The total depth of contamination is 12 inches (approximately 225 sf).

(AREA B) A small deposit near the driveway is contaminated to a depth of 6 inches (approximately 12 sf).

The areas on both sides of the city sidewalk should be monitored during remedial action for possible spillover.

The recommended remedial action for this property, DOE ID No. GJ-10759-RS, includes removal of all areas identified as containing radioactive material (as discussed in Section 3.5 and shown in Appendix Figure 3.3) and transport of removed material to the disposal site.

After remedial action is completed, the areas involved will be restored to original condition in accordance with the Bendix drawings, Vicinity Properties General Construction Specification (Bendix Field Engineering Corporation, 1984), and Statement of Work for Construction Subcontractor.
