RADIOLOGIC AND ENGINEERING ASSESSMENT

DOE ID NO.: GJ-04396-RS
ADDRESS: 2654 SACOMA COURT

JUNE 1985

BENDIX FIELD ENGINEERING CORPORATION
P.O. Box 1569
Grand Junction, Colorado 81502

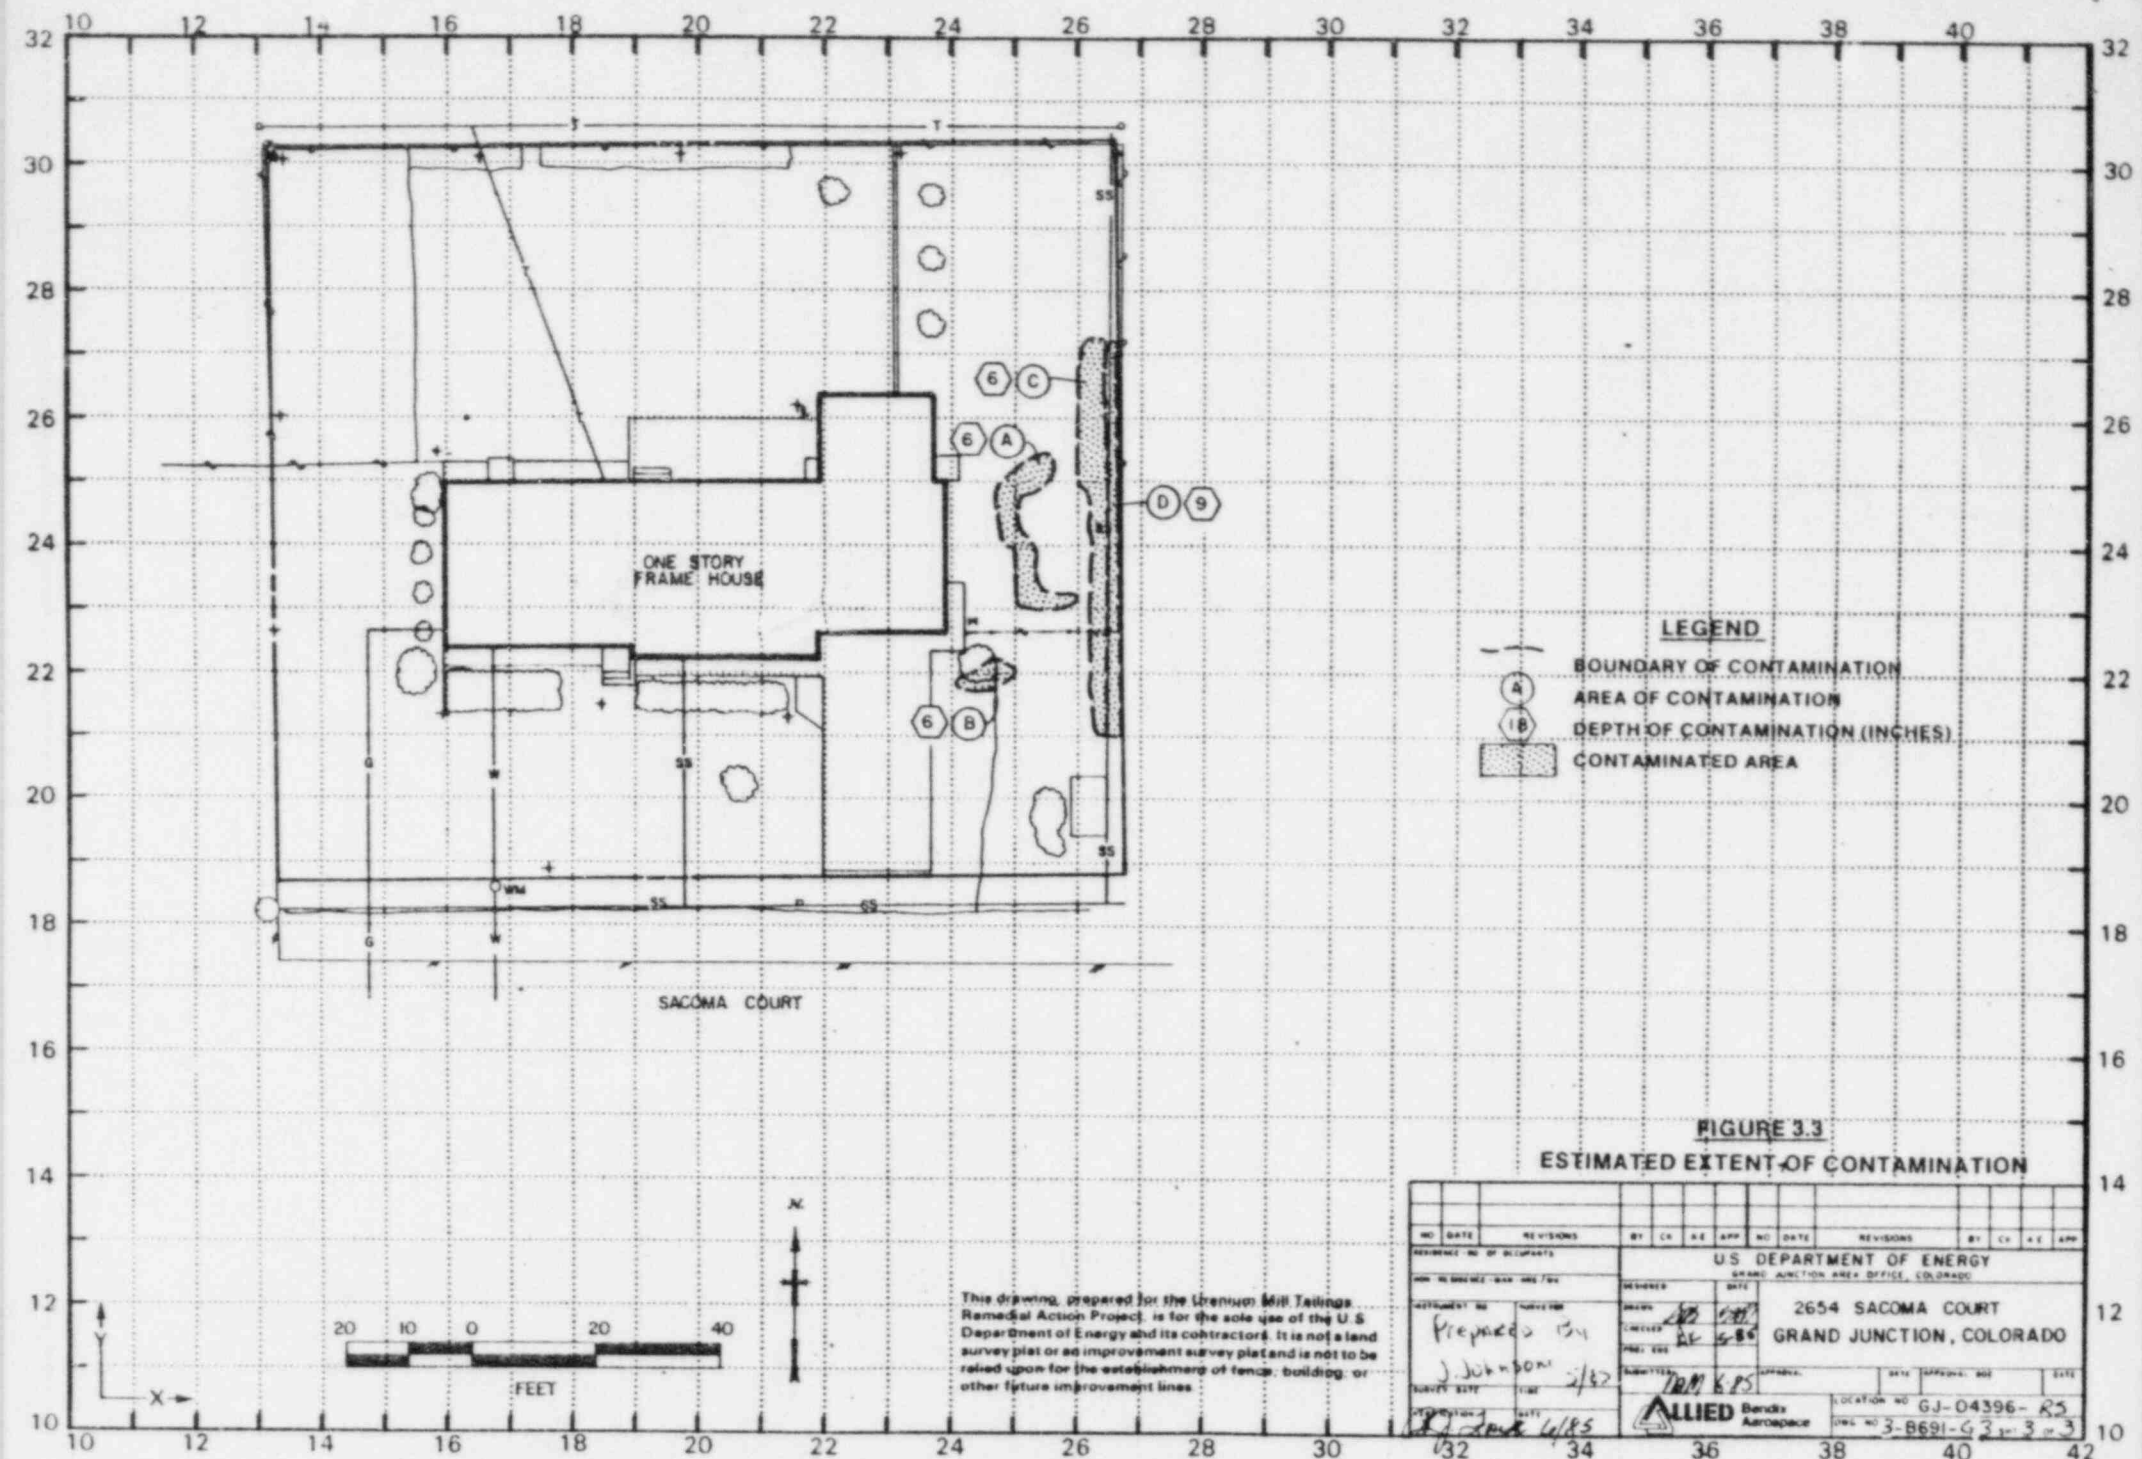
Appendix Figure 3.3 shows identified areas and estimated depths of contamination on this property, based on assessments of all measurements taken. As noted in this figure, areas recommended for remedial action that contain identified residual radioactive materials are:

- (AREA A) Contamination east of the primary structure extends to a depth of 6 inches (approximately 102 sf).
- (AREA B) A contaminated deposit around an evergreen tree, southeast of the primary structure, extends to a depth of 6 inches (approximately 36 sf).
- (AREA C) Contamination near the east property boundary extends to a depth of 6 inches (approximately 198 sf).
- (AREA D) A deposit along the fence, at the east property boundary, has contamination 9 inches deep (approximately 186 sf).

The recommended remedial action for this property, DOE ID No. GJ-04396-RS, includes removal of all areas identified as containing radioactive material (as discussed in Section 3.5 and shown in Appendix Figure 3.3) and transport of removed material to the disposal site.
