RADIOLOGIC AND ENGINEERING ASSESSMENT

DOE ID NO.: GJ-06194-CS  
ADDRESS: 908 NORTH 1ST STREET

JUNE 1985

BENDIX FIELD ENGINEERING CORPORATION  
P.O. Box 1569  
Grand Junction, Colorado 81502

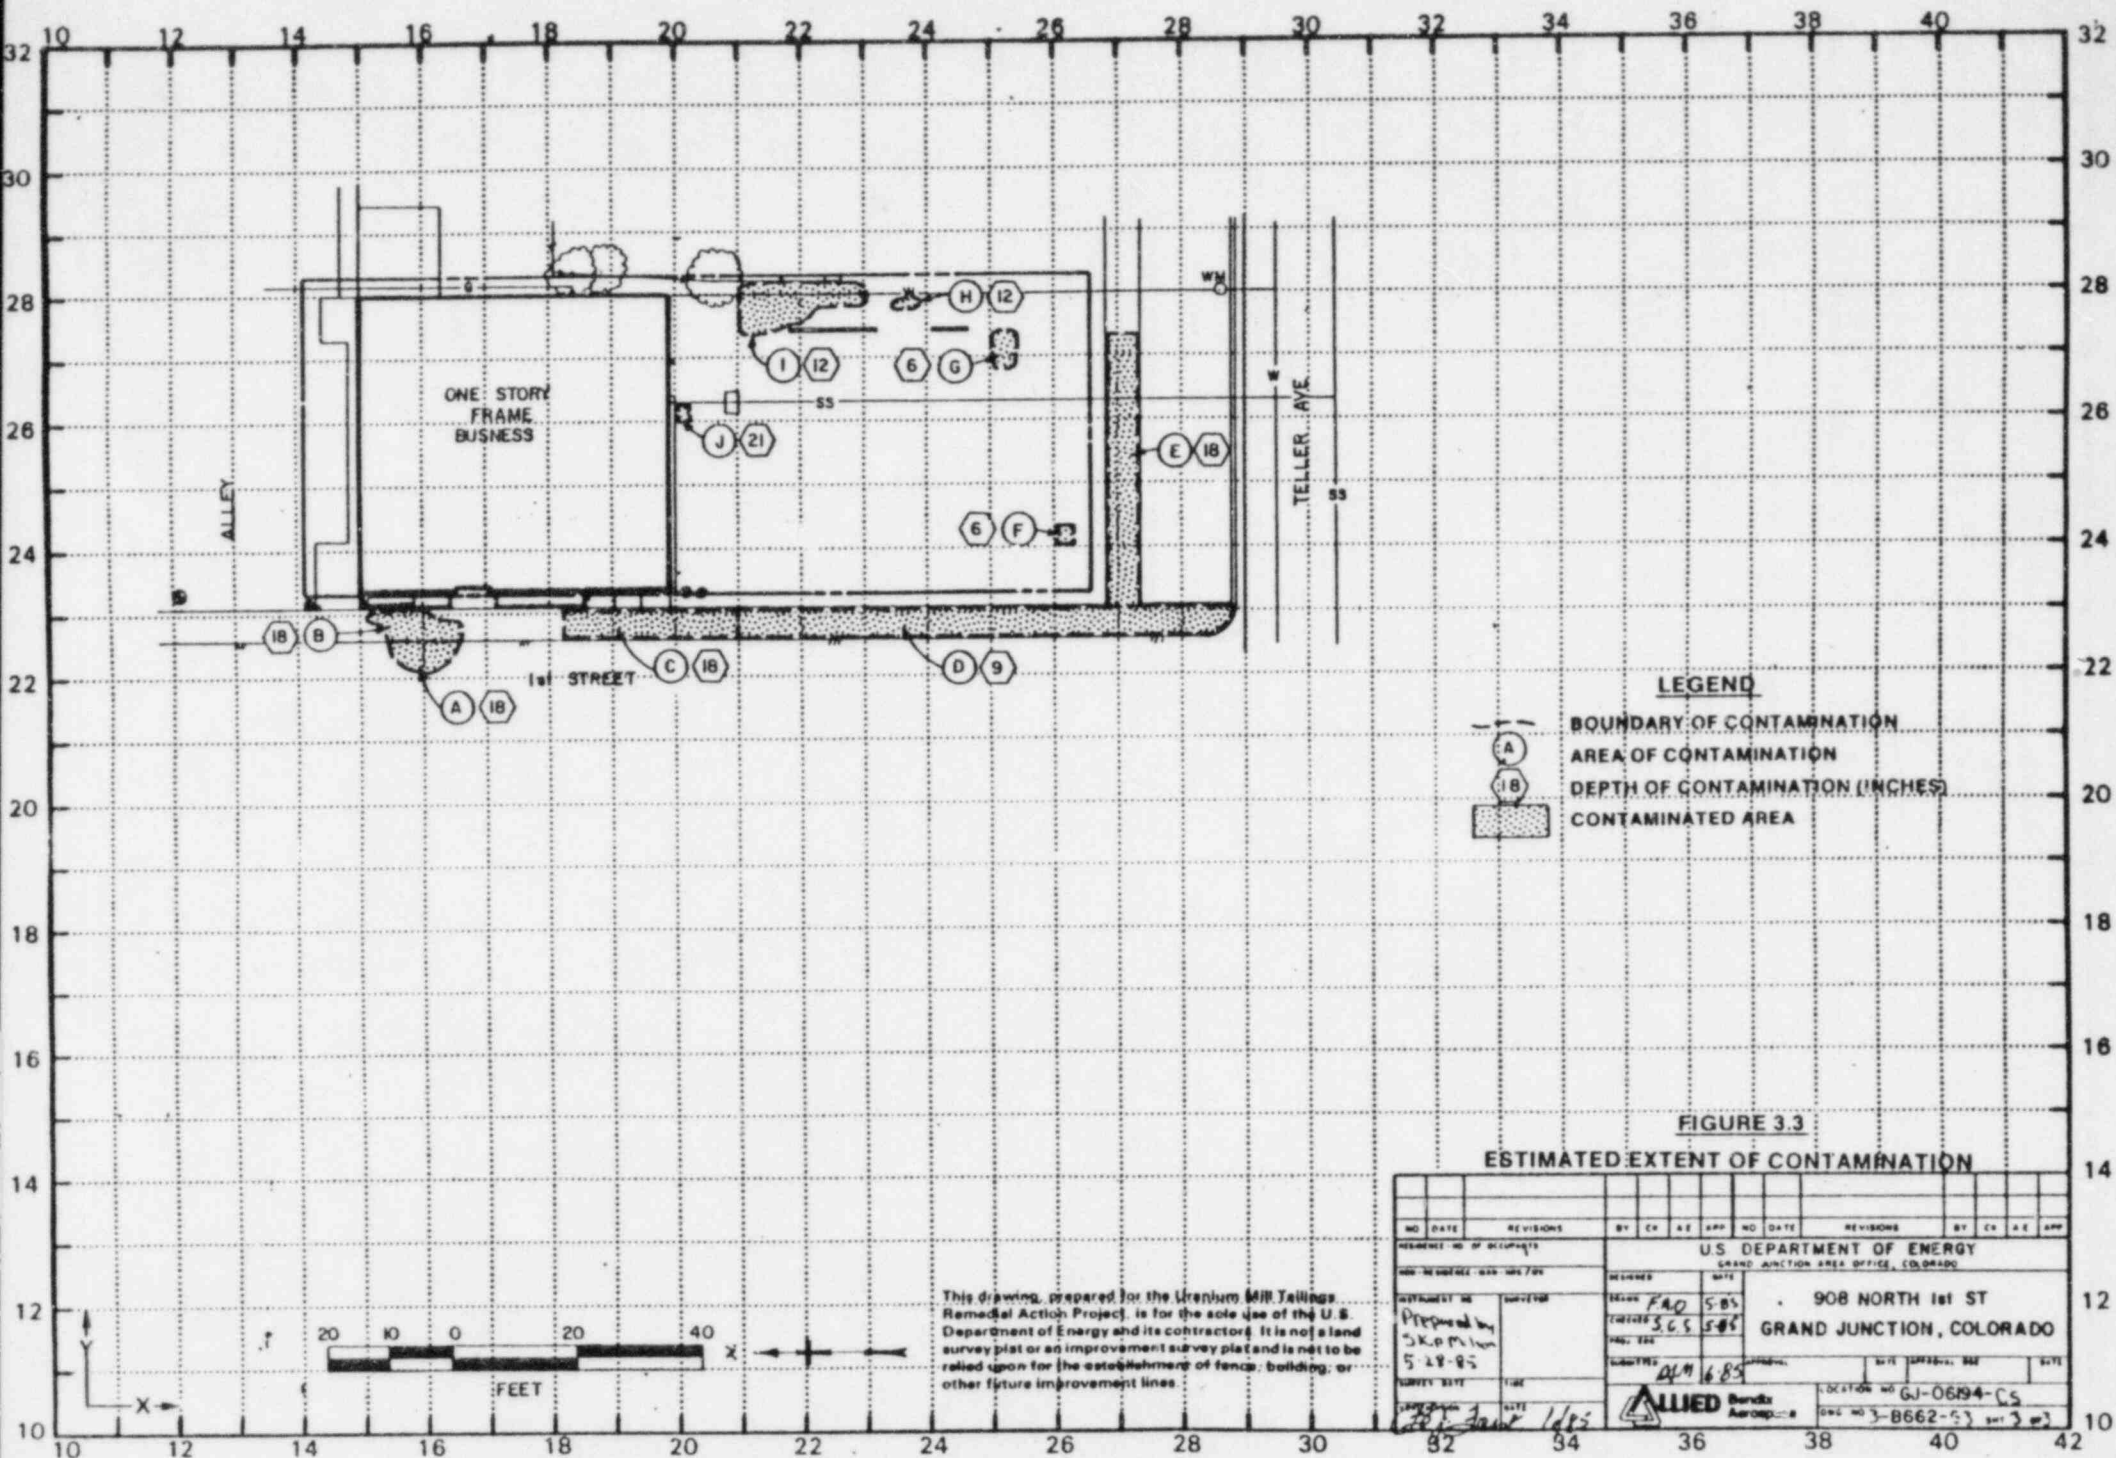
**FIGURE 3.3**

- (AREA A) Under the asphalt in the city street west of the primary structure, contamination extends to a total depth of 18 inches, based on information collected in Area B (approximately 50 sf). This area shall not be removed because tailings are not removed when found under city streets or alleys.

- (AREA B) Under the 4-inch-thick concrete sidewalk west of the primary structure, contamination extends to a depth of 14 inches. The total depth of contamination is 18 inches (approximately 50 sf).

- (AREA C) Southwest of the primary structure, contamination under the 4-inch-thick concrete sidewalk extends to a depth of 14 inches. The total depth of contamination is 18 inches (approximately 90 sf).

- (AREA D) South of Area C, contamination extends under the 4-inch-thick concrete sidewalk to a depth of 5 inches. The total depth of contamination is 9 inches (approximately 380 sf).

- (AREA E) South of the primary structure, contamination extends under the 4-inch-thick concrete sidewalk to a depth of 14 inches. The total depth of contamination is 18 inches, based on information collected in Area C (approximately 210 sf).

- (AREA F) In the gravel parking lot south of the primary structure, contamination extends to a depth of 6 inches (approximately 9 sf).
- (AREA G) In the gravel parking lot, a deposit of contamination extends to a depth of 6 inches (approximately 24 sf).

- (AREA H) A small deposit of contamination along the east property line extends to a depth of 12 inches, based on information collected in Area I (approximately 8 sf).

- (AREA I) Southeast of the primary structure, contamination extends to a depth of 12 inches (approximately 136 sf).

(AREA J) South of the primary structure, contamination extends to a depth of 21 inches. An old slab of concrete is buried in this area (approximately 6 sf).

Areas under the sidewalk should be closely monitored during remedial action to assure all contaminated material is removed.

The recommended remedial action for this property, DOE ID No. GJ-06194-CS, includes removal of all areas identified as containing radioactive material (as discussed in Section 3.5 and shown in Appendix Figure 3.3) and transport of removed material to the disposal site.
