RADIOLOGIC AND ENGINEERING ASSESSMENT

DOE ID NO.: GJ-00069-RS
ADDRESS: 1733 NORTH 17TH STREET

JUNE 1985

BENDIX FIELD ENGINEERING CORPORATION
P.O. Box 1569
Grand Junction, Colorado 81502

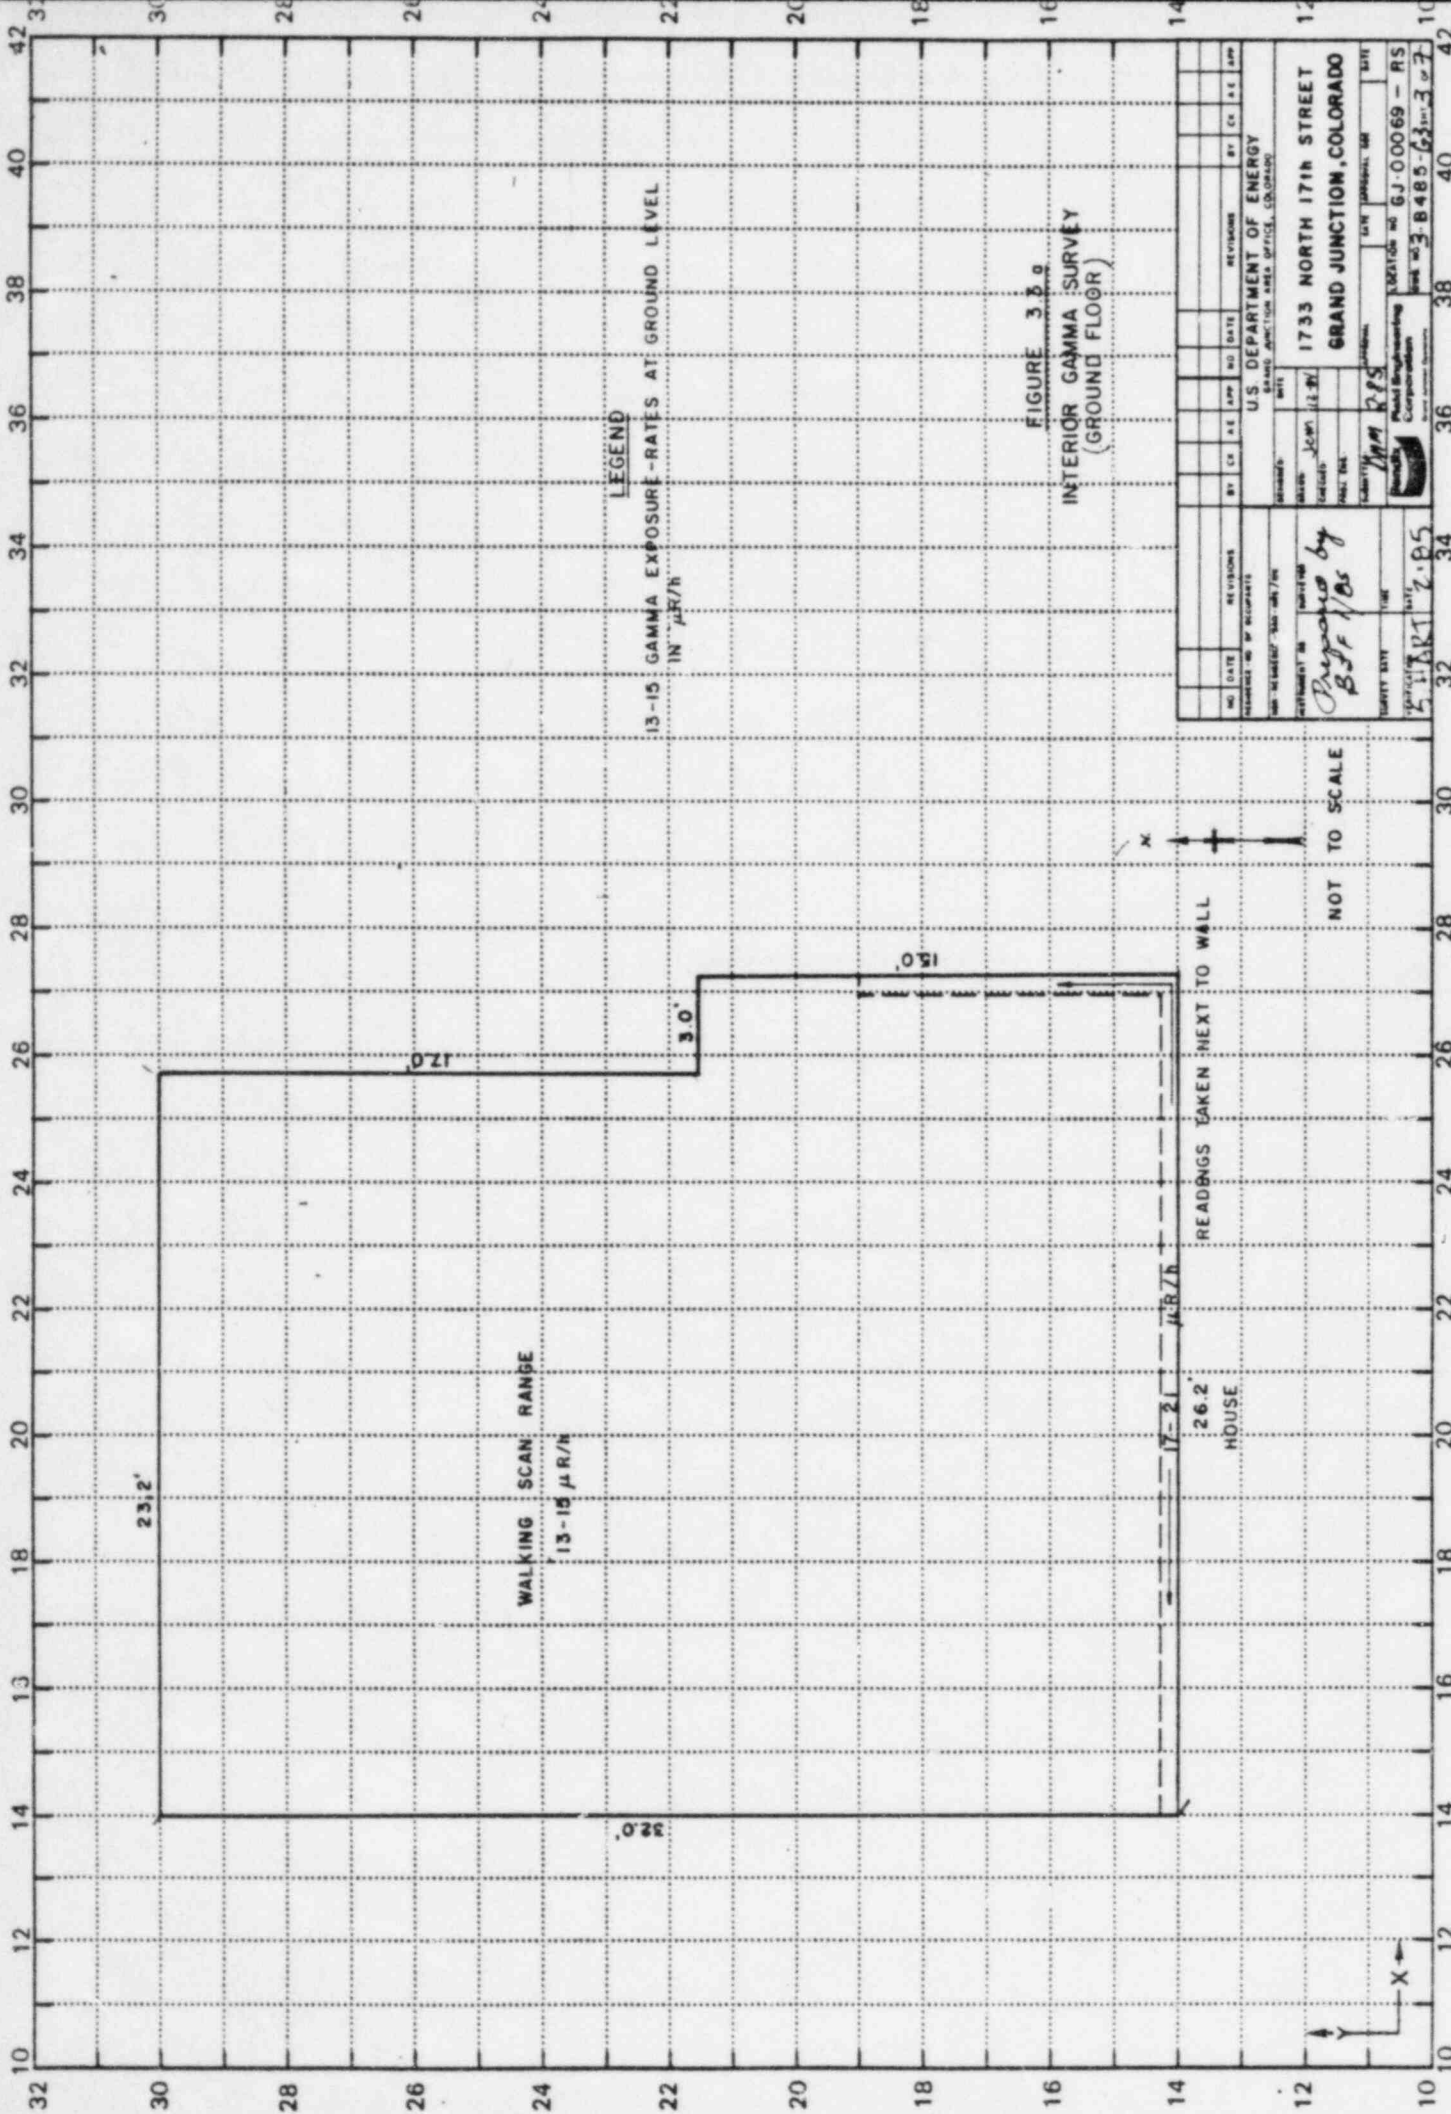
FIGURE 3.3.9
INTERIOR GAMMA SURVEY
(GROUND FLOOR)

Interior gamma exposure-rate measurements are summarized in Appendix Table 3.2. Appendix Figures 3.3a and 3.3b show interior exposure rates and locations of these measurements.

* The CDH and ORNL data indicated the absence of interior contamination associated with the primary structure at this property. This information was investigated by performing a walking gamma scan. These areas and the ranges of gamma measurements are shown in Appendix Figure 3.3a. Exposure rates for the garage and shed are shown in Appendix Figure 3.3b.
